Watershed Field Assessment Report North Branch Park River Watershed

Connecticut Department of
Environmental Protection

March 2010

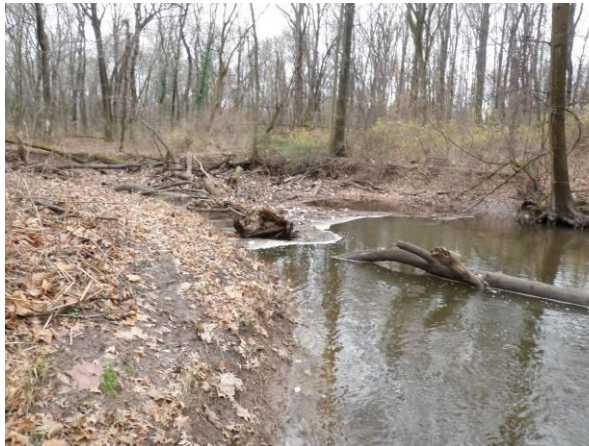
NBP-14: Excellent

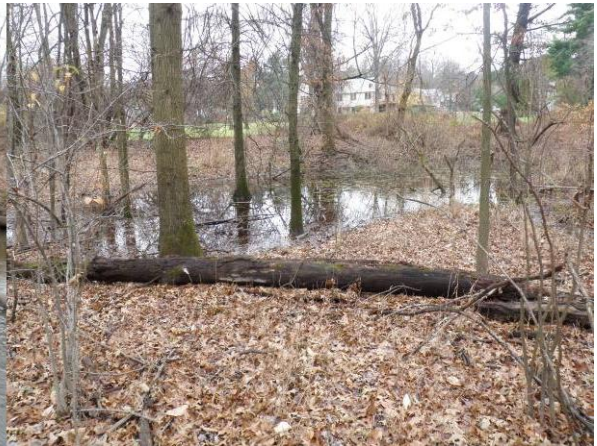
NBP-13: Good

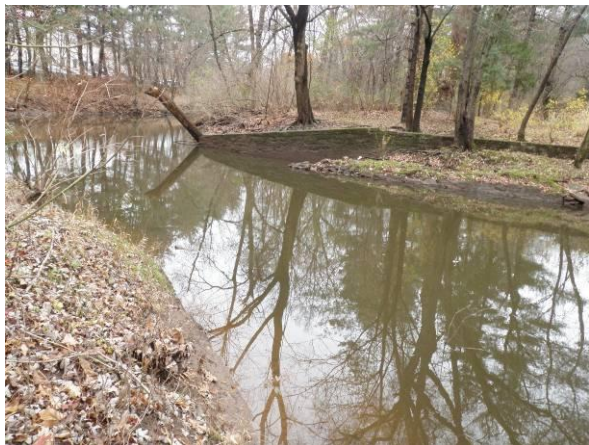
NBP-15: Fair

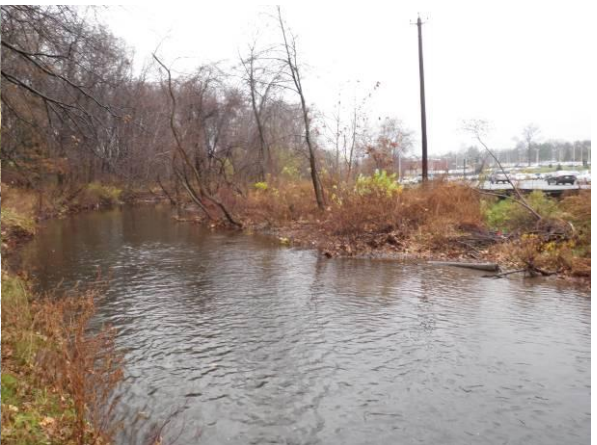
NBP-10: Marginal

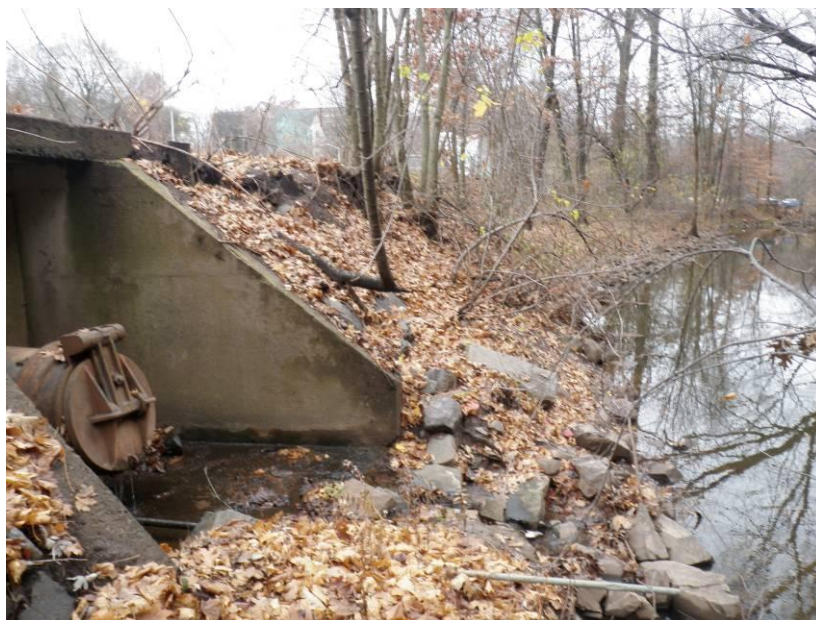
NBP-16: Poor overall condition, with little connectivity to the floodplain, modified bank habitat, and numerous outfalls

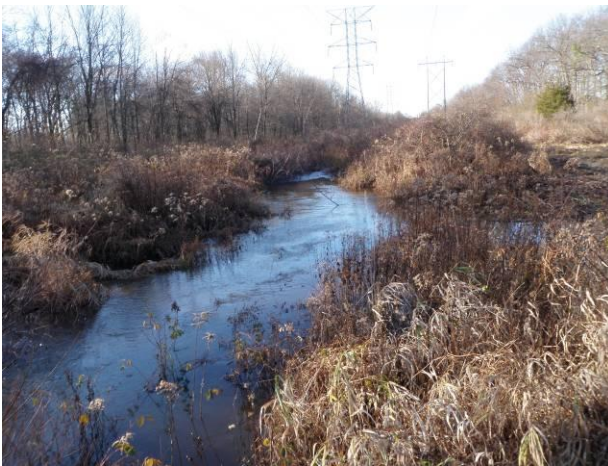
The buffer and floodplains of BBE-02 were well-vegetated; however, BBE-01 and part of the BBE-04 floodplain is actively managed to maintain clearance between the power lines and vegetation, such that the stream is poorly shaded. The riparian area of BBE-04 is also impacted by adjacent residential lawns.

BBE-01: Electric utility line vegetation maintenance in the riparian area.

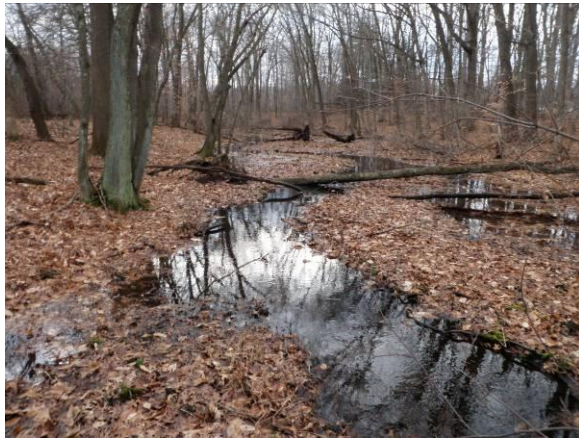
WBN-04: A high-quality, scenic portion of the reach.

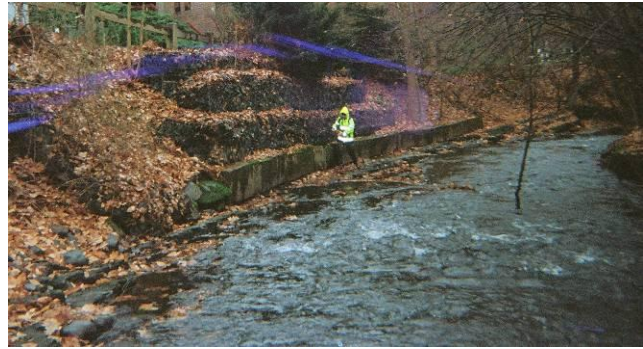
WBS-11 shows evidence of erosive instability throughout, but especially in the downstream portion, south of Cottage Grove Road. Some of this section runs over bedrock, and the adjacent bank and slopes have been reinforced by riprap and gabions, primarily on the left bank near a medical center and along the right bank where the brook flows close to Bloomfield Avenue. In spite of the armoring, slope failures are present between the stream and the road.

WBS-11: Steep bank reinforced with gabions.

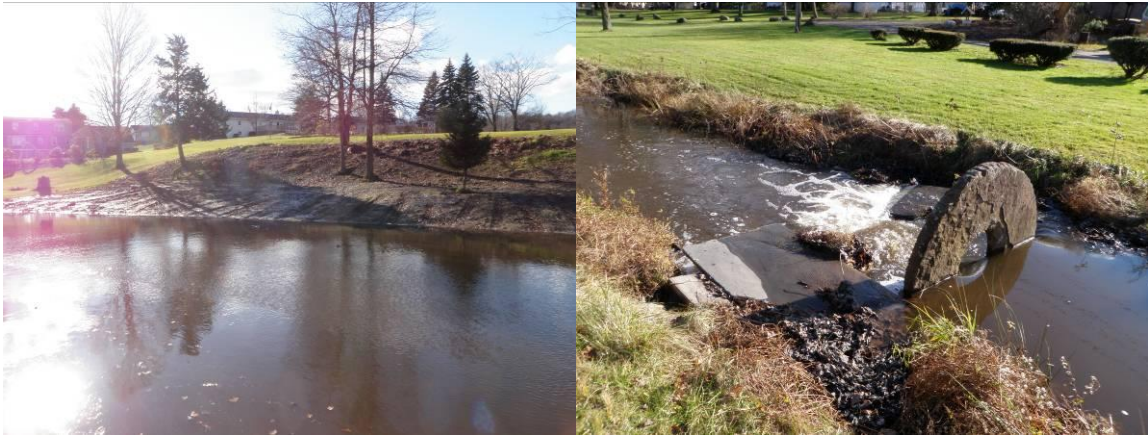
WBS-04: Bank and channel modification and evidence of recent pond dredging.

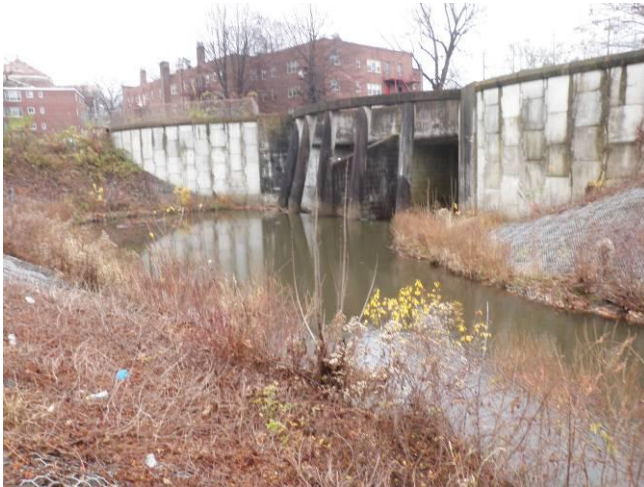
NBP-16: North Branch Park River at entrance to flood control conduit.

NBP-16 is the reach immediately upstream of the flood control conduit. This reach is highly altered, characterized by extensive attempts at channel and slope stabilization near the conduit entrance. This reach is rated as "Poor," and is the lowest-rated reach in the entire watershed. Numerous parking lots are located close to the river along the left bank. Where the bank is not armored, it is often eroding, and many large outfalls discharge to this reach. The buffer on the right bank is mostly wooded and less disturbed, except at the downstream end, where there is a steep armored slope, and slope failure where the armoring

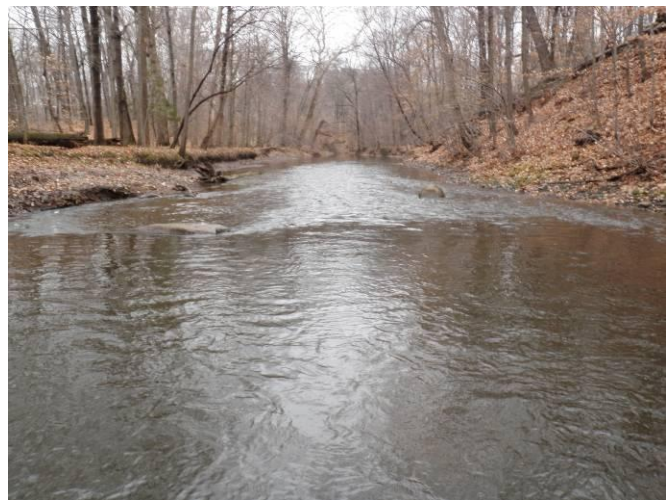
NBP-14 is rated as "Excellent," with the highest score of all the reaches assessed, due to the relatively stable stream channel (although erosive forces are still evident) and the extensive, mature forested riparian buffer. Some sizable stormwater pipes are located along the left bank. A sewer line also appears to cross the river near the middle of the reach.

NBP-14: High-quality reach of the North Branch Park River.

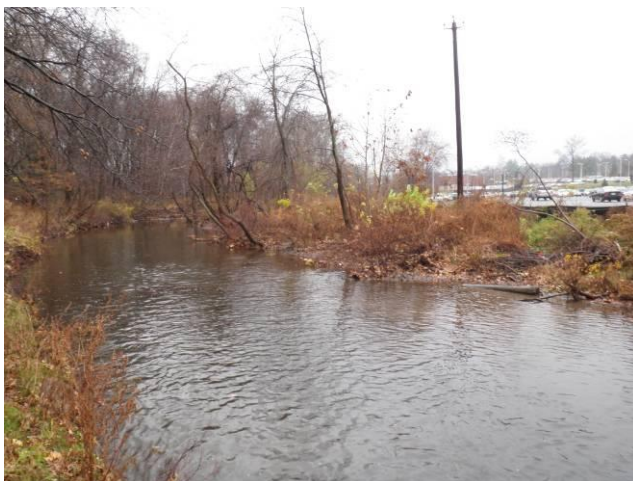
NBP-10: University of Hartford parking lots adjacent to the North Branch Park River.

Conditions in NBP-10 are slightly better; the stream reach was rated as “Marginal.”

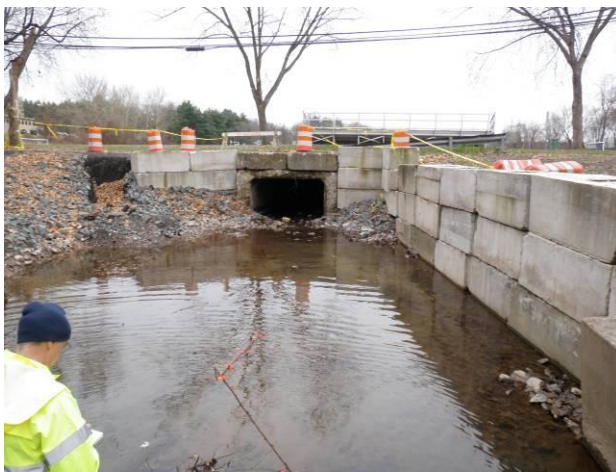
- The downstream end of Reach NBP-19 appears to have been recently modified through armoring the banks with riprap and concrete blocks and removing riparian vegetation. The work appears to have been performed to repair the entrance to a culvertized section of the stream. This site may be a good candidate for bank stabilization and riparian restoration.

NBP-19: Channel heavily and recently modified upstream of Burnham Street.

NBP-19 is a segment of a small tributary located northeast of the University of Hartford. Reach NBP-19 flows through a narrow wooded area east of Granby Street. The channel is somewhat disturbed, with broken outfall pipes and a toppled headwall, fallen trees, debris dams, and scoured banks. A major stormwater outfall pipe and eroded channel on the right bank are located near the upper end of the reach. The downstream end of the stream reach is highly altered and appeared to have been recently excavated, lined with riprap, and the channel modified with large concrete blocks on the right bank. The reach ends at a culvert under Burnham Street, which

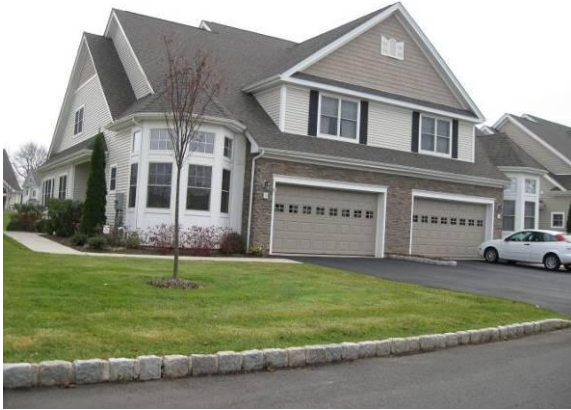
The Greens at Gillette Ridge

This medium-density neighborhood consists of single-family residences and townhomes and is approximately 35 acres in size. It is located in the Tumbledown Brook subwatershed in Bloomfield and is associated with the Gillette Ridge Golf Course, which is located immediately to the south and west of the subdivision. The subdivision is approximately 5 years old and is not yet fully built-out. The existing homes are on approximately ¼-acre lots. The lots have approximately 50% impervious cover and approximately 30% grass cover, with intensive turf management

practices including lawn irrigation systems and the use of chemical fertilizers. There is no tree cover in this neighborhood since it was recently developed. The driveways, streets and catch basins are clean, dry and clear of trash, litter or organic debris such as leaves. All of the observed roof leaders are directly connected to the storm drain system despite the majority of the houses having adequate space for on-site rain gardens and rain barrels for watering of landscaped areas. This neighborhood is a good candidate for rain barrel and rain garden education programs, including environmentally-friendly residential lawn care and landscaping practices.

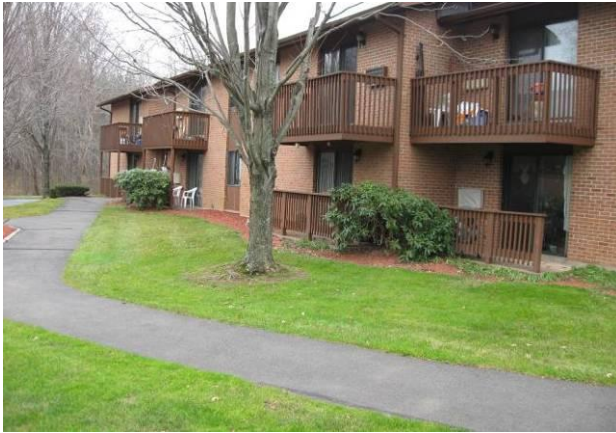
The Woodside Village apartments are located on Dorothy Drive in Bloomfield in the Wash Brook South subwatershed. The approximately 21-acre complex is constructed along 1,500 feet

of Wash Brook. Stormwater runoff from the complex drains directly to Wash Brook without attenuation or treatment. The landscape maintenance intensity of the property was generally high, with managed turf areas and mulched gardens. Many roof leaders drain to turf areas. One roof leader was observed to drain to a turf area within 5 feet of yard drains, which is insufficient separation to effectively infiltrate runoff into the lawn.

Potential opportunities for improvements at this complex include stenciling the catch basins along the roadways and driveways, planting a wider buffer to Wash Brook along the roadside, installing rain gardens to receive stormwater from roof leaders that discharge to narrow vegetated strips, and implementing parking lot stormwater retrofits such as water quality swales or bioretention.

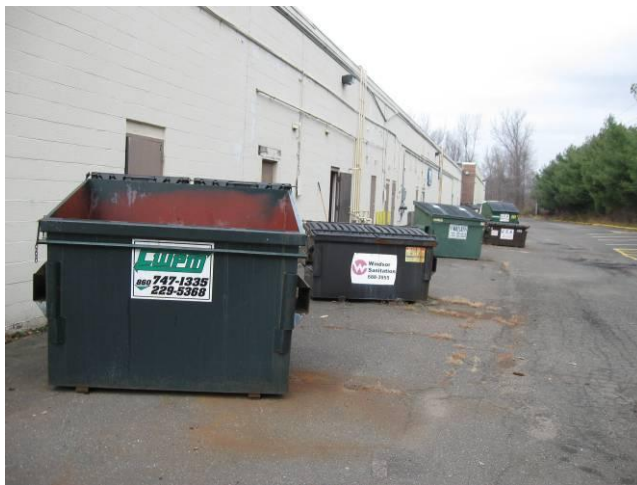
Runoff from garbage dumpster area drains to nearby catch basin

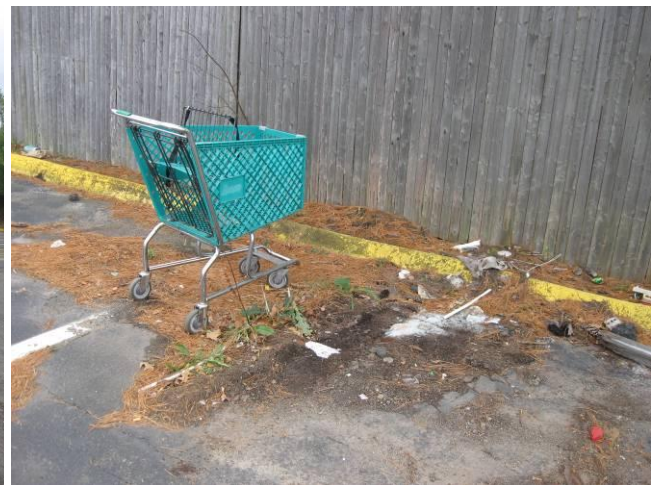
The parking lot pavement is breaking up and stained and sediment and debris have collected in some areas.

The shopping plaza parking lot is estimated to be approximately 15 years old. The pavement is in poor condition, with areas of broken pavement and significant oil staining. The storage of outdoors materials and loading operations could be improved to reduce the potential for stormwater pollution from the site. Each retail store appears to rent its own dumpster, and some dumpsters were not properly covered, many are located near a catch basin, and staining on the ground was observed around the dumpsters. Materials were stored outdoors without cover including bins, crates, packing materials, and various other items. The conditions and practices observed at this shopping plaza are typical of those at similar commercial shopping

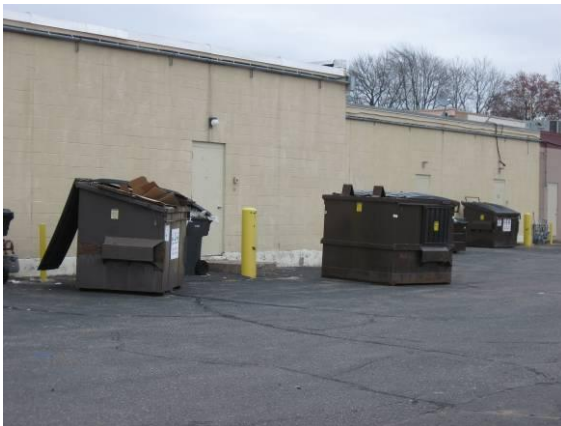
An uncovered dumpsters near a catch basin.

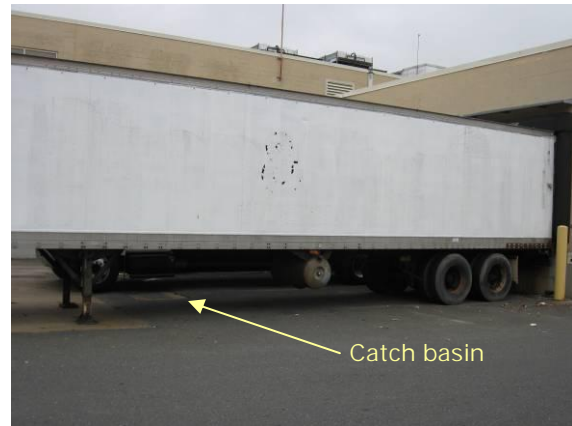
- Loading operations – Loading docks are positioned over drainage catch basins. Idling trucks may leak oil or other vehicle fluids that can discharge directly to the stormwater drainage system.
- Outdoor materials storage – The shopping center maintains outdoor sand and salt storage piles. The salt pile and one of the sand piles were covered, but a larger sand pile was not covered at the time of the evaluation. A catch basin is located nearby, although no evidence of material migration to the stormwater system was observed.
- Waste Management – Several dumpsters in the rear of the retail shops had no covers and were overflowing with garbage. The dumpsters are also located near catch basins.

Truck loading/unloading operations at this dock occur over a stormwater catch basin, increasing the potential for oil and spills to enter the system.
