Reach Level Assessment

SURVEY REACH ID: <u>NR-4</u>		WTRSHD/SUBSHD:		DATE: <u>11/23/09</u>		ASSESSED BY: <u>SG+CM</u>	
START TIME: <u>10:15</u> AM/PM	LMK: <u>FORMATION</u>	END TIME: <u>11:45</u> AM/PM	LMK: <u>ARMY</u>	GPS ID:			
LAT <u>41° 43' 04"</u> LONG <u>72° 43' 24"</u>		LAT <u>41° 48' 18"</u> LONG <u>72° 43' 34"</u>		DESCRIPTION:

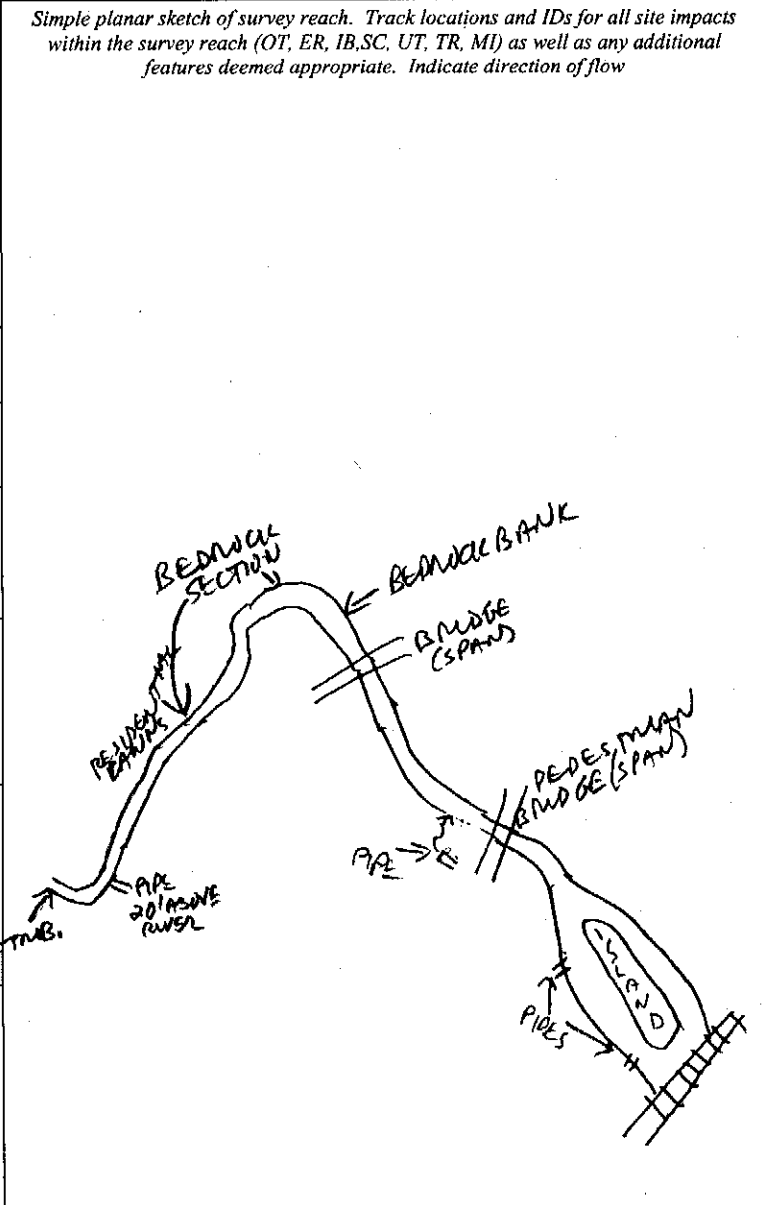
NOTES: (biggest problem you see in survey reach) some impacted water associated w/ U.H. FORD AND with private landownery - difficult accessibility + bedrock substrate would likely make this a poor candidate for restoration.

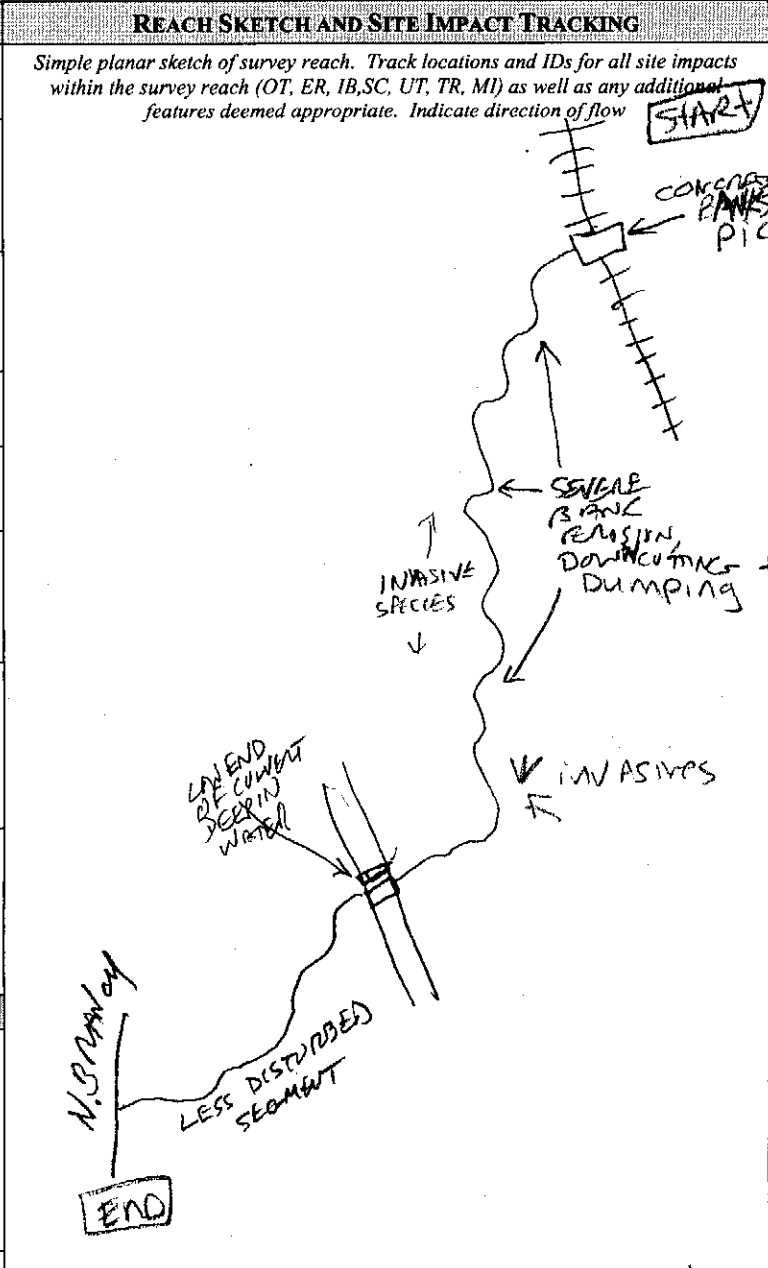
NOTES: (biggest problem you see in survey reach) Dumping, flashy flow, or invasive plants, SEDIMENT LOAD.

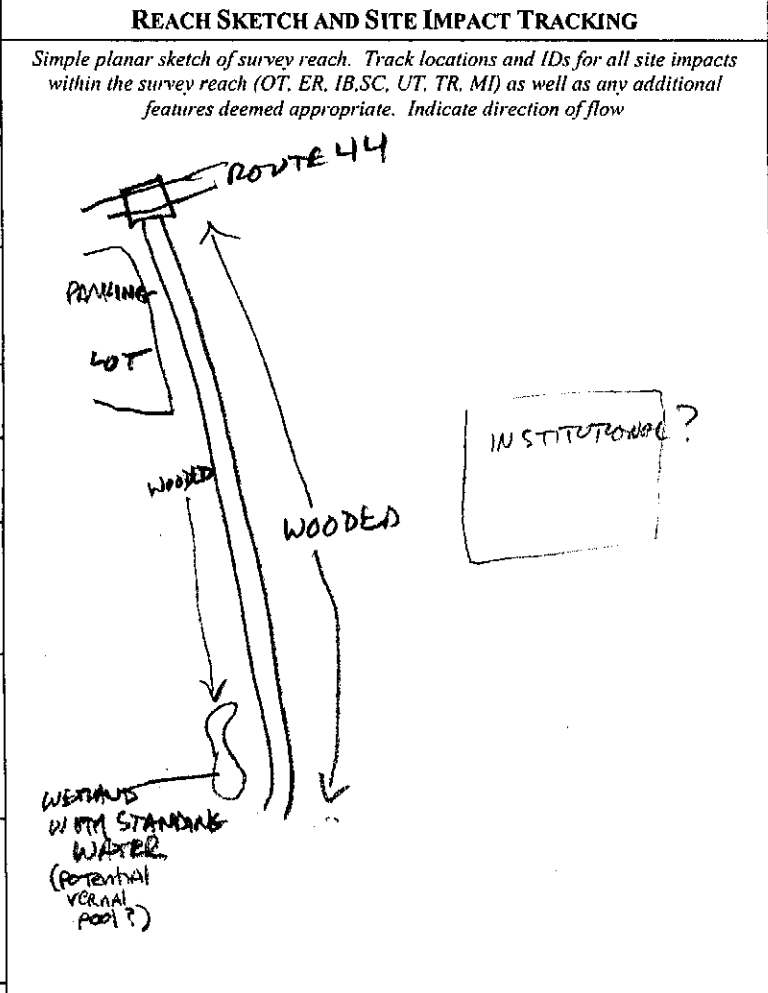
NOTES: (biggest problem you see in survey reach) Debris, parking lot adjacent to nearly 1/2 of right bank to this reach, stormwater cut fall pipes in need of repair.

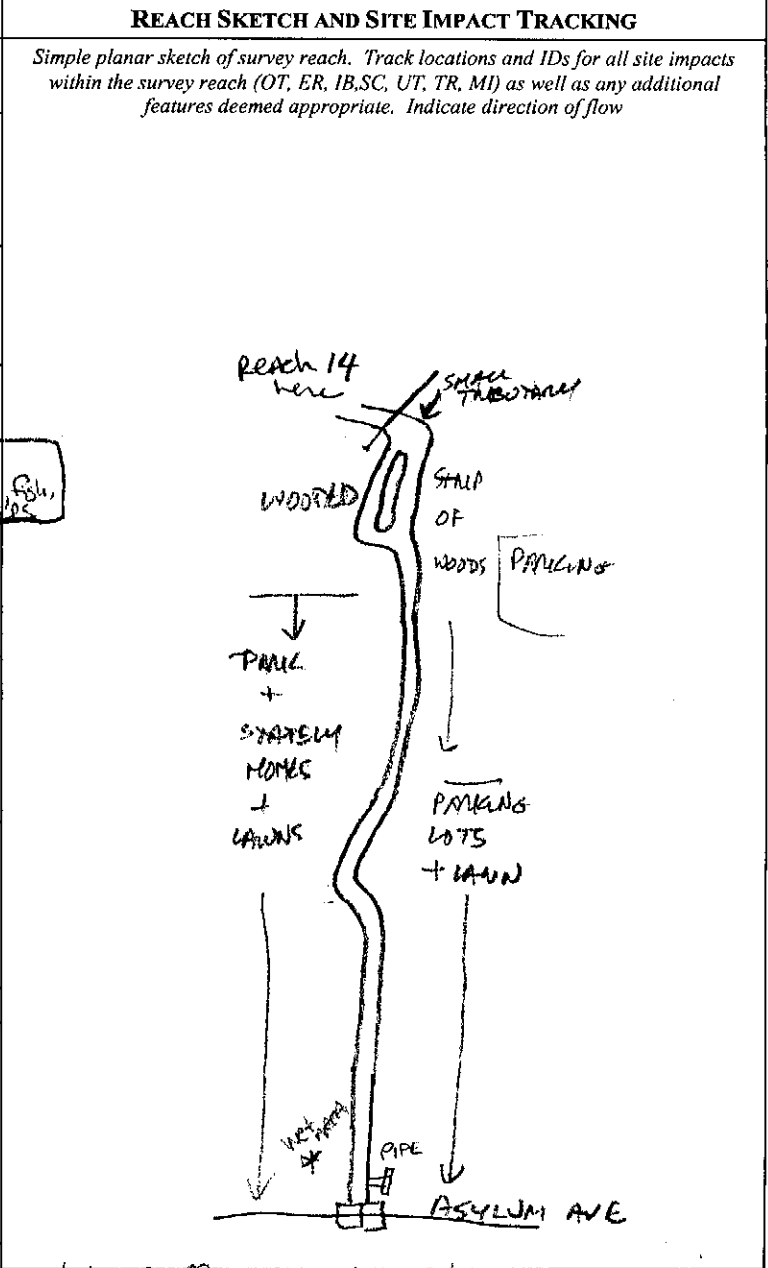
NOTES: (biggest problem you see in survey reach) Impacted Buffer due to parking lots, Main thorough LAWN, invasive plants (J. Knotweed), TRASH, stormwater runoff + chunks of concrete in isolated areas.

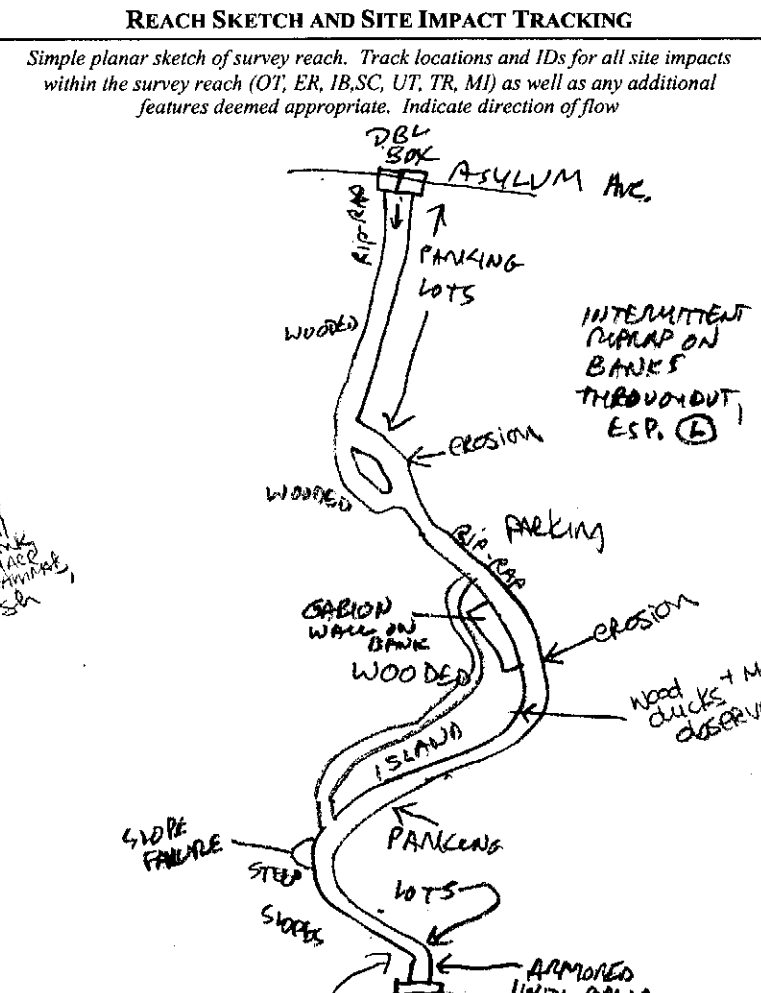
NOTES: (biggest problem you see in survey reach) Impacted Buffer ⇒ Parking lots adjacent to bank, rip-rap along almost entire reach/bank, residential lawn mowing, yard waste dumping, snow piling, TRASH/debris, invasive species (especially Jap. Knotweed).  
Unstable channel related to impacted buffer + stormwater inputs.

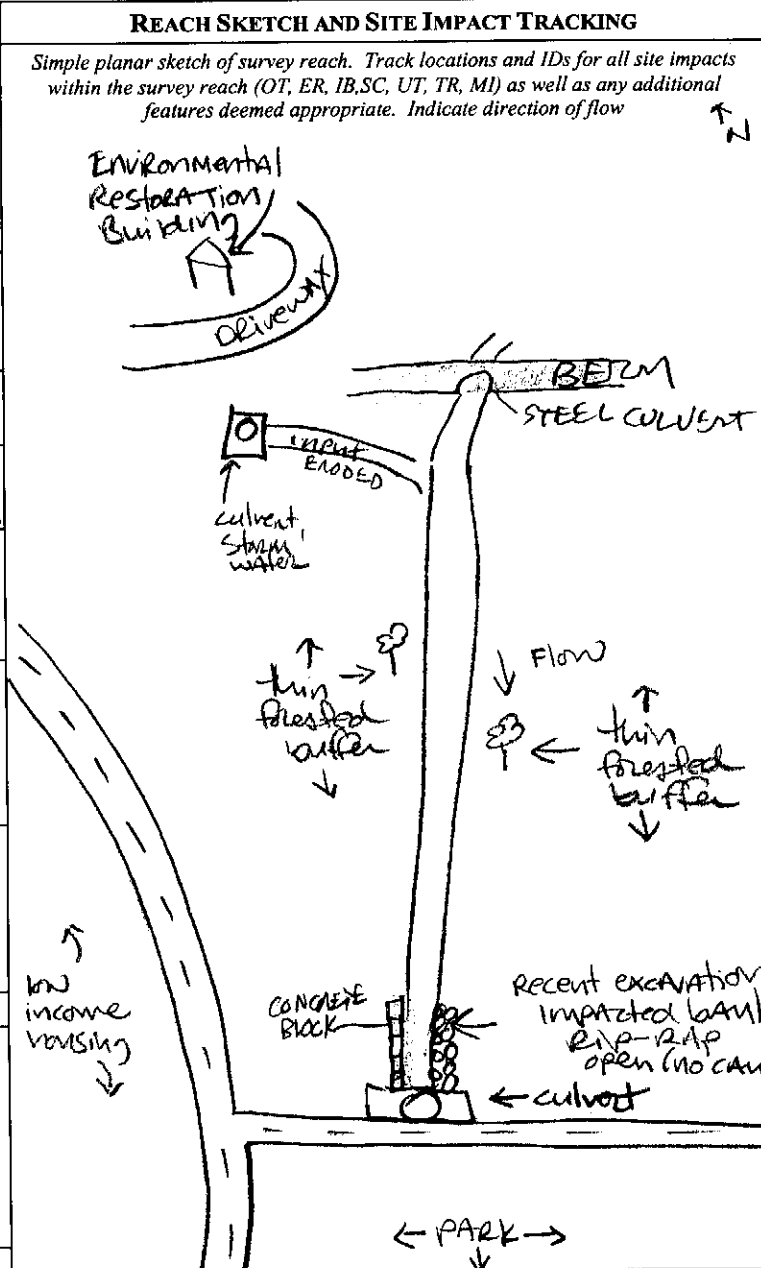
NOTES: (biggest problem you see in survey reach)  
 Impacted bank & southern end upstream of culvert. The underlying tunnel that carries water downstream must be very long - it is not located on the other side of the street - or it is closed.

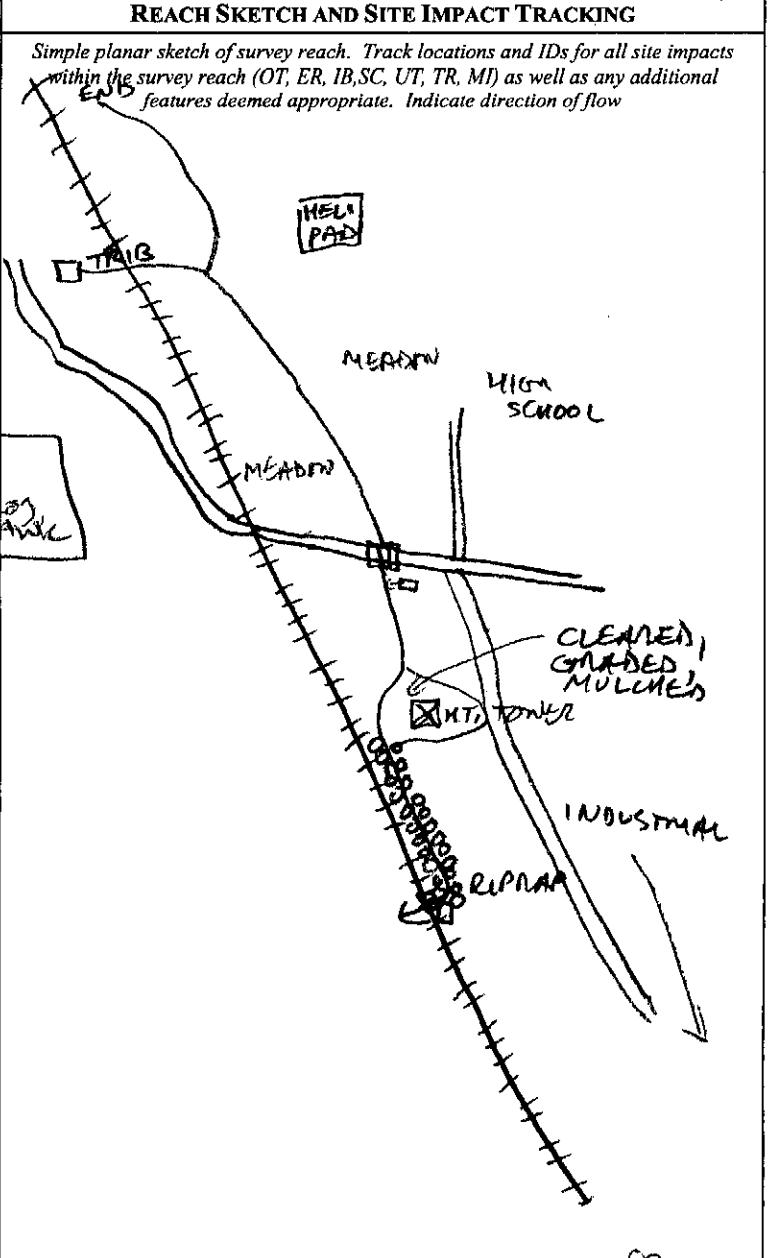
NOTES: (biggest problem you see in survey reach) Impacted buffer: lacks tall trees + wide buffer, mostly herbaceous with some shrubs, saplings + vines. AREAS of RIP-RAP, adjacent to Reel, road, Railroad tracks

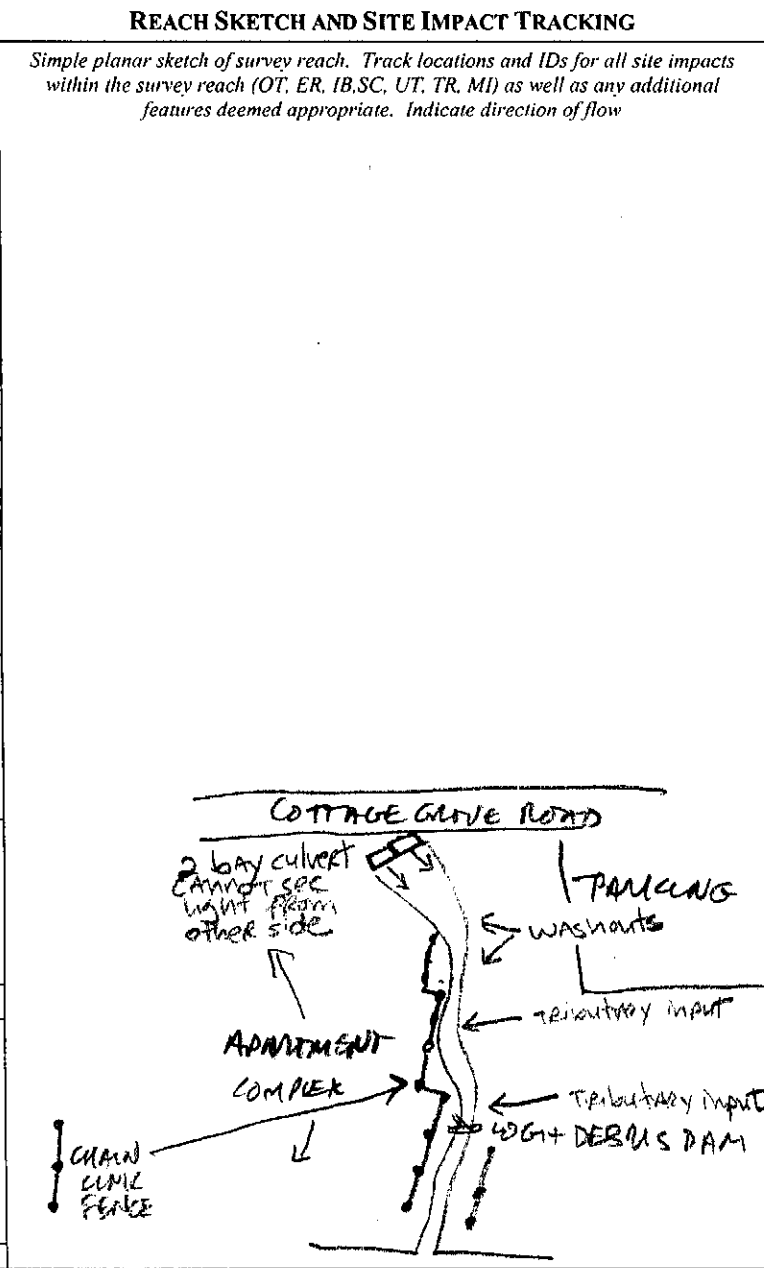
NOTES: (biggest problem you see in survey reach) STORMWATER RUNOFF NOT WELL MANAGED.

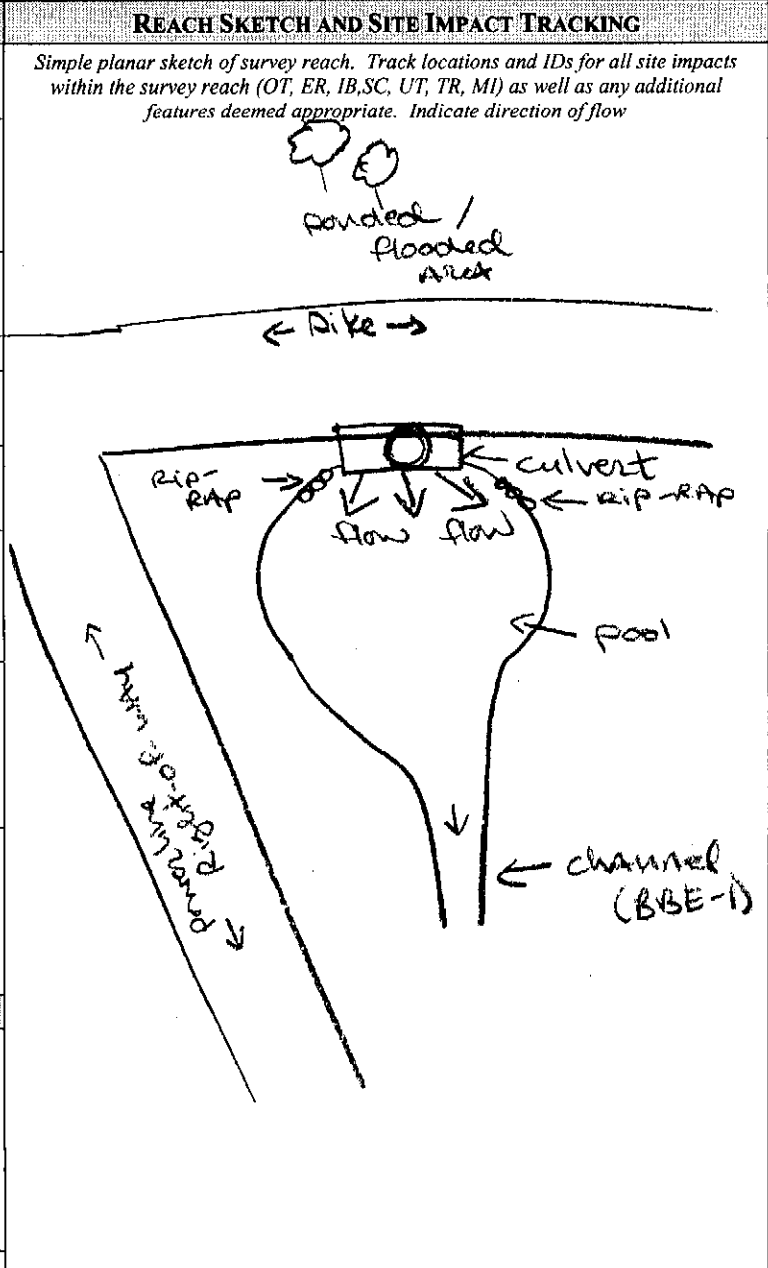
NOTES: (biggest problem you see in survey reach) 5 4 3 2 1 The velocity of flow through the culvert was so high it caused the water to pool + the banks to blowout (hence the rip-rap). There is no canopy cover - thermal increase.
