SURVEY REACH ID: 2	WTRSHD/SUBSHD: BBE	DATE: 12/3/09	ASSESSED BY: CM/BG
START TIME: 9:00 AM	LMK:	END TIME: 9:20 AM	LMK:
LAT: ? ° ' "	LONG: ? ° ' "	LAT: 41 ° 50 ' 21 "	LONG: 72 ° 42 ' 49 "
DESCRIPTION: Junction with BBE-4/BBE-3		DESCRIPTION: Junction with BBE-01

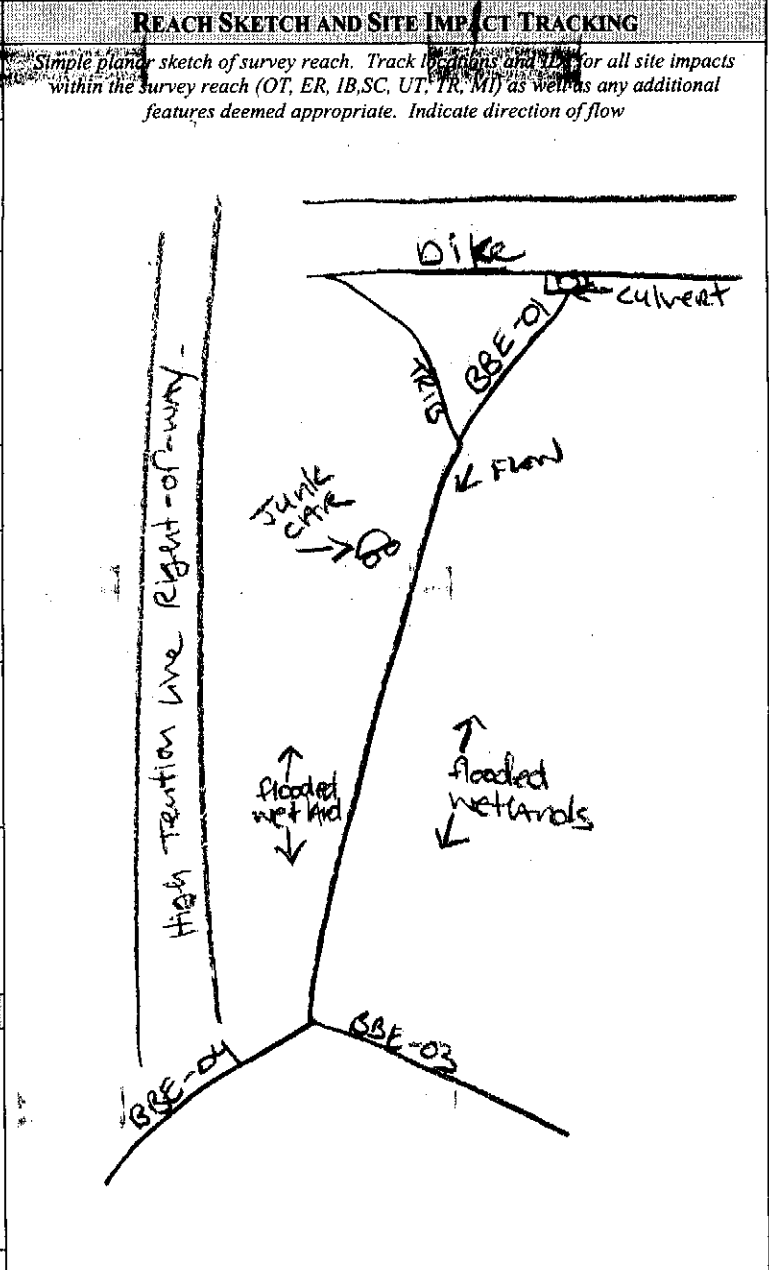
NOTES: (biggest problem you see in survey reach) Junked car + heavy sediment load

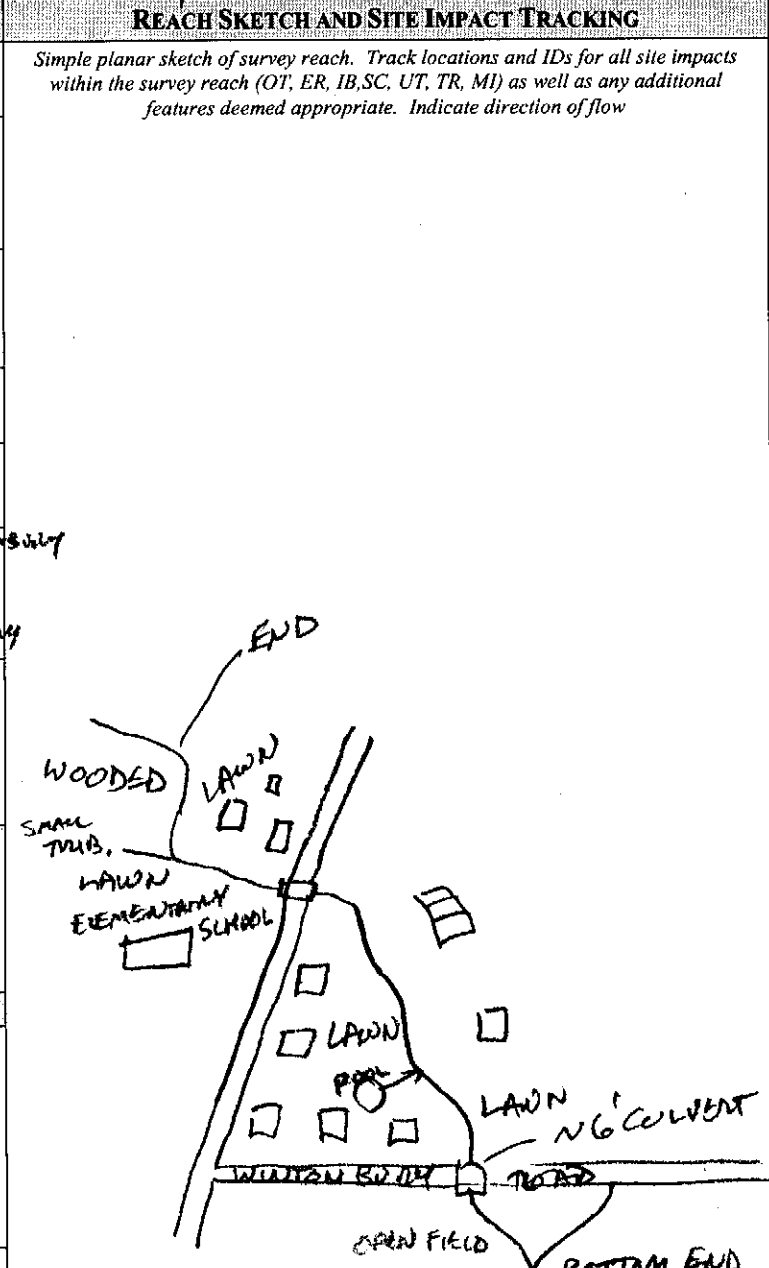
NOTES: (biggest problem you see in survey reach) **SUBURBANIA: MOWN LAWNS, DUMPING OF YARD WASTE, DRAINING OF POOL TO STREAM**

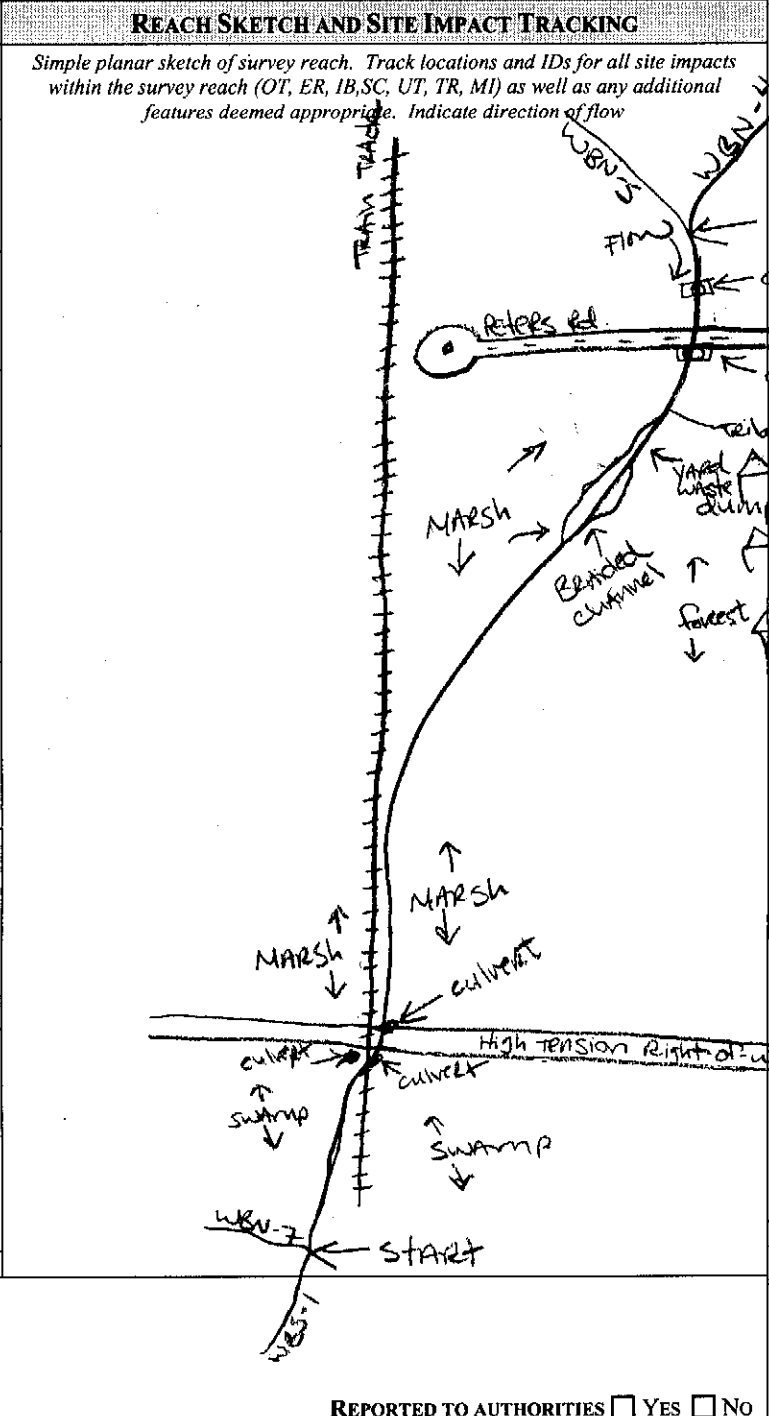
NOTES: (biggest problem you see in survey reach)
 Stone toe of RAILROAD tracks

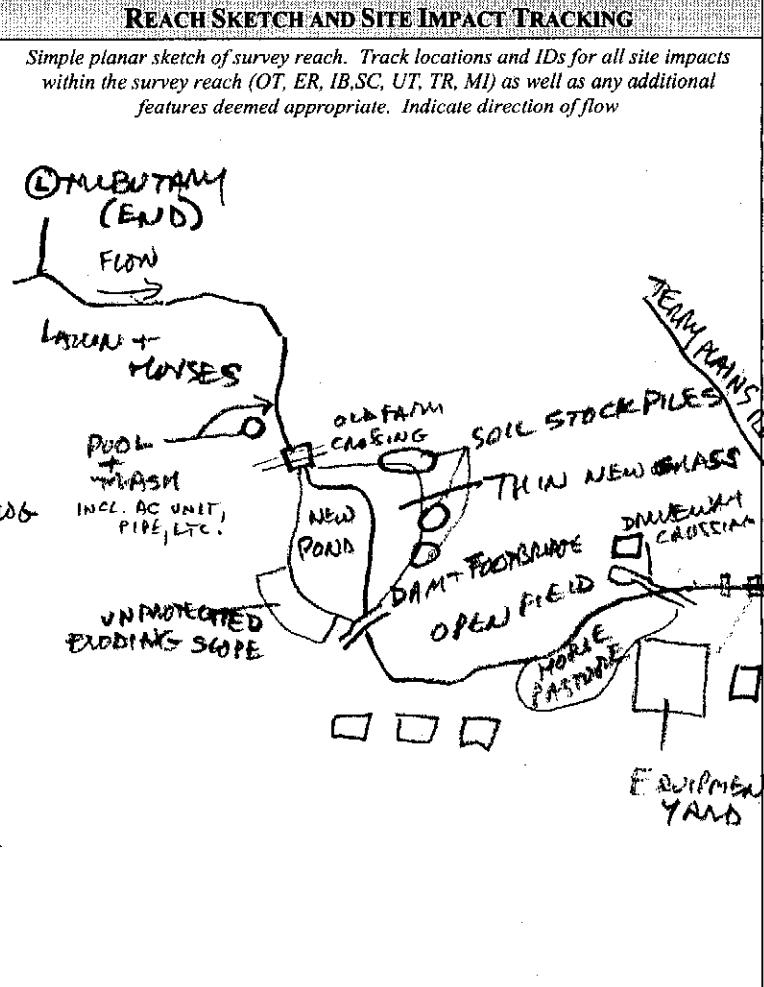
NOTES: (biggest problem you see in survey reach) RECENT POND EXCAVATION WITH VERY POOR EROSION + SEDIMENT CONTROL, PUTTING SEDIMENT INTO STREAM. ALSO EXTENSIVE BUFFER IMPACTS: TRASH, EQUIPMENT, MOWING, POOL

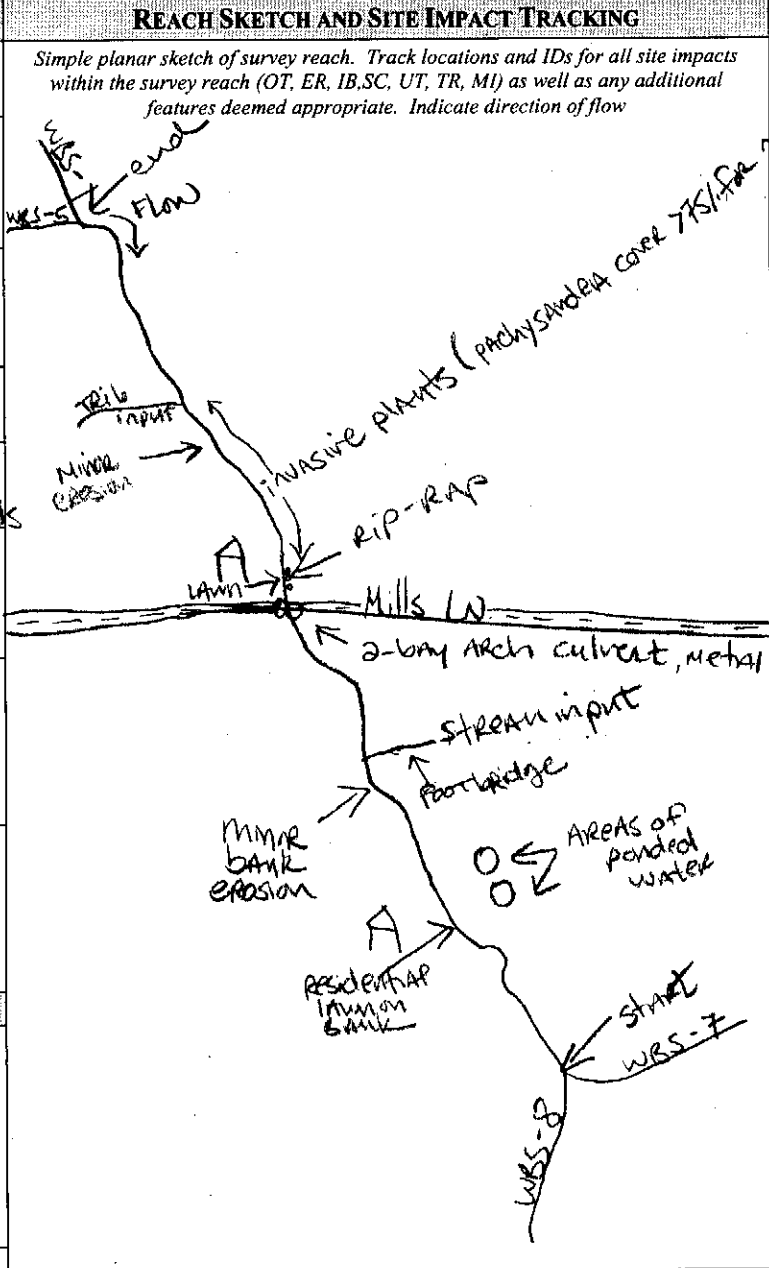
NOTES: (biggest problem you see in survey reach) *OVERGROW - this reach abuts residential homes. + garden "escapes" such as PACHYSANDRA + JAPANESE BARBERY ARE common + in some AREAS those plants dominate their stream.*

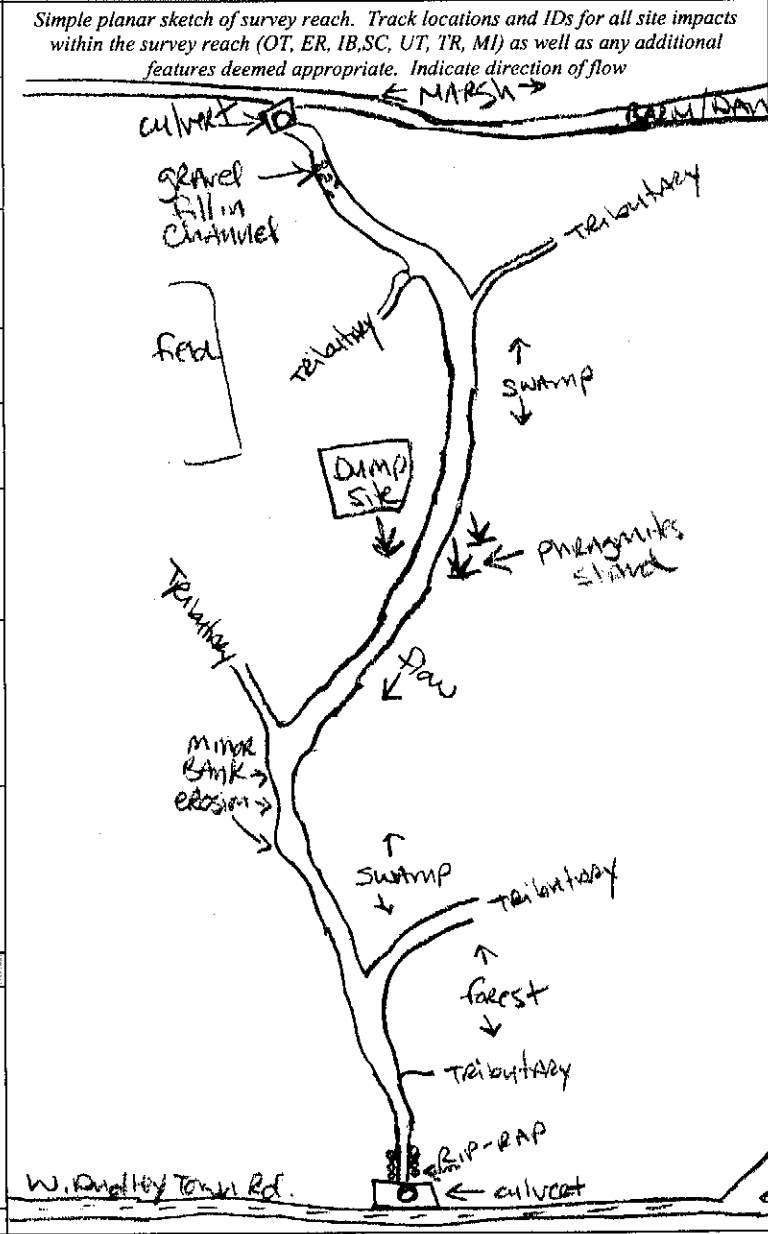
NOTES: (biggest problem you see in survey reach) Dumping, trash

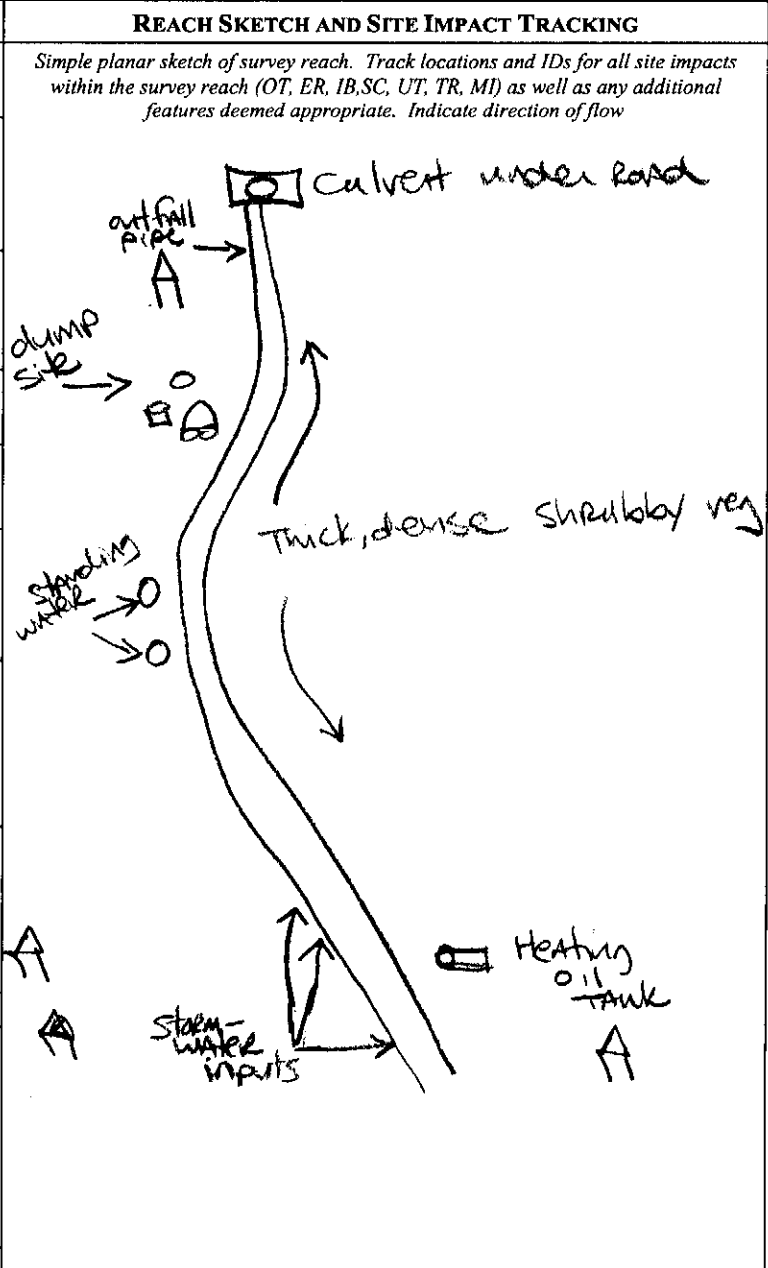
NOTES: (biggest problem you see in survey reach) Dumping, including old car, heating oil tank, oil drums, store, toilet, sink, tires. Some invasive plants (multiflora rose, knotweed, garlic mustard, barberry).

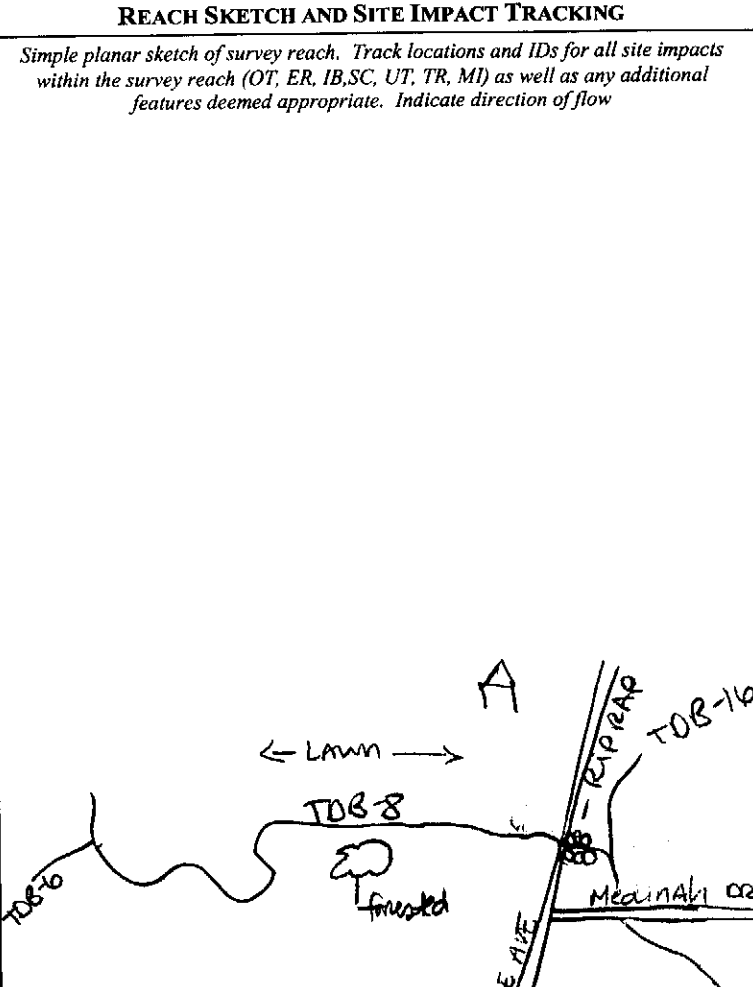
NOTES: (biggest problem you see in survey reach) Impacted buffer due to residential lawns along left bank in particular, some rip-rap on both banks, east of Maple Ave.

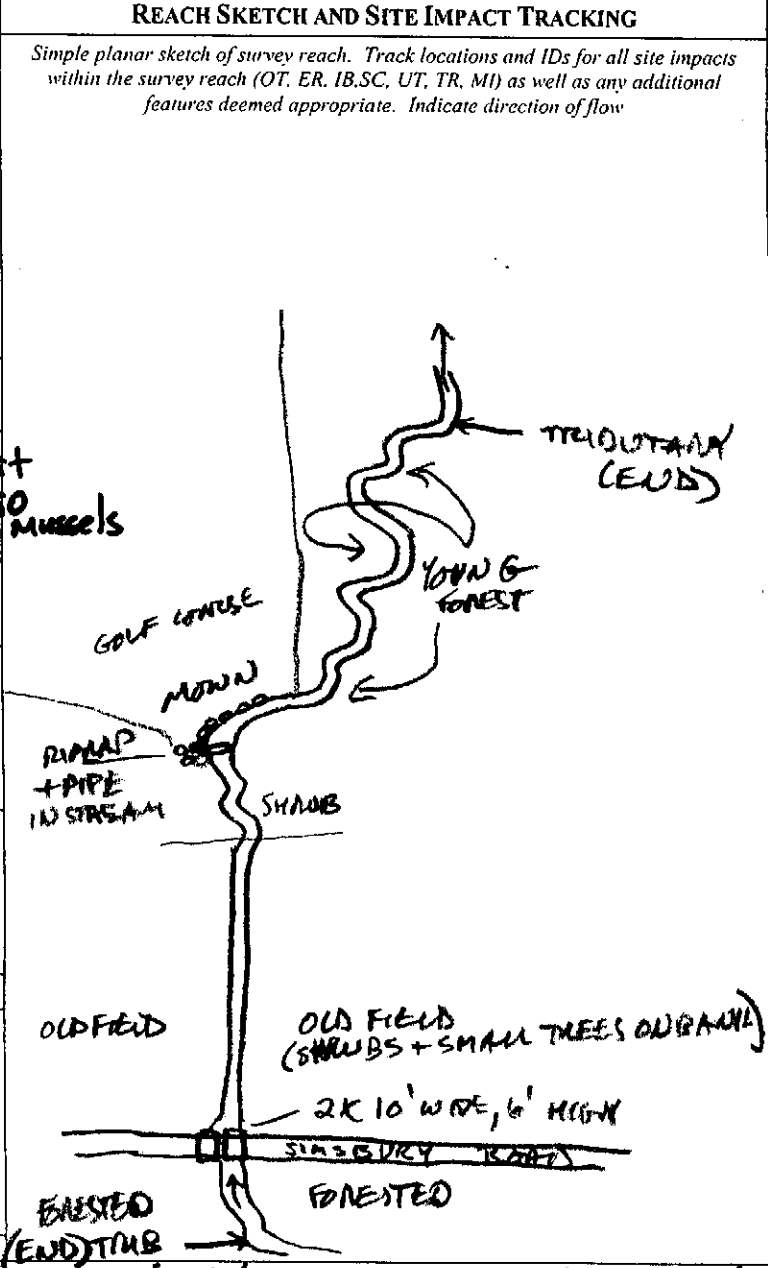
NOTES: (biggest problem you see in survey reach) Golf course impacts - chemical / thermal loading + increase in trash/debris (golf balls + bottles). Otherwise this reach is in good overall condition.
