### Trinity College Water Quality Monitoring Results

# Baseline Water Quality Analysis of the North Branch of the Park River Watershed

Summer 2008

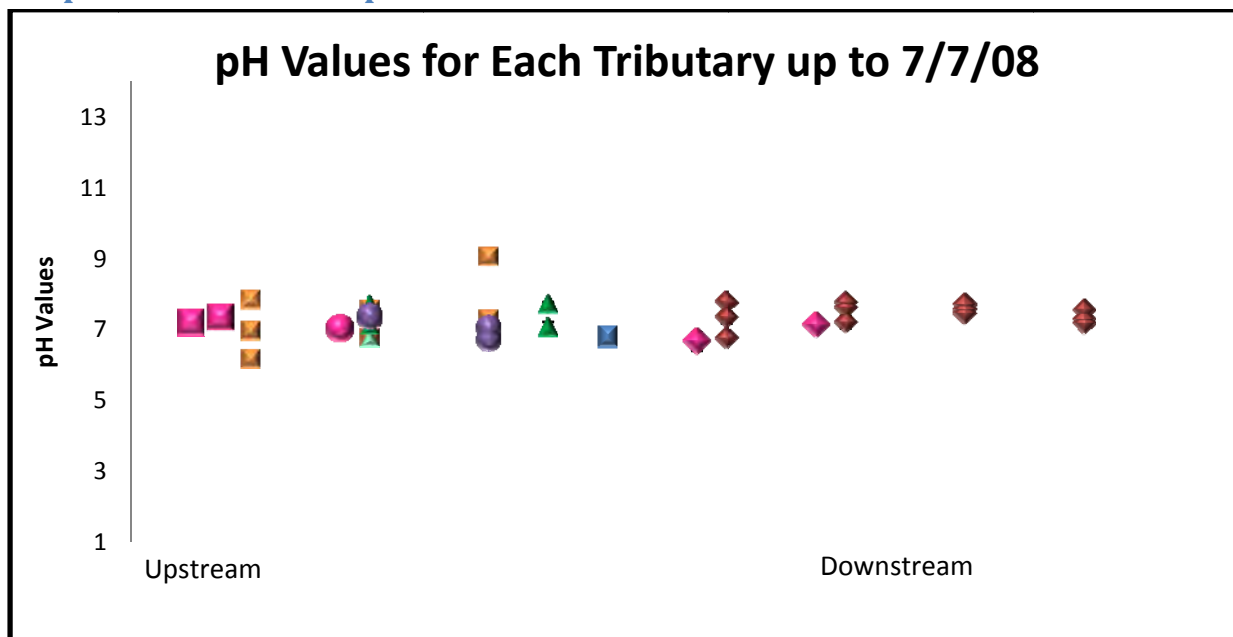
Graph 1: This graph shows the pH values by tributary.

After data collection was finished, the three readings were averaged together and standard deviation was derived. The data was then graphed in two different ways. The first graph of each parameter portrays the data by tributary and its location in the watershed so it is possible to observe how data changes along the watershed. Each site has its own position number according to how far upstream or downstream it is in the watershed. For example, the most upstream site has a value of 1 and the most downstream site has a value of 8. The second graph of each parameter portrays the changes over time. All of the raw data is in the form of data tables by tributary. Graphs 1 and 2 show the pH values graphed both ways. Both have a general trend of not showing any change over time or along the watershed. There are no clear outliers present. Therefore the results show that there are not any abnormalities concerning pH values in any of the tributaries.

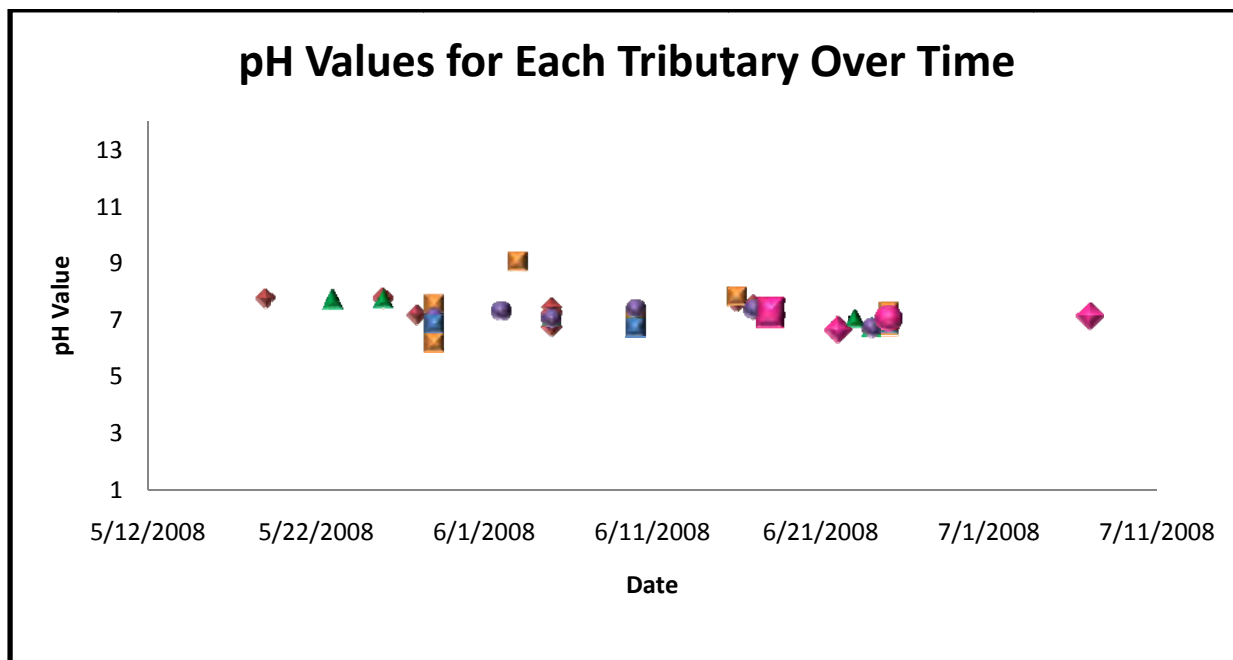
Graph 2: This graph shows the pH values over time for each site.

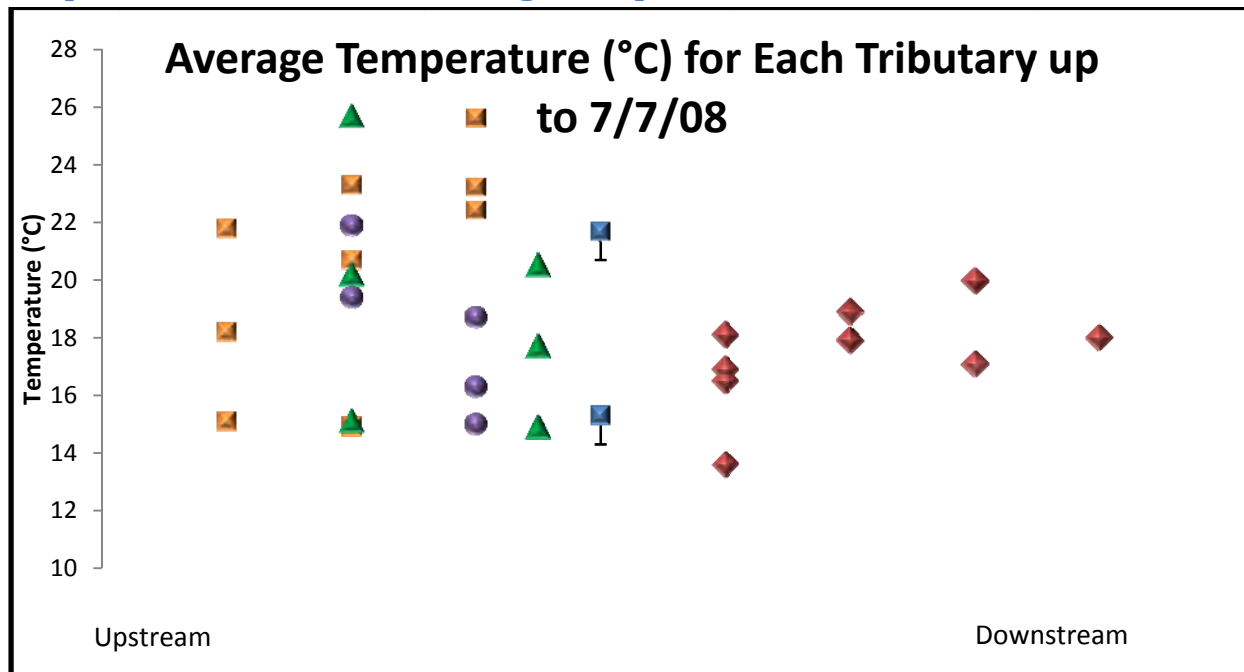
Graph 3: This graph shows the temperature in °C for each tributary.

Graphs 3 and 4 illustrate temperature readings for the tributaries. Graph 3 has a slight decreasing trend but when the data is graphed over time, there is an upward trend over the study period. Graphs 5, 7, 9, and 11 are the graphs for TDS, salinity, conductivity, and hardness respectively and show how these parameters change through the watershed. None of these graphs really have very strong consistent trends. Salinity is the only parameter with a trend. It has a slightly increasing trend across the watershed which could be due to the fact that the Park River is a more urban setting than its tributaries. However when these parameters are graphed over time, there is an obvious decreasing trend. This is illustrated in graphs 6, 8, 10, and 12.

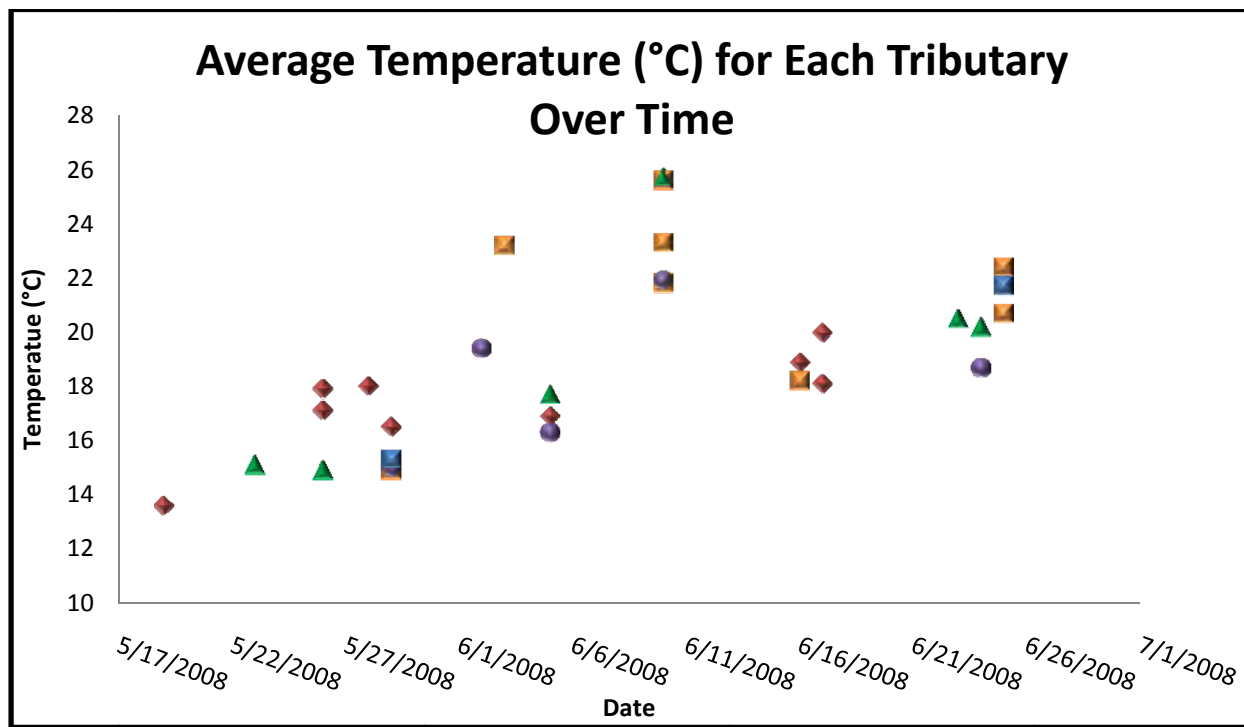
Graph 4: This graph shows the temperature in °C of each tributary over time.

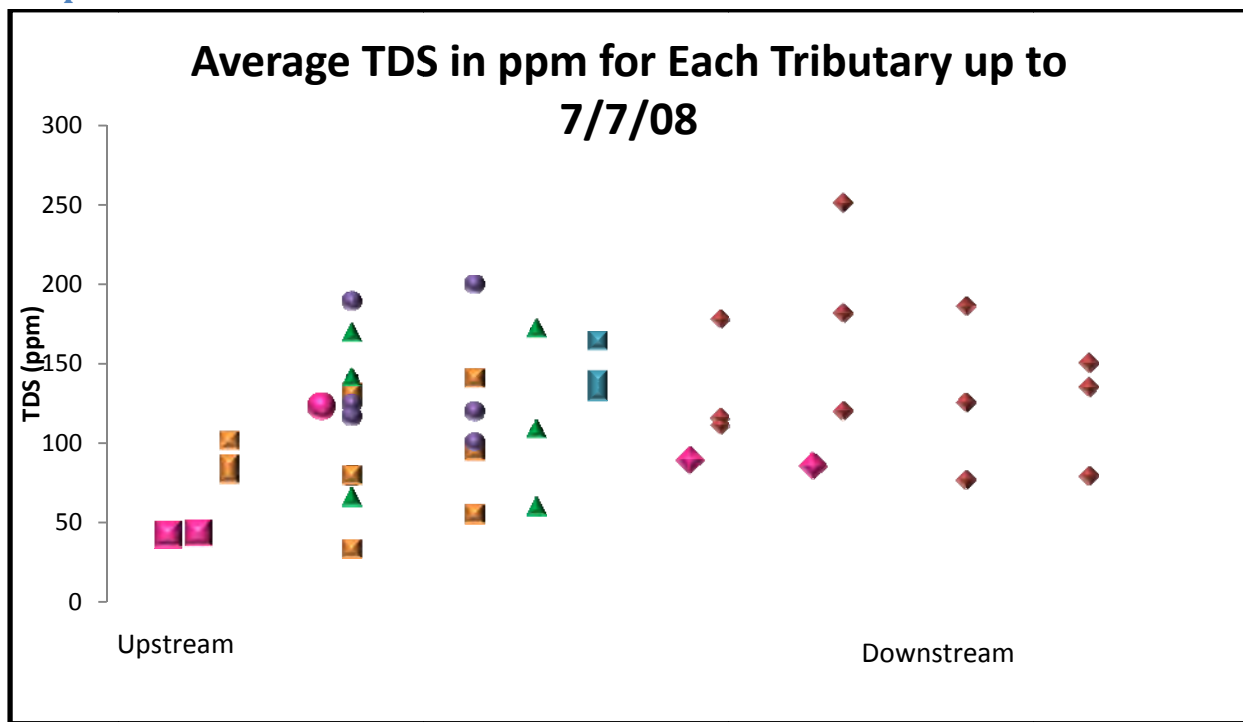
Graph 5: This graph shows the total dissolved solids in ppm in each tributary.

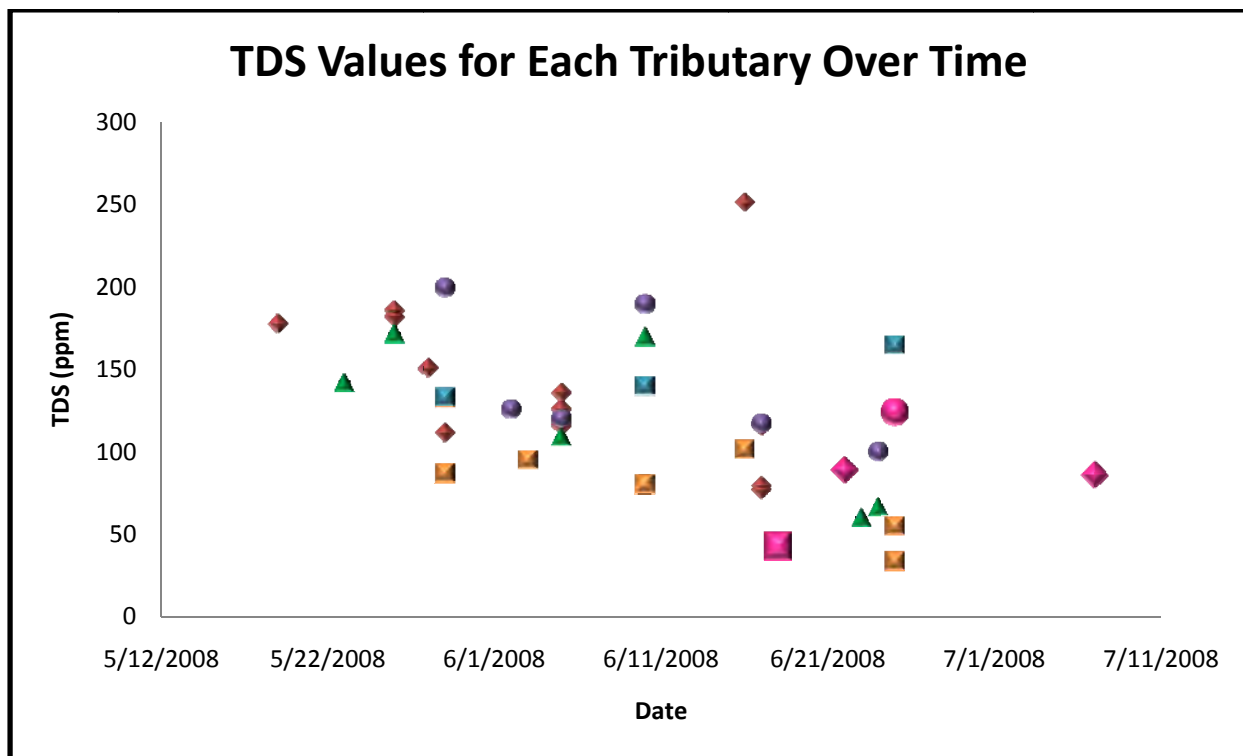
Graph 6: This graph shows the amount of total dissolved solids in ppm in each tributary over time.

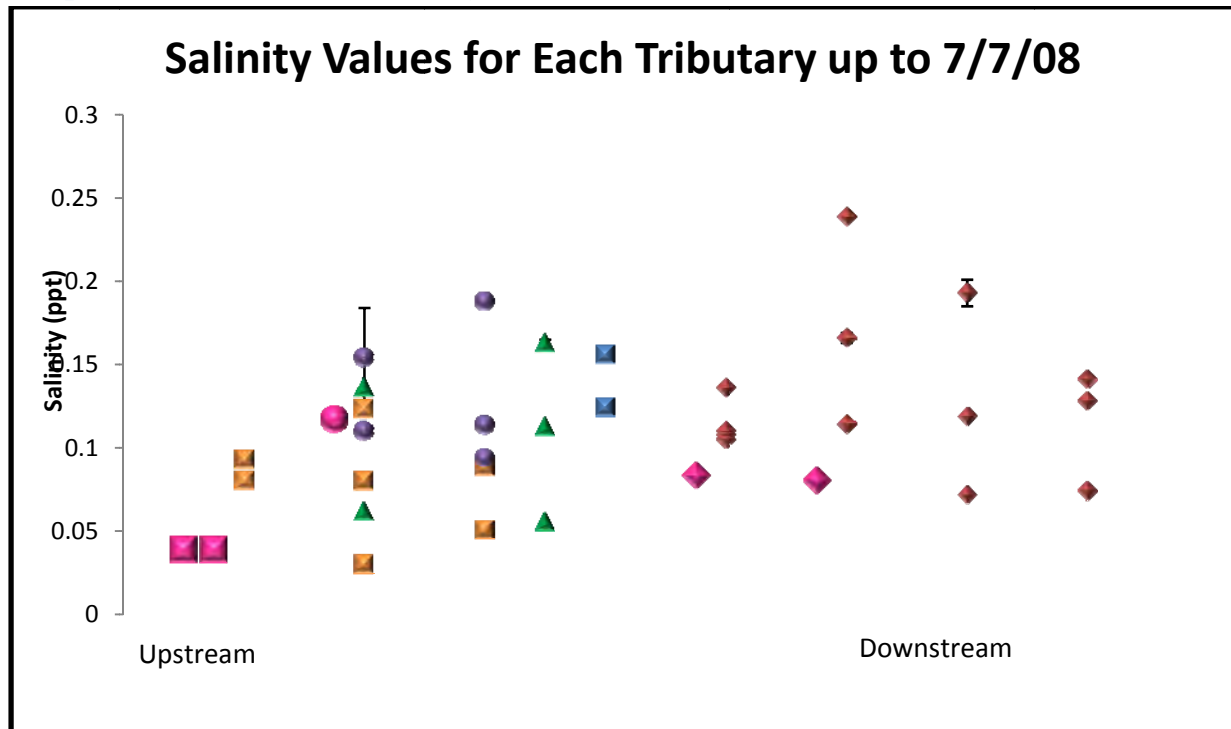
Graph 7: This graph shows the salinity values in ppt for each tributary.

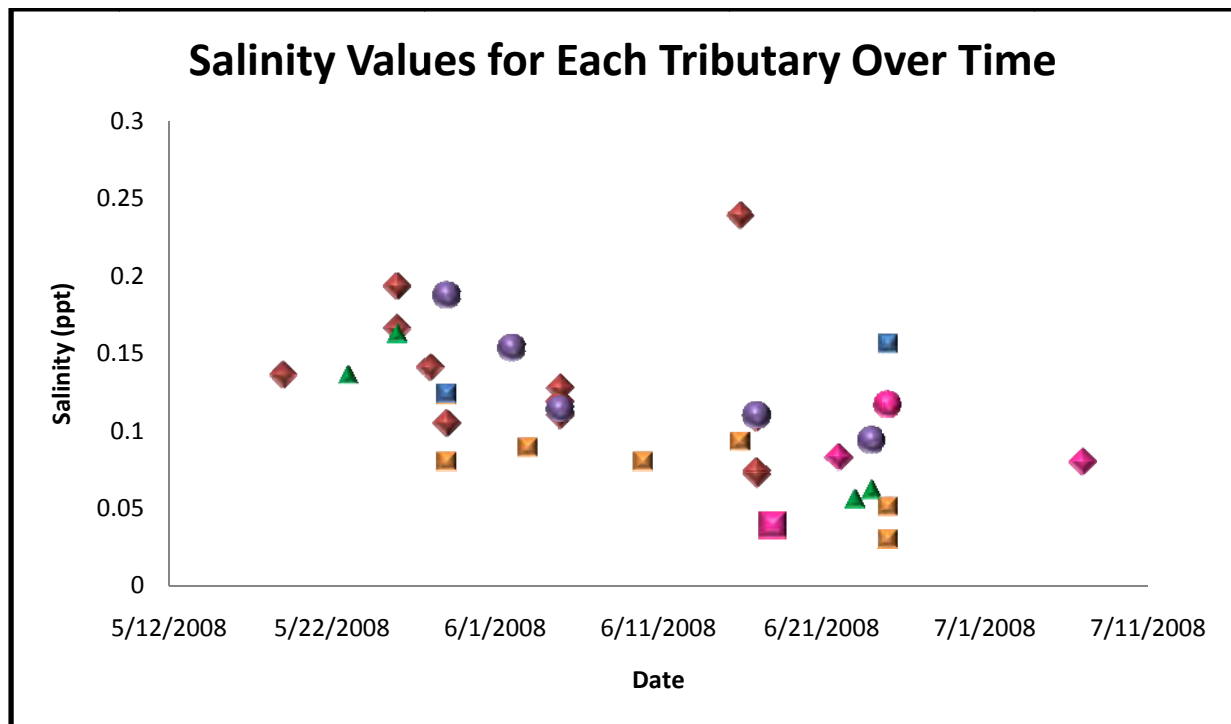
Graph 8: This graph shows the salinity values in ppt for each tributary over time.

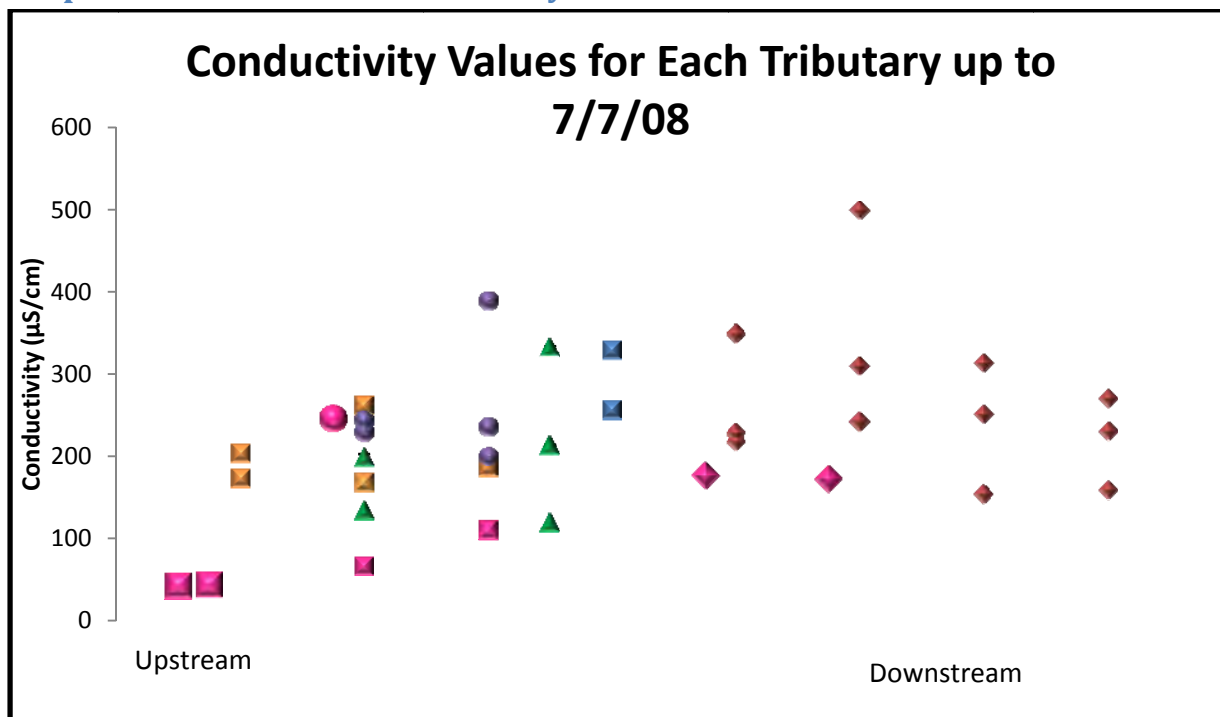
Graph 9: This graph shows the conductivity values in  $\mu\text{S/cm}$  for each tributary.

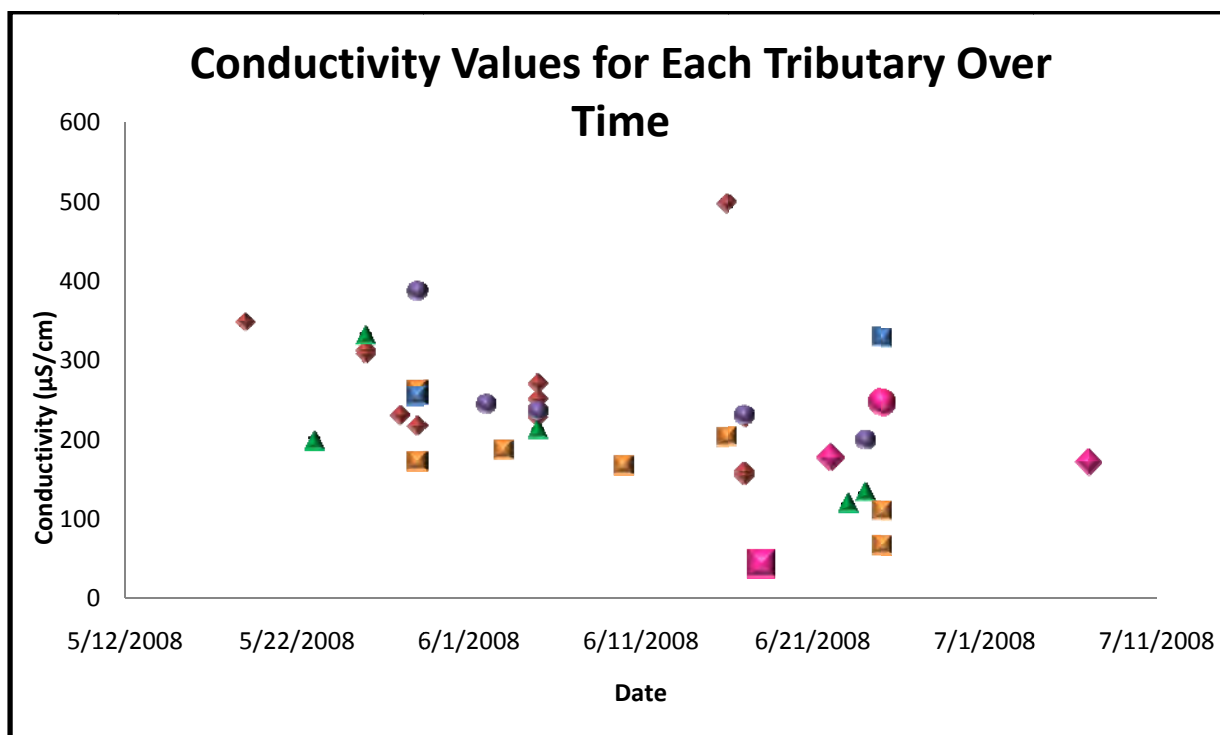
Graph 10: This graph shows the conductivity values in  $\mu\text{S/cm}$  for each tributary over time.

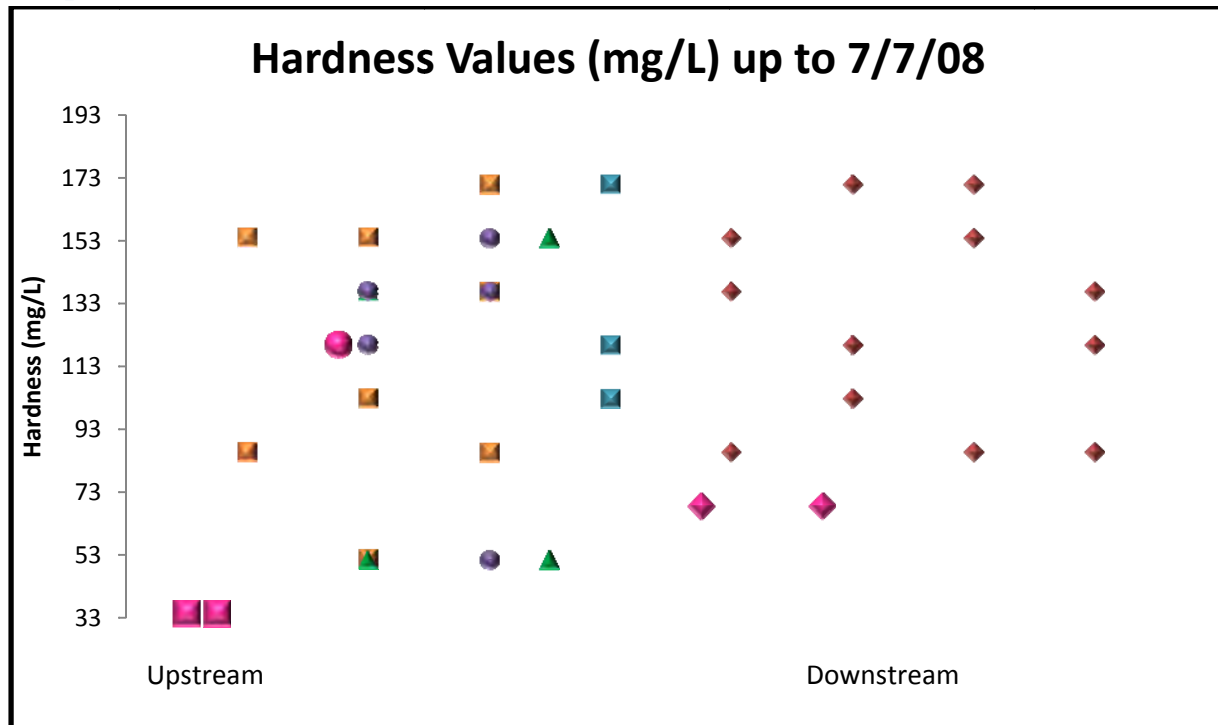
Graph 11: This graph shows the hardness values in mg/L for each tributary.

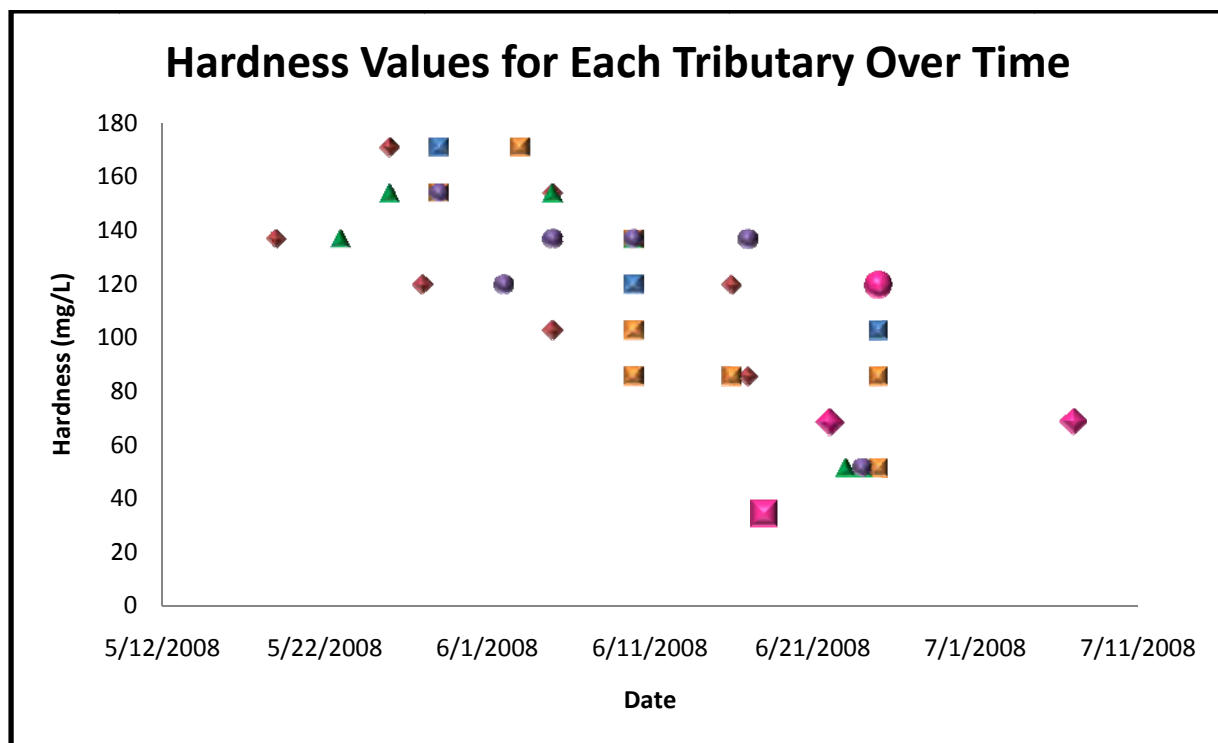
Graph 12: This graph shows the hardness values in mg/L for each tributary over time.

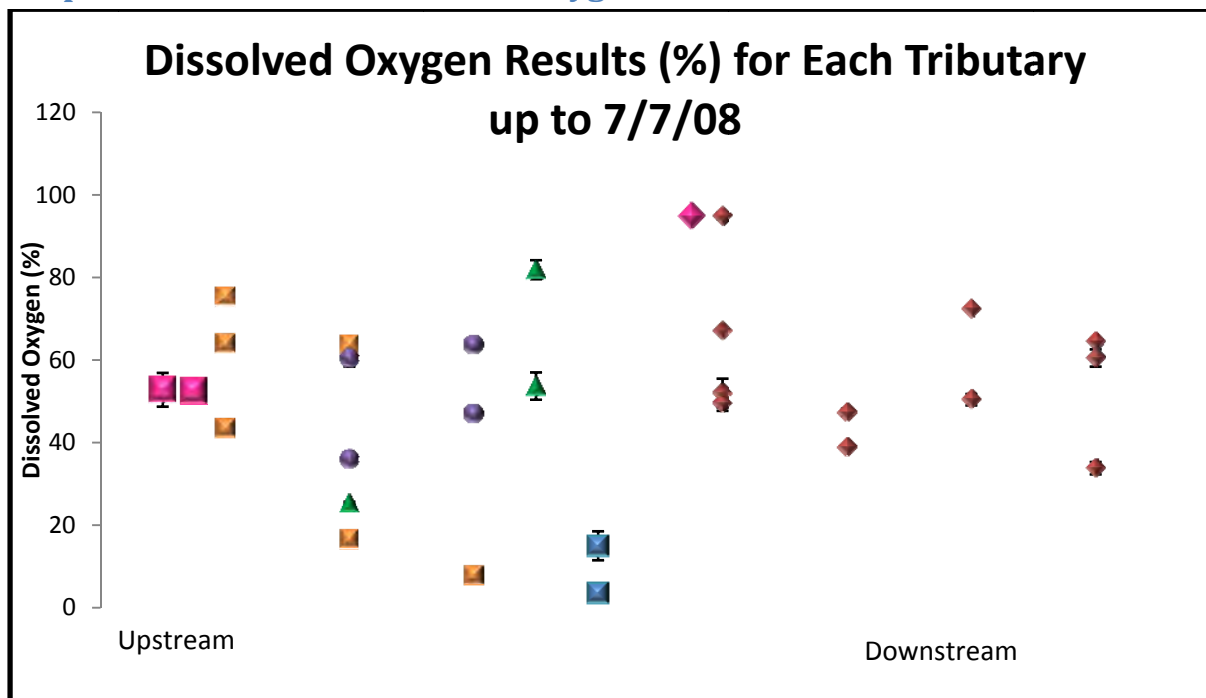
Graph 13: This graph shows dissolved oxygen readings in % air saturation for each tributary.

The last four graphs show dissolved oxygen in both % air saturation and in mg/L. Graphs 13 and 15, which show the dissolved oxygen readings across the watershed, do not have a clear trend. When graphed over time (graphs 14 and 16) the results show a trend that decreases and then instantly increases. In fact DO readings are dependent on the temperature of the water (EPA, 2006) because warm water holds less dissolved oxygen than cold water. Graphs 14 and 16 should look like the TDS, conductivity, salinity, and hardness graphs and have a clear decreasing trend. This could be something significant in the quality of the water or the DO meter could have malfunctioned during that period of testing. Also some of the DO readings are very low when they should not be. For example, table 39 shows that the readings for TBB 9 change from 2.6 to 6.77 in one week which does not seem plausible because the most of the other readings are more or less stable. The meter constantly flashed error messages and despite some of our attempts to try and clean the probe, it would still malfunction and take long periods of time to stabilize.

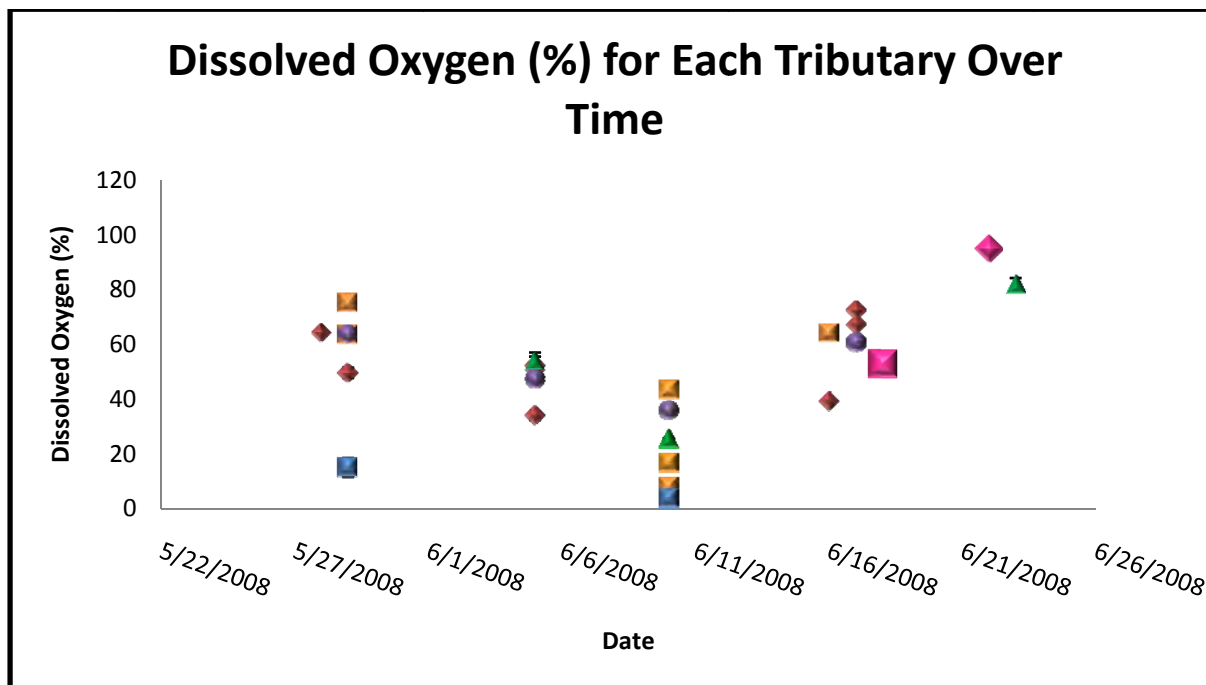
Graph 14: This graph shows the dissolved oxygen readings in % air saturation for each tributary over time.

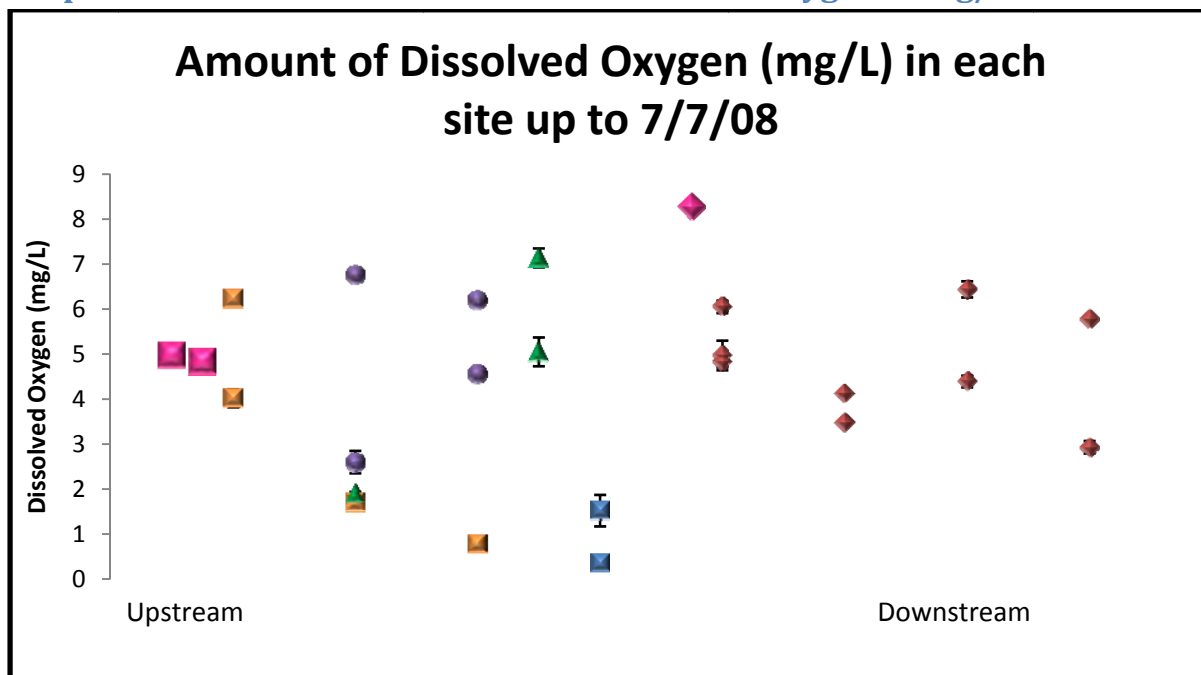
Graph 15: This graph shows the amount of dissolved oxygen in mg/L for each tributary.

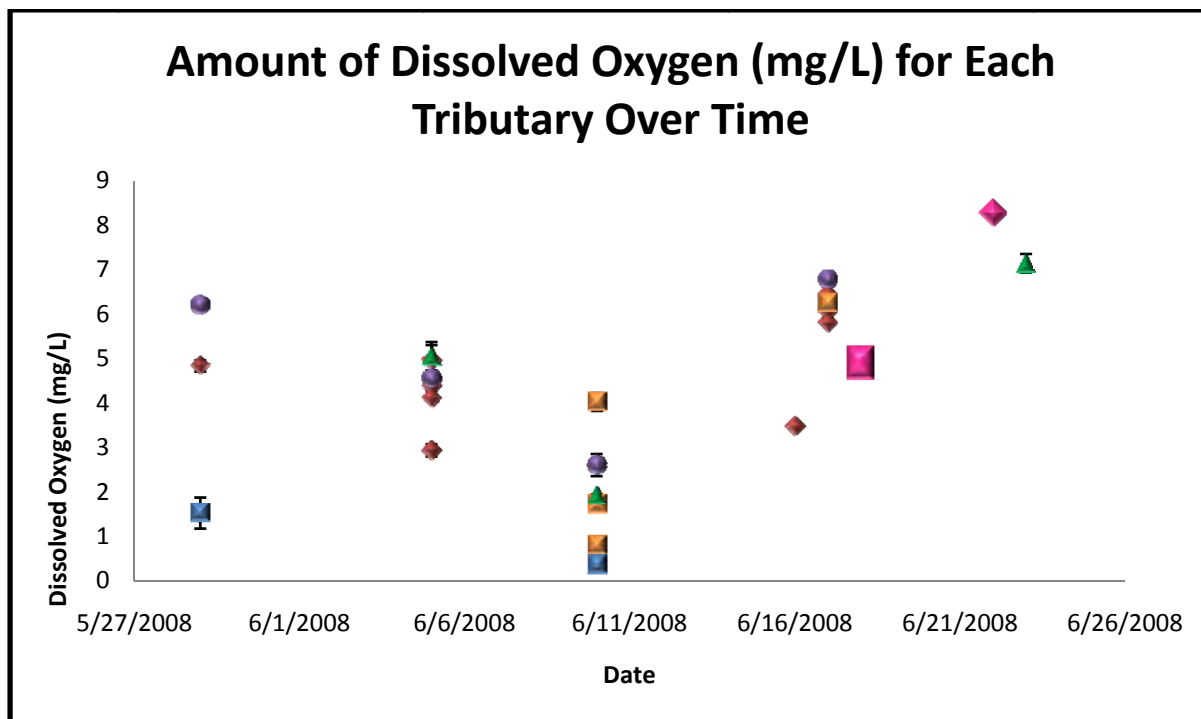
Graph 16: This graph shows the amount of dissolved oxygen in mg/L for each tributary over time.

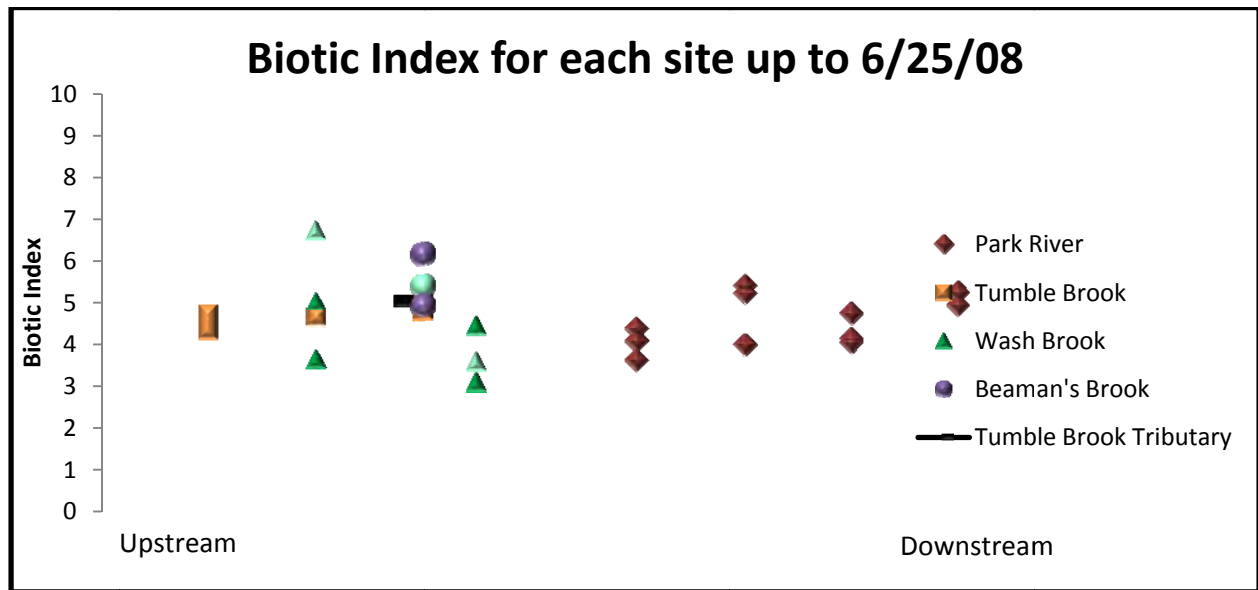
Figure 1. The biotic indices of each sample taken from all sites along the Park River and each Tributary by position.

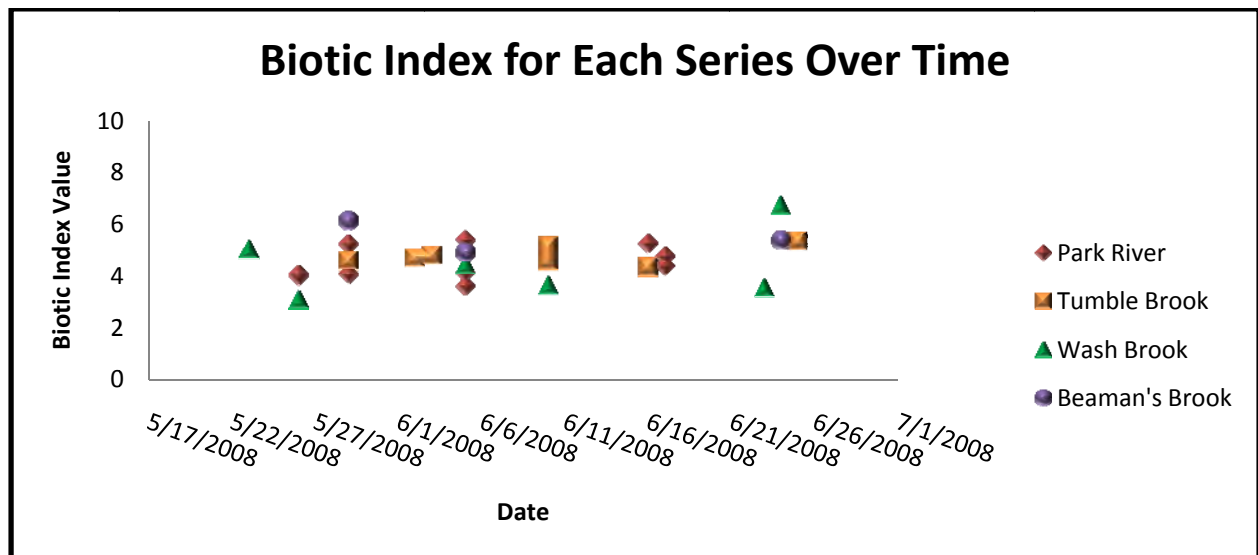
Figure 2. The biotic indices from each sample taken from all sites graphed by time.

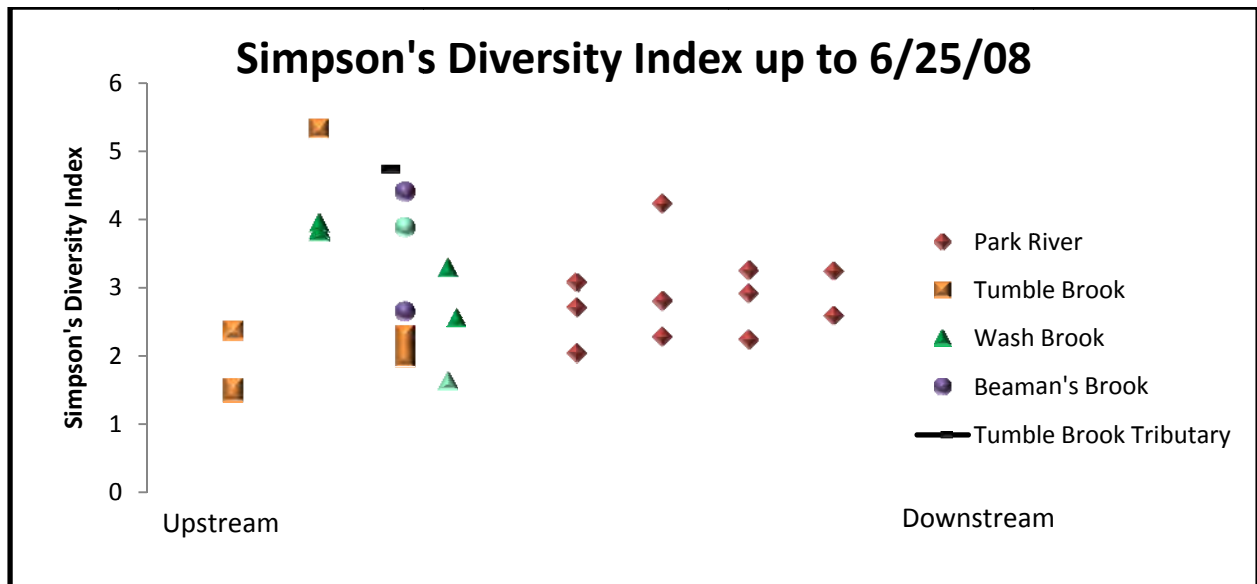
Figure 3. The Simpson's Diversity Index for each sample taken graphed by position.

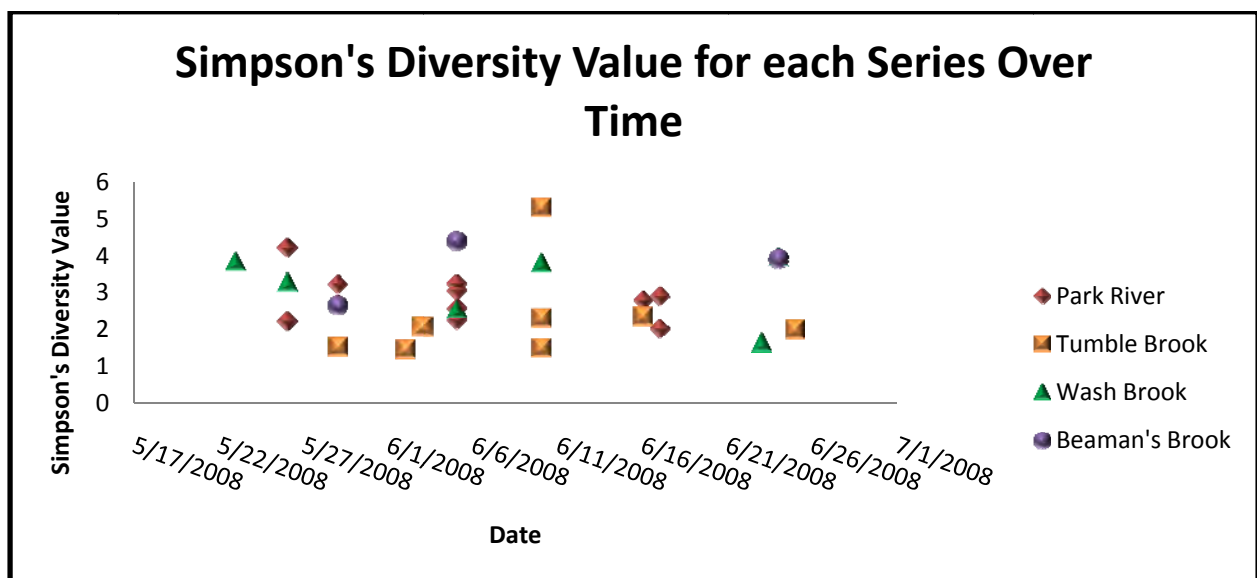
Figure 4. The Simpson's Diversity index for each sample graphed over time.

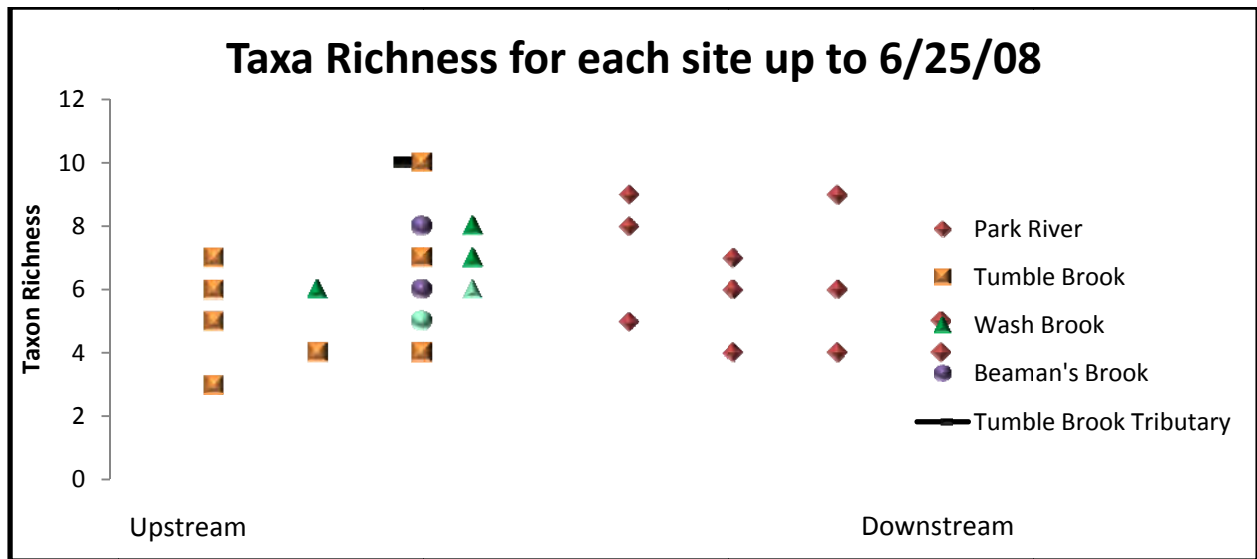
Figure 5. The taxa richness of each sample from all sites graphed by position.

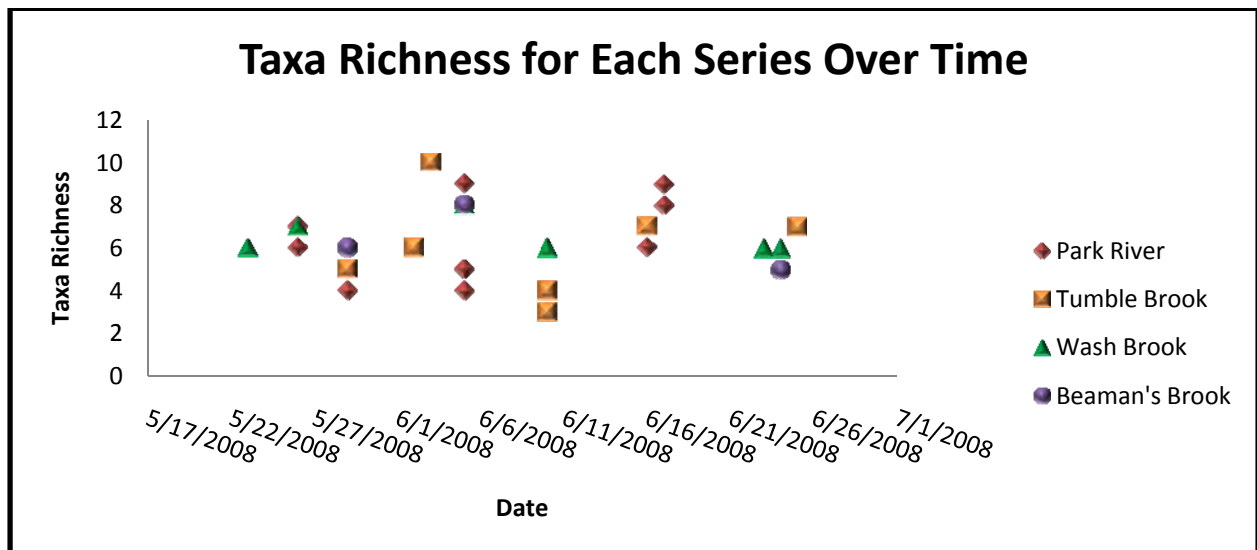
Figure 6. The taxa richness from each sample graphed over time.

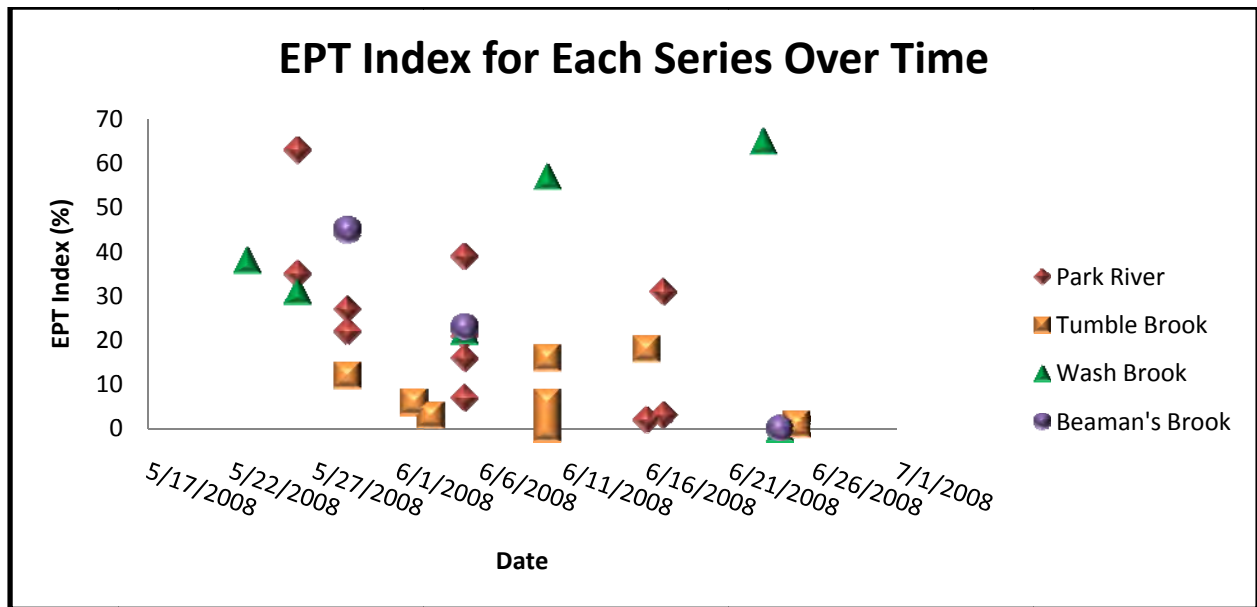
Figure 7. The percent EPT for each site over time.

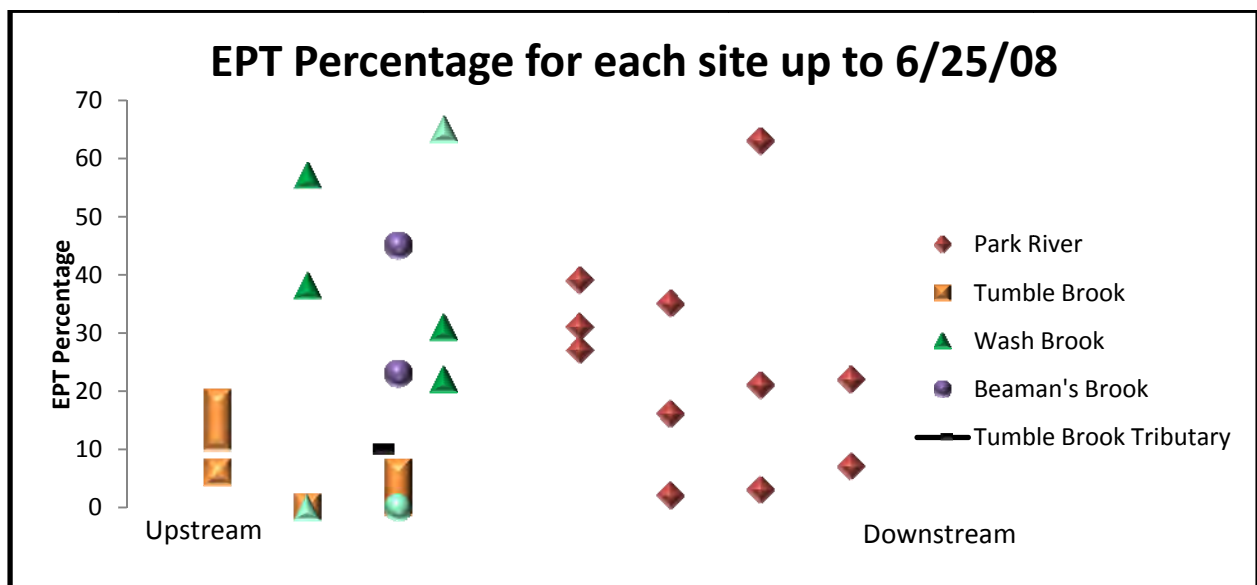
Figure 8. The percent EPT for each site by position.

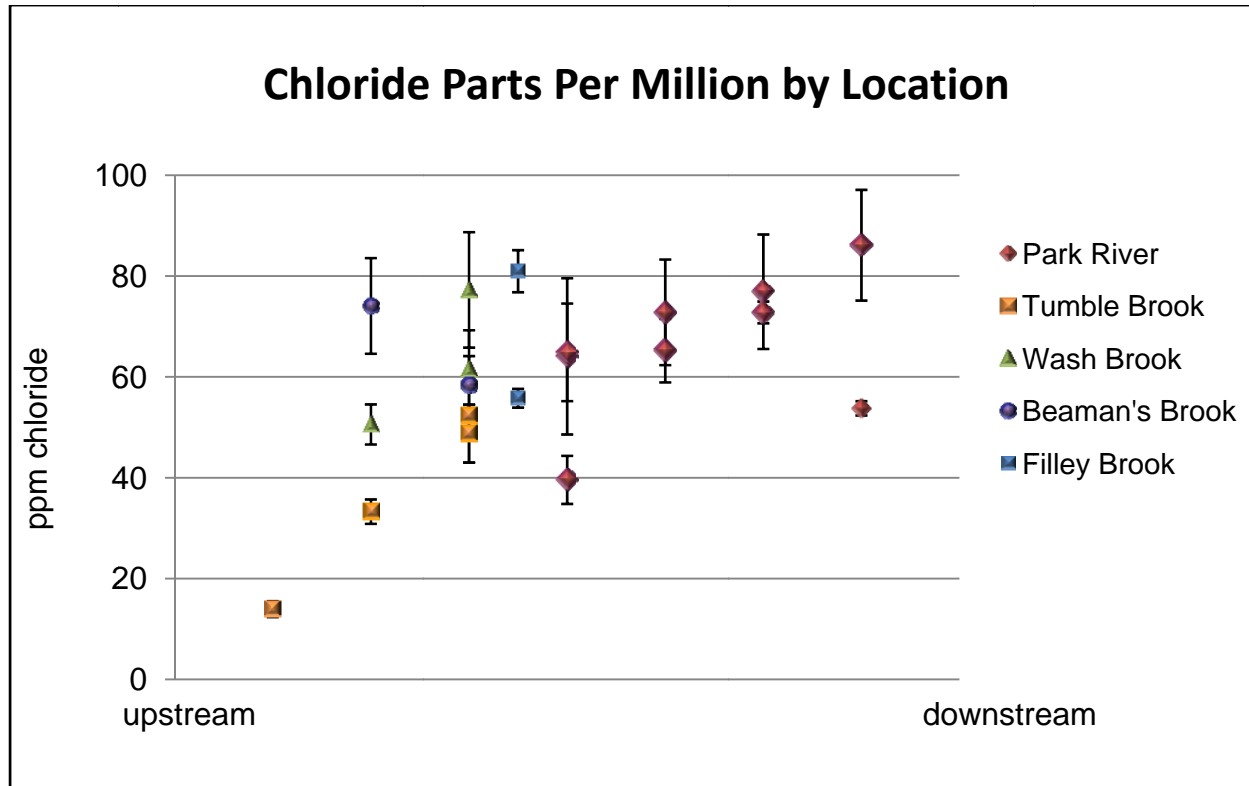
Graph 1:

Graph 1 shows the chloride anion concentration in parts per million organized by position in the watershed. There is generally a steady upward trend in chloride anion concentration across the watershed. However, not all tributaries show this trend. There is no trend evident in Filley Brook since there are so few data points. Beamans Brook anion concentration decreases, however, there are only two data points, both with large margins of error. The Tumble Brook tributary shows an upward trend, as does Wash Brook and the Park River, not including the one obvious outlier for the Park River. There are three data points, one for Beamans Brook, Wash Brook, and Filley Brook, that have higher anion concentrations than would be expected so far upstream in the watershed.

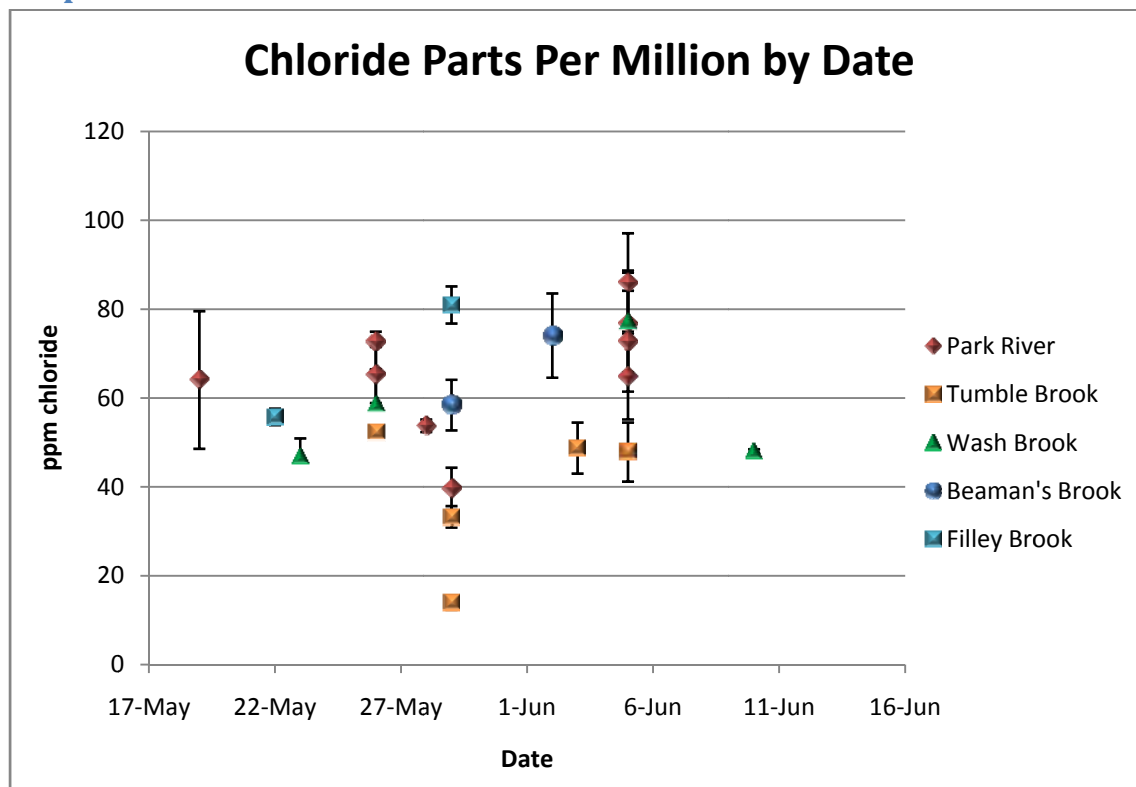
Graph 2:

Graph 2 shows the chloride anion concentration in parts per million organized by date collected. There is not a trend in chloride anion concentration across time.
