### Trinity College Water Quality Monitoring Results

# Baseline Water Quality Analysis of the North Branch of the Park River Watershed

Summer 2008

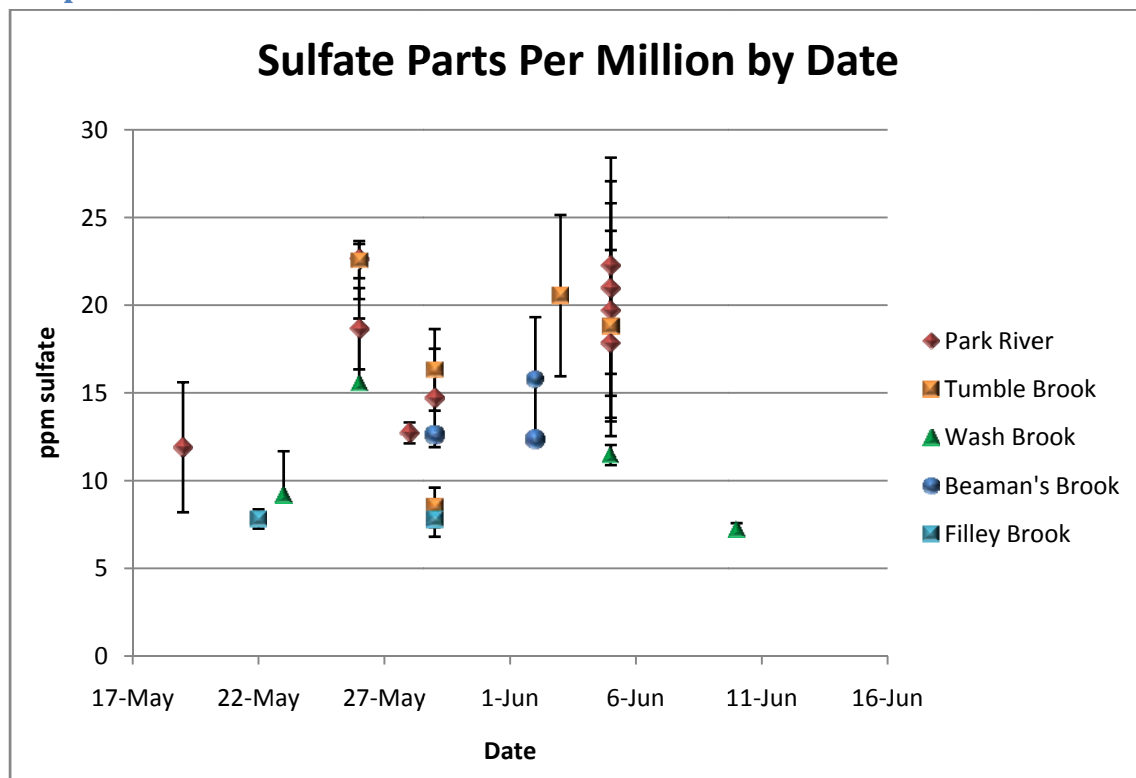
**Graph 6:**

Graph 6 shows the sulfate anion concentration in parts per million organized by date collected. There is not an obvious trend in sulfate anion concentration across time.

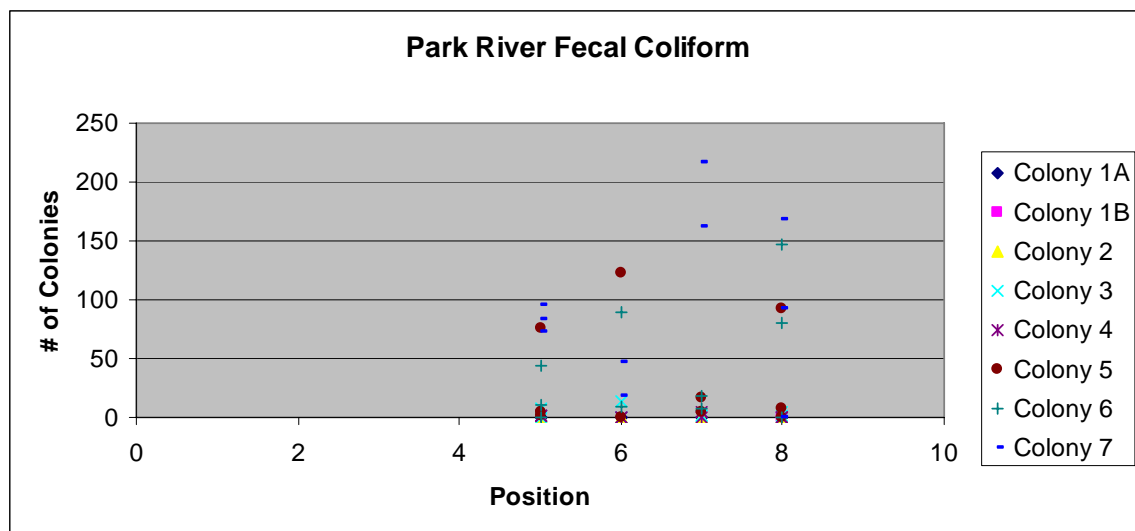
Figure 1. The number of each type of colony from samples of 5 ml of water taken from the Park River, graphed by position.

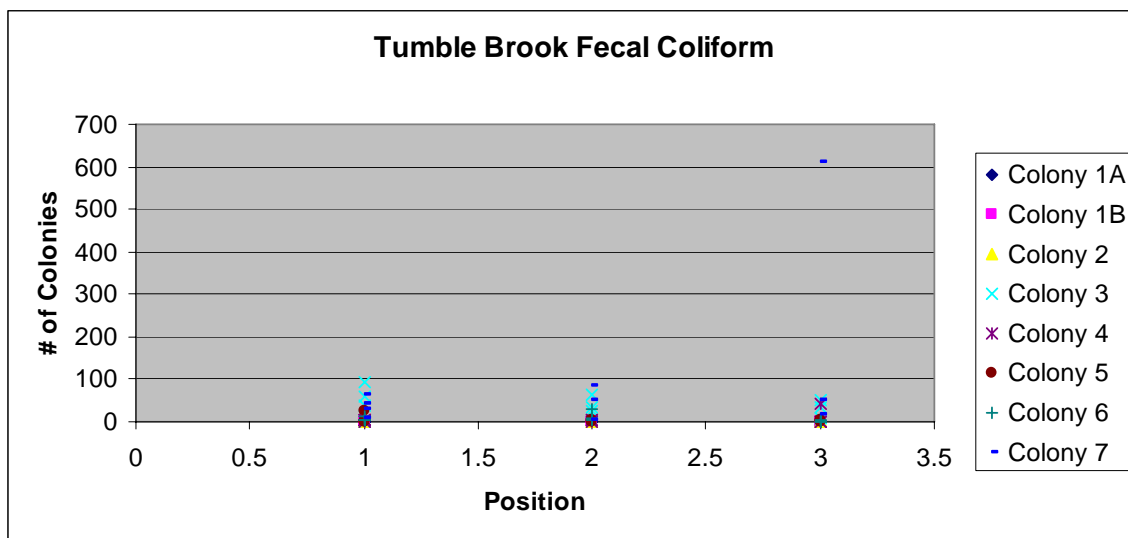
Figure 2. The number of each type of colony from samples of 5 ml of water taken from the Tumble Brook, graphed by position.

One spike in type 7 was found at the end of Tumble Brook on 6/3/2008, where there were 612 colonies. Though this number is higher than at other locations, the type of colony is neither a fecal colony nor a coliform colony, so it is not of concern.

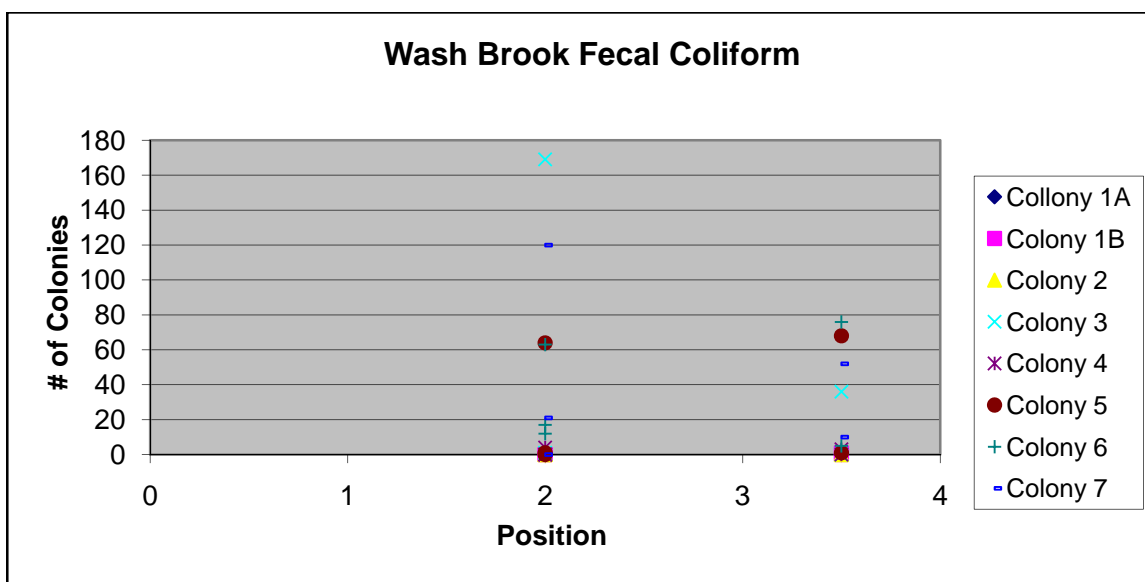
Figure 3. The number of each type of colony from samples of 5 ml of water taken from the Wash Brook, graphed by position.

No fecal coliform colonies were found in the Park River, Filley Brook, Beaman's Brook, or Tumble Brook from any samples. One fecal coliform colony (type 1B) was found at EWB 8 (end of Wash Brook) on June 24<sup>th</sup>, 2008. Another fecal coliform colony was found from a storm water sample at the top of the North Branch Park River from 6/23/2008. This was also type 1B. This occurrence of fecal coliform could be due to storm drains carrying urban runoff, especially since no fecal coliform colonies were found in the North Branch Park River during baseline conditions. Most of our samples from each site contained non-fecal coliform colonies. All samples from Wash Brook and Tumble Brook had non-fecal coliform colonies present. All but one sample from Filley Brook, Beaman's Brook, and The North Branch Park River contained non-fecal coliform colonies.

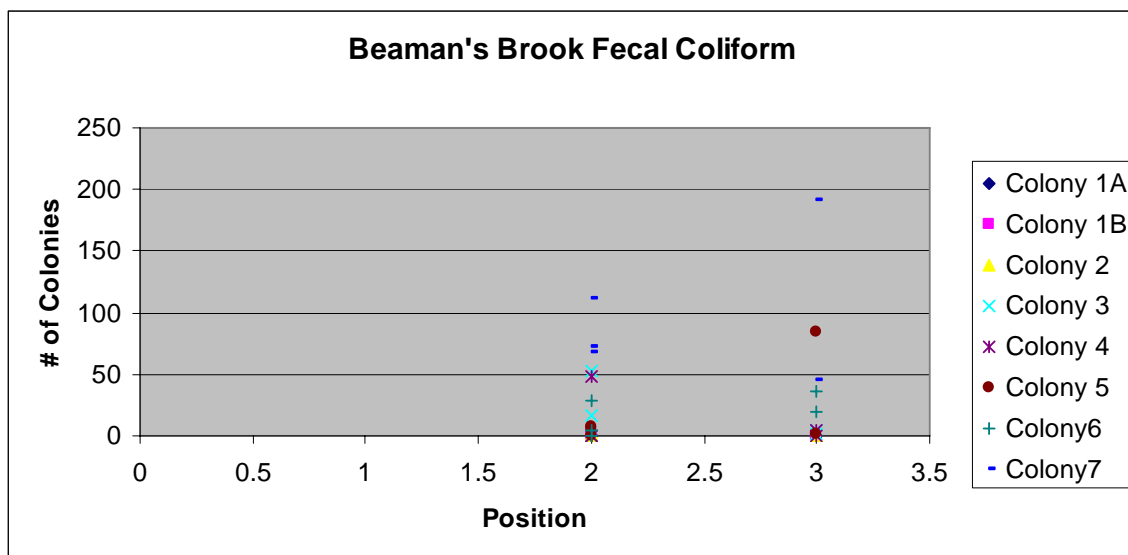
Figure 4. The number of each type of colony from samples of 5 ML of water taken from the Beaman's Brook, graphed by position.

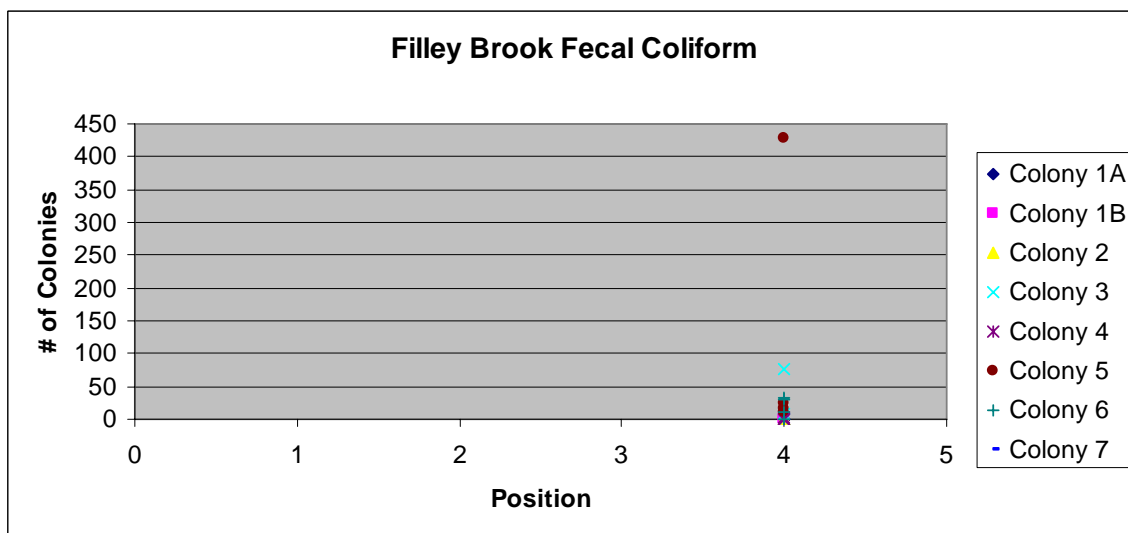
Figure 5. The number of each type of colony from samples of 5 ML of water taken from the Filley Brook, graphed by position.

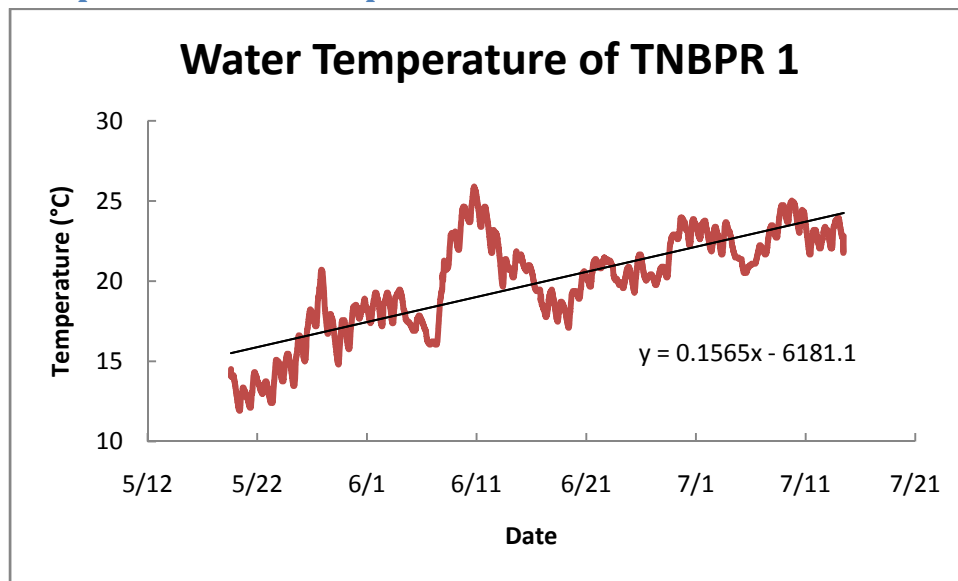
Figure 1: This graph shows the water temperature data from May 19th 2008 to July 14th for site 1

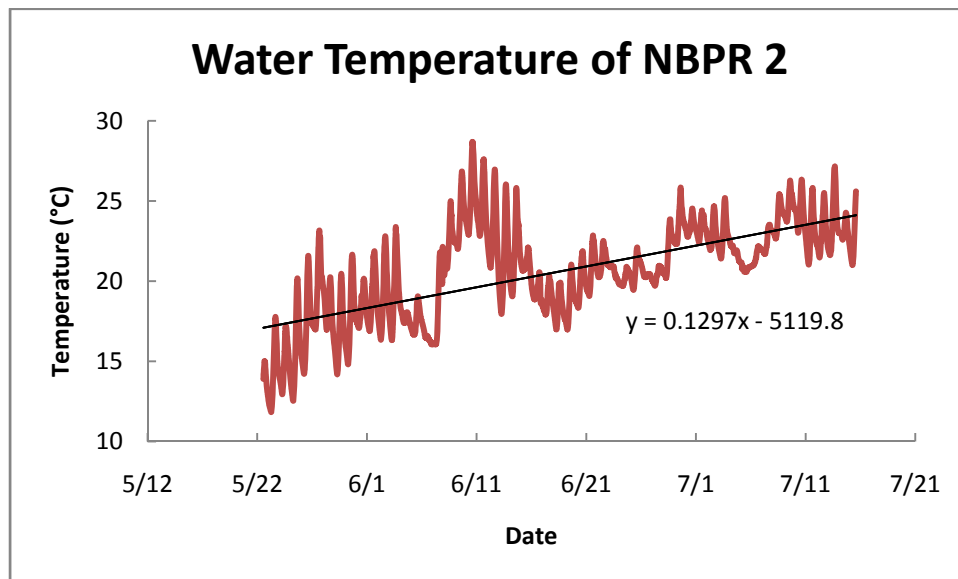
Figure 2: This graph shows the water temperature data from May 22nd to July 15th for site 2

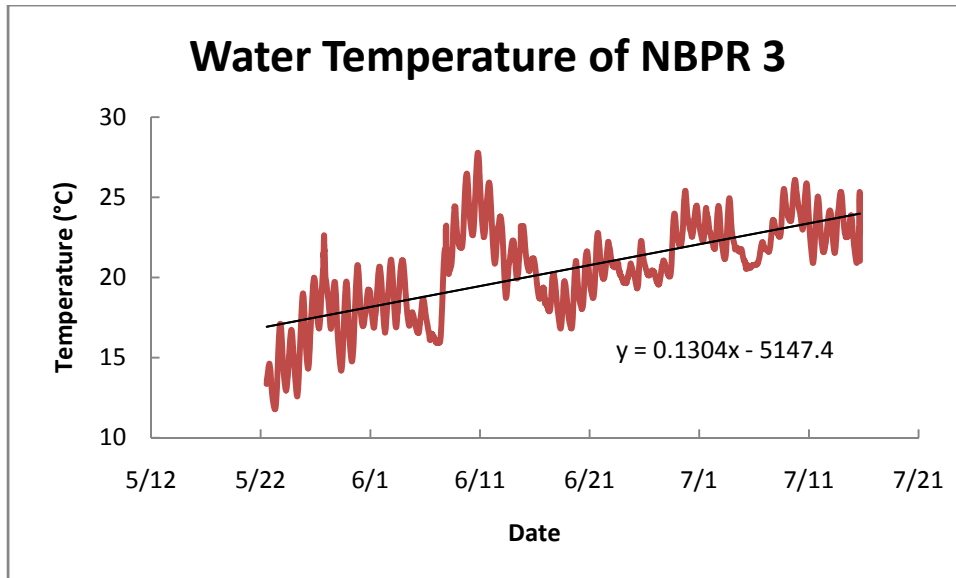
Figure 3: This graph shows the water temperature data from May 22nd to July 15th for site 3.

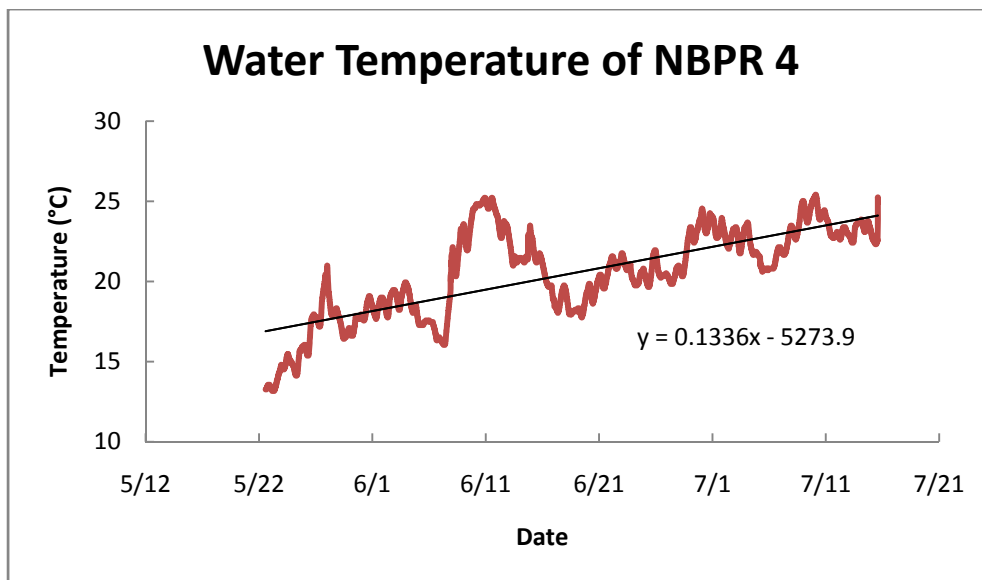
Figure 4: This graph shows the water temperature data from May 22nd to July 15th for site 4.

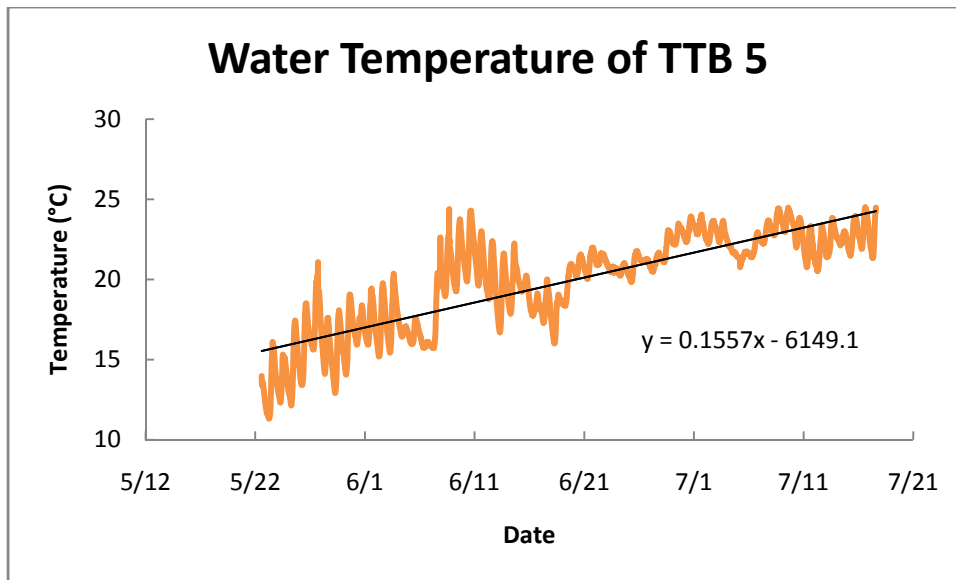
Figure 5: This graph shows the water temperature data from May 22nd to July 17th for site 5.

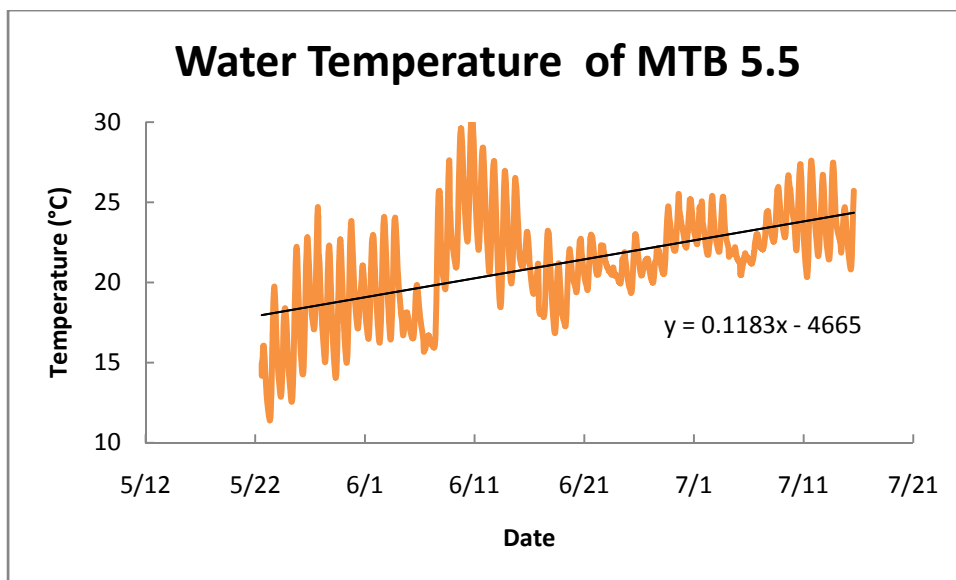
Figure 6: This graph shows the water temperature data from May 22nd to July 15th for site 5.5.

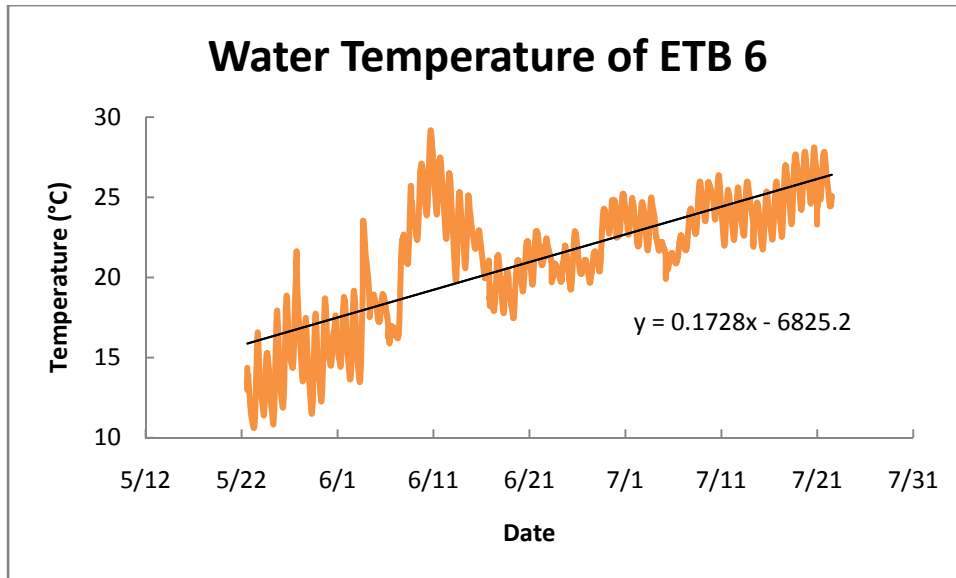
Figure 7: This graph shows the water temperature data from May 22nd to July 22nd for site 6.

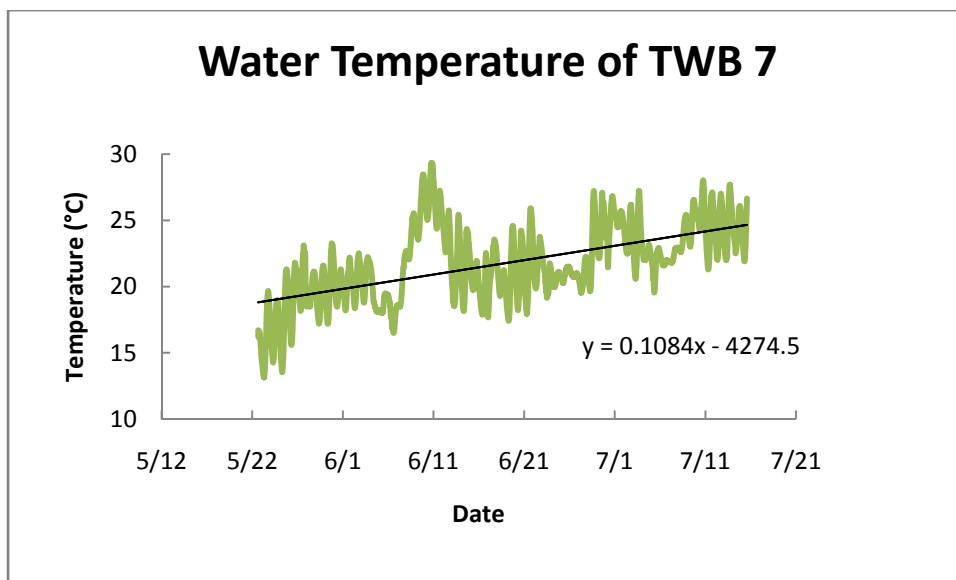
Figure 8: This graph shows the water temperature data from May 22nd to July 15th for site 7.

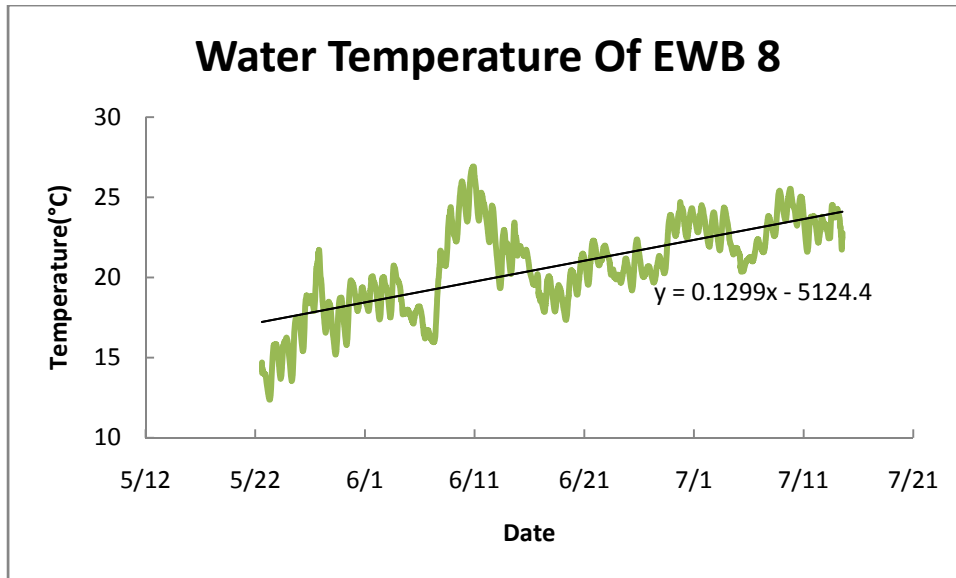
Figure 9: This graph shows the water temperature data from May 22nd to July 14th for site 8.

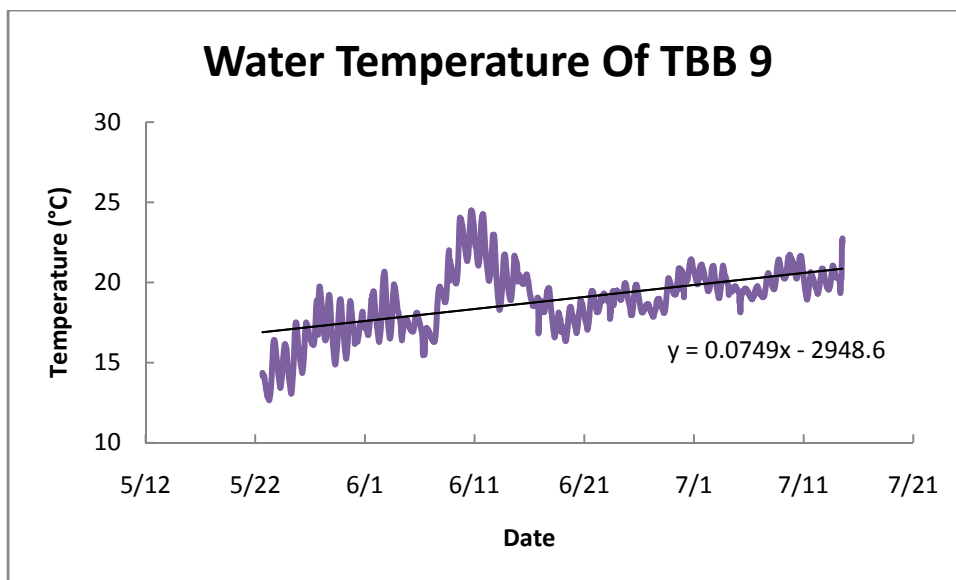
Figure 10: This graph shows the water temperature data from May 22nd to July 14th for site 9

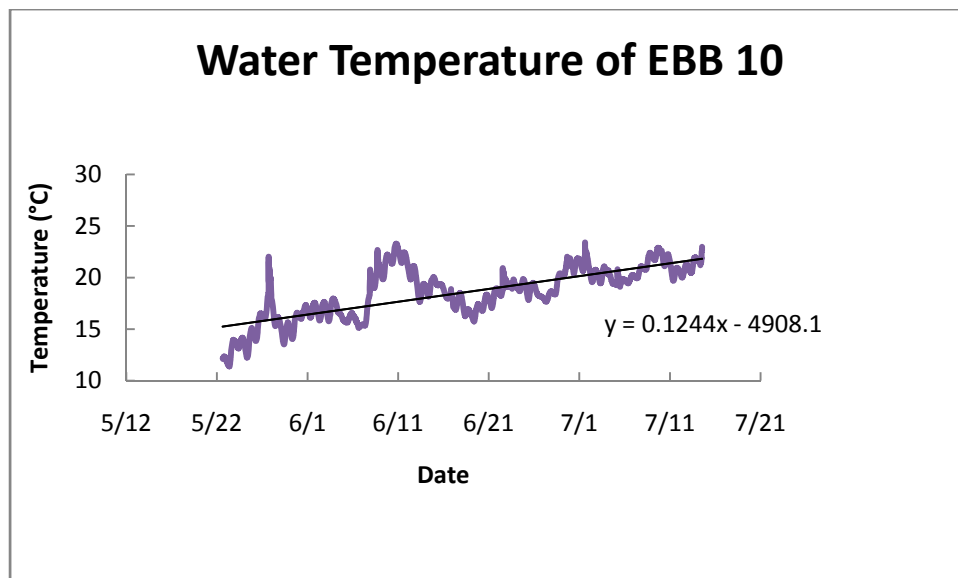
Figure 11: This graph shows the water temperature data from May 22nd to July 14th for site 10.

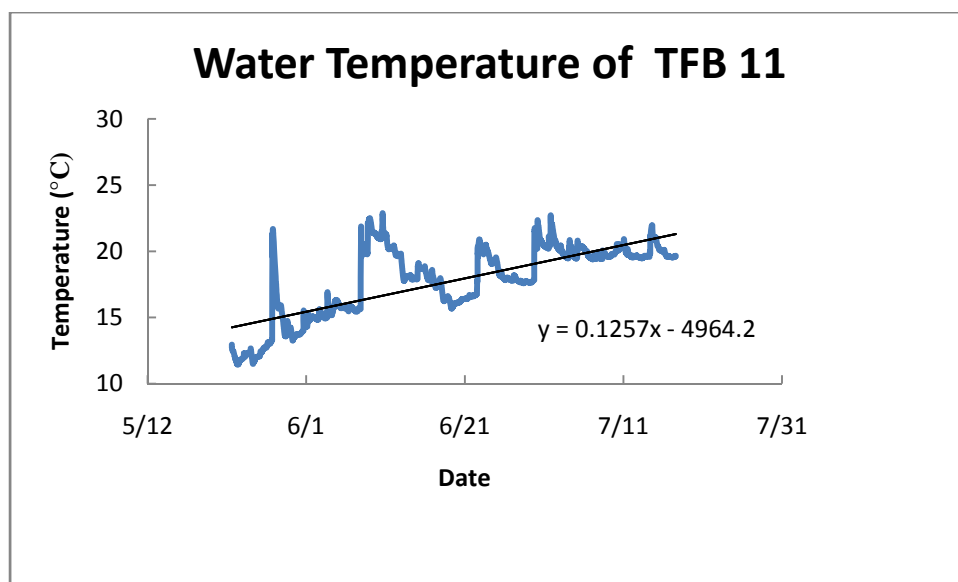
Figure 12: This graph shows the water temperature data from May 22nd to July 17th for site 11.

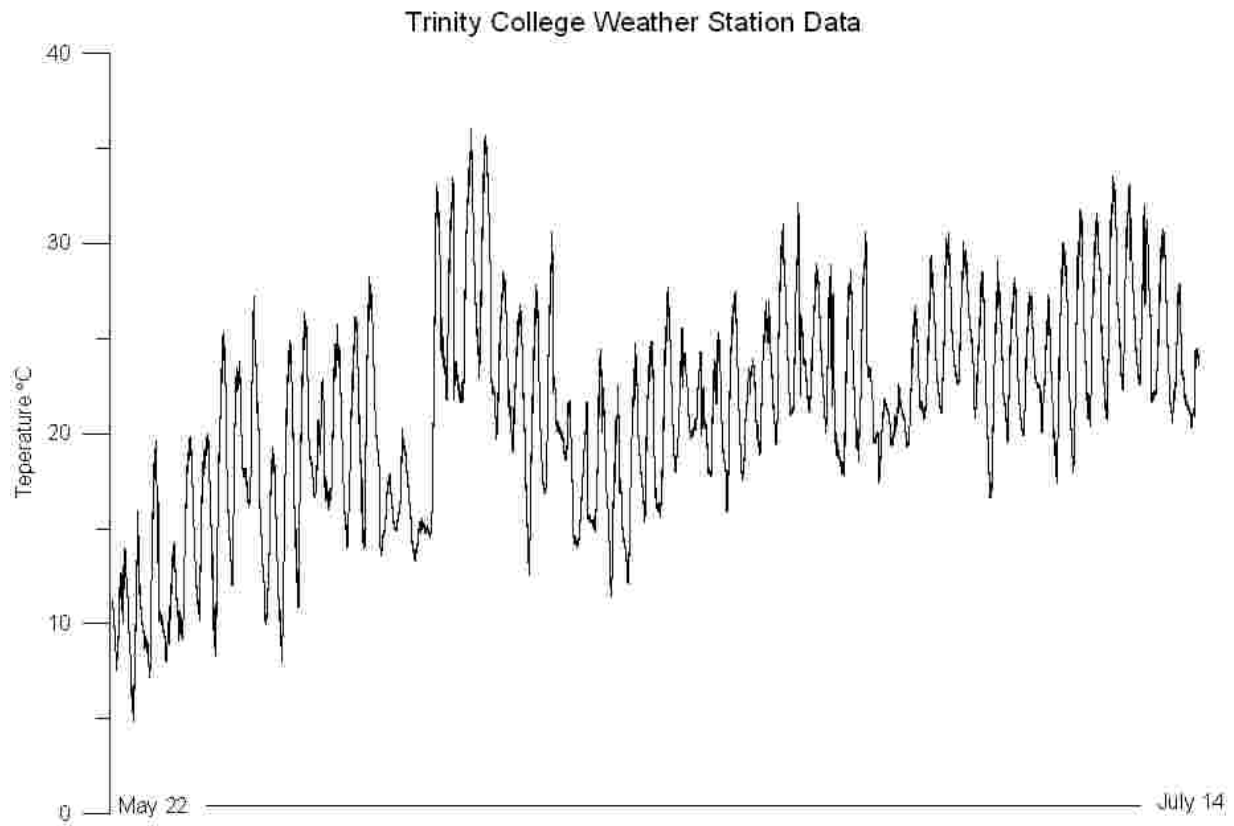
Figure 13: Air Temperature at Trinity College Weather Station

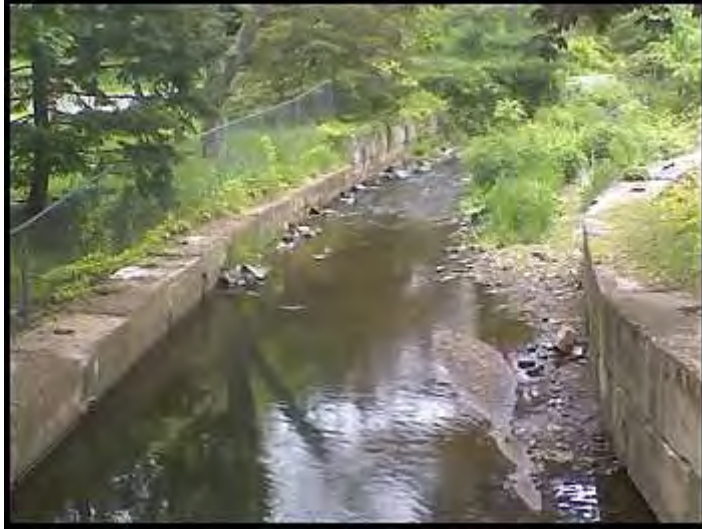
Site 5 (Top Tumble Brook) – TTB 5

This portion of the stream is in a residential area of West Hartford. It is lined with a concrete wall on both sides. A bridge crosses over the river, and there is a discarded refrigerator beneath it. The bridge, which supports Mountain Road, is located .2 miles south east of the intersection between Still Road and Mountain Road. The sampling site is located just downstream from the bridge. The water is deep near the bridge, about 1 meter, and gets very shallow, about 1 foot, downstream. There is a long riffle zone downstream. The bottom is covered with scattered cobbles and a few small boulders. Looking downstream, there are shrubs, weeds, overgrown grasses, and small bushes on the right bank.

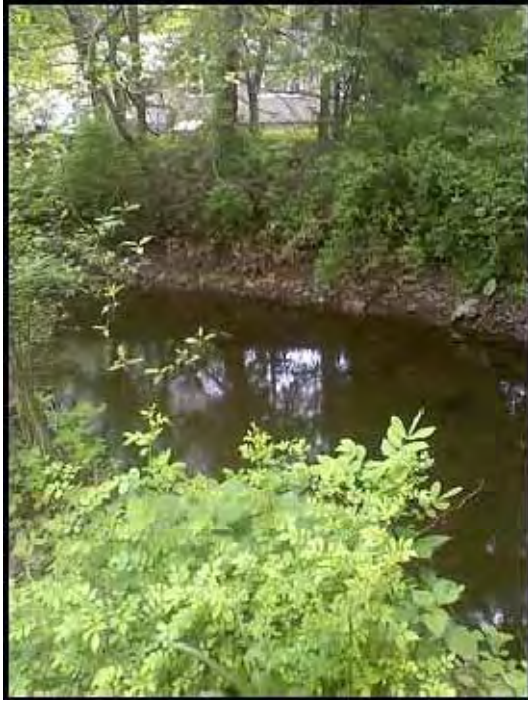
Site 5.5 (Middle Tumble Brook) – MTB 5.5

This portion of the river runs through a residential area. The water is about 1 meter deep. The water is still and the bottom is muddy. There is little vegetation on the banks. There is a bridge, which supports Still Road, crossing over the river. Still Road intersects the Brook a half mile west of the intersection of Still Road and Route 173.

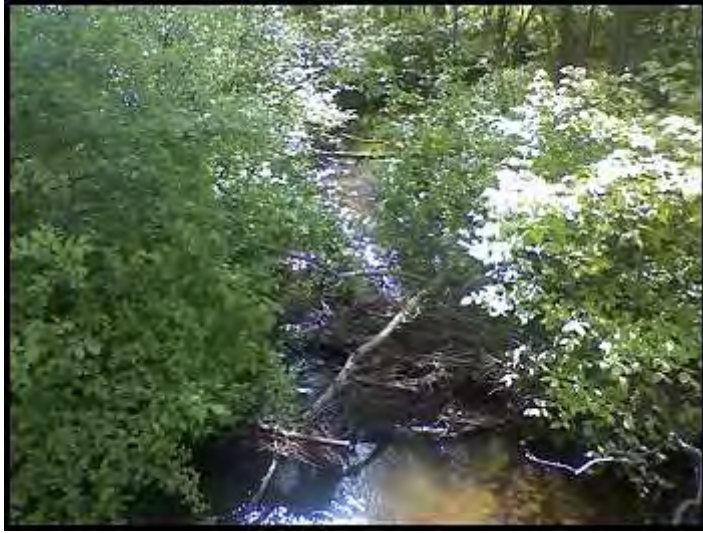
Site 7 (Top Wash Brook) – TWB 7

The site is located on Route 189,  $\frac{3}{4}$  of a mile North of where Terry Plains Road intersects Route 189. There is a small beaver dam downstream from the bridge/road. There are several outflow pipes draining into the river. The depth of the water varies; it is deeper under the bridge, and gets shallower downstream, near the beaver dam. It is mostly muddy bottom with a few small rocky parts (around 4 feet long). There are slow-flowing riffle zones directly after the beaver dams. There is rip rap surrounding the abutment of the bridge

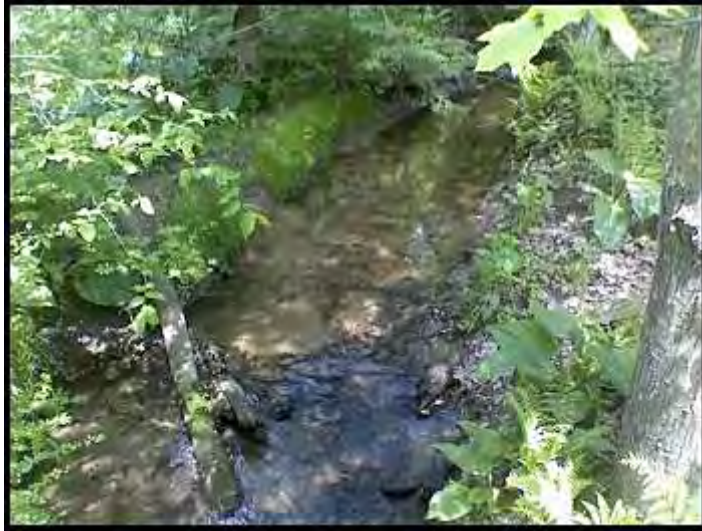
Site 9 (Top Beamans Brook) – TBB 9

Site 9 is located at the end of an unmarked dirt road which runs west from Dudley Town Road, .65 miles south of Blue Hills avenue. This section of the brook is near a construction site that is home to a future animal rescue shelter. Other than the future animal shelter the area is relatively isolated. The brook is at the edge of a forest and a small wooden bridge crosses it. No riffle zones are present in this section. The bottom is sandy and without rocks.

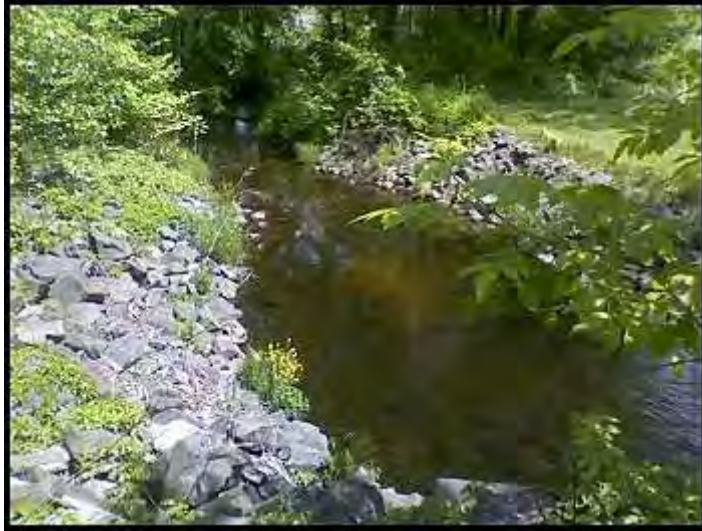
Site 6 (End Tumble Brook) – ETB 6

A bridge crosses the river upstream from our sampling location. There are tall grasses surrounding the right bank (looking downstream) and a forested area on the left. There is a tree whose branches shade the river over the riffle zone. There are small-medium rocks covering the bottom. The sampling site is accessible from Medinah Drive .1 mile east of Maple Avenue.

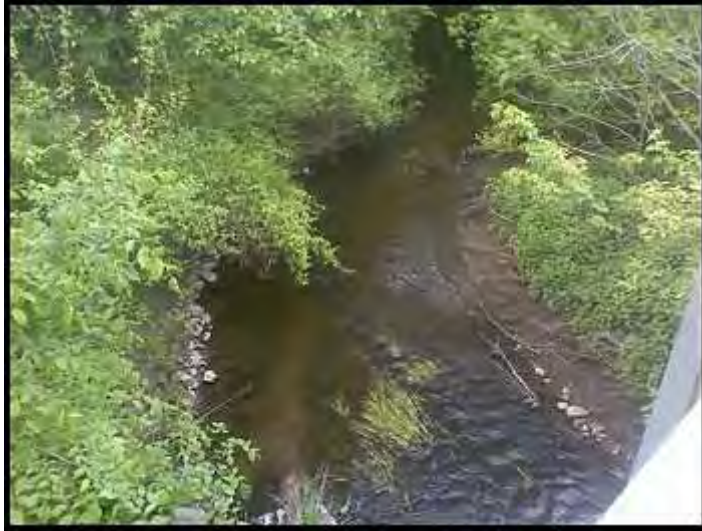
Site 10 (End Beamans Brook) – EBB 10

Site 10 is located a few hundred feet West of where Goodman St. intersects Route 218. The sampling site is located just downstream of bridge, South of Route 218. The river is very shallow at the sampling site, about a foot deep, but it gets deeper downstream. The bottom is mostly muddy but with a small riffle zone up stream under the bridge.

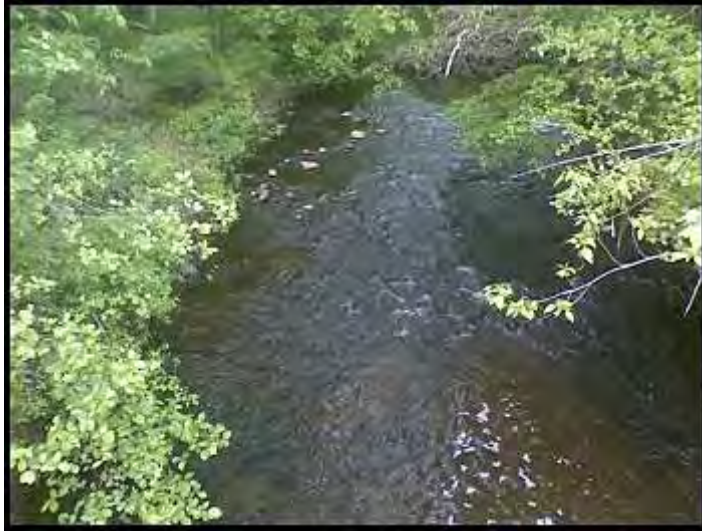
Site 8 (End Wash Brook) – EWB 8

Site 8 is located at the intersection of Route 218 and Bloomfield Avenue. A bridge crosses downstream of our sampling site. The section under the bridge is channelized. The river is much shallower in the channelized section under the bridge, about a foot and a half deep. On the other side of the bridge, the water is calm, and still shallow. The section of the river used for sampling is downstream of the bridge, and is a fast-flowing riffle zone. The bottom is very rocky, containing rocks of various sizes. Trees, shrubs, and grass are present on both banks.

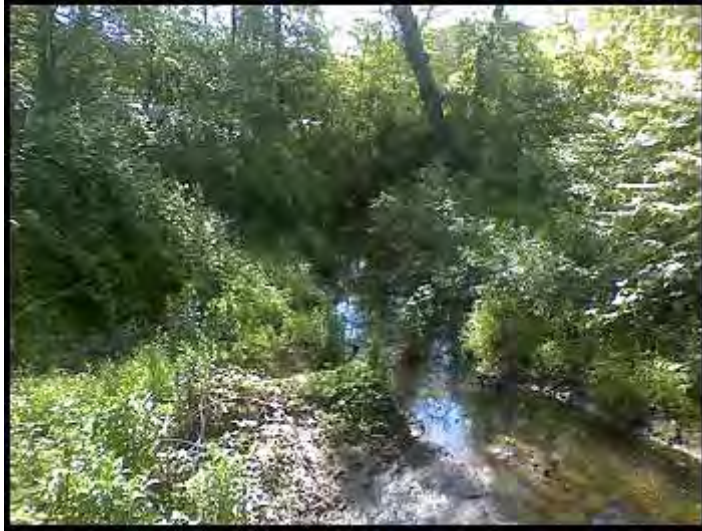
Site 11 (End Filley Brook) – EFB 11

Site 11 is located on the South side of Route 218 just east of the 600 Apartments. Water is about a meter and a half deep in the center. The mud is very thick and one sinks into it when walking in the stream. The banks are wooded on both sides of the stream. On one side there is an office park and on the other side there is an apartment complex. The water is also stagnant and brown in color.

However, Filley Brook site's data shows an increasing trend in these graphs. This site seems to be the most polluted; the water is very turbid and it has a pungent odor. It is located between parking lots and a large apartment complex whose storm water runoff could be contributing to the condition of the site. This also may account for the abnormal increasing trends. Also there is an outlier present in the TDS, conductivity, and salinity graphs. According to tables 11, 16, and 21, this data was collected on June 16<sup>th</sup> at site MNBPR 2 which is located in the University Hartford. This site is adjacent to several parking lots and a road so perhaps that could have influenced these high readings. This data could also be a result of the equipment malfunctioning on that particular day because the rest of the data for the site is normal.

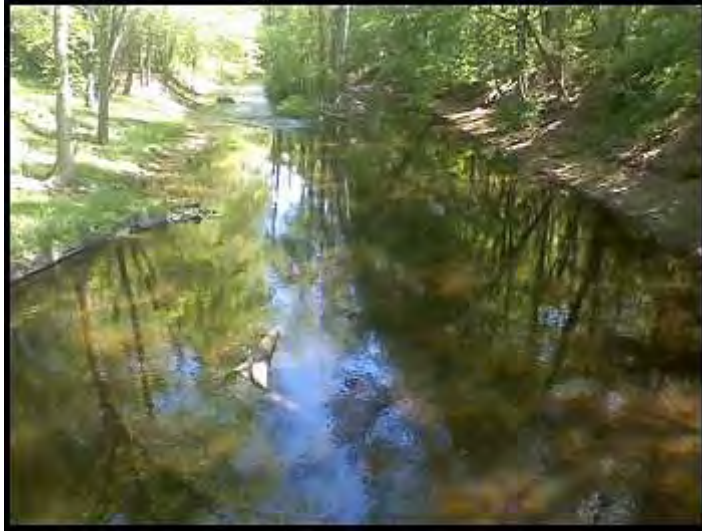
Site 1 (Top North Branch Park River) – TNBPR 1

Site 1 is located just downstream of where Portage Road crosses over the river, approximately .1 miles east of where Portage Road intersects Bloomfield Avenue. This section of the river runs through a residential area with houses on both banks. It has a rocky bottom that includes a mixture of rock sizes.

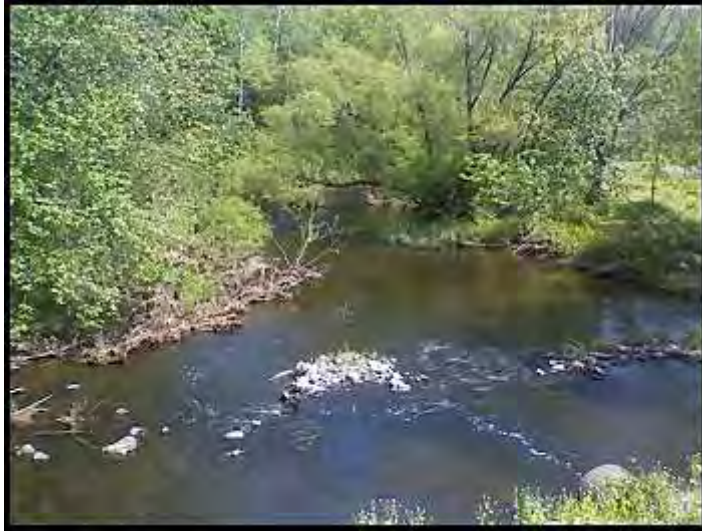
Site 2 (Mid 2 North Branch Park River) – MNBPR 2

Site 2 is located on University Drive .44 miles north-east of the intersection of University Drive and Bloomfield Avenue. The river is surrounded by dense shrubs and weeds, including poison ivy. There is a series of tunnels that go into the river and under the bridge. There is rip rap surrounding the abutment of the bridge. The depth of the river varies upstream to downstream and across the width. The bottom is covered with large rocks in most areas. There is a very small island (about 3ft in diameter) directly downstream from the third tunnel. This is where our uppermost riffle zone is located. Another riffle zone lies slightly downstream and to the right. This is the largest riffle zone at the site. The last riffle zone is much farther downstream and far to the left. This riffle zone is calmer than the others.

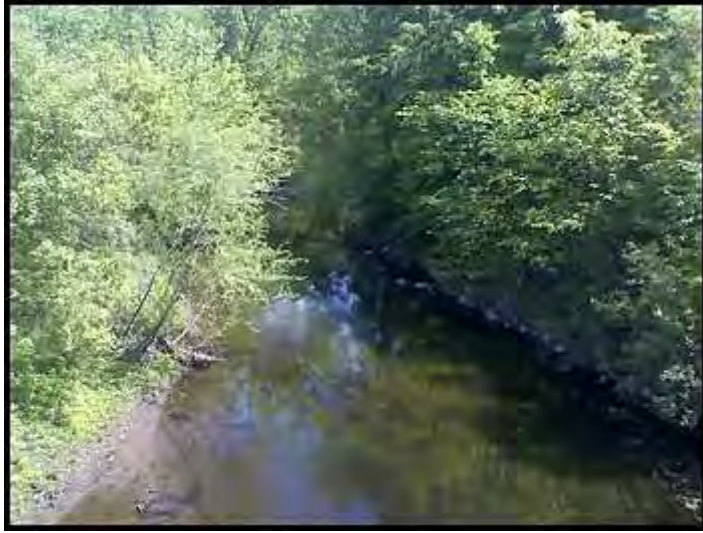
Site 3 (Mid 3 North Branch Park River) – MRBPR 3

Site 3 is located just downstream from the intersection of Albany Ave and Scarborough Street. The river is deep even on the bank and only gets slightly deeper in the middle. The river reaches a depth of approximately 1 meter in the middle. The riffle zone is downstream from blocks of concrete that create a miniature waterfall. There is a fast current around the riffle zone.

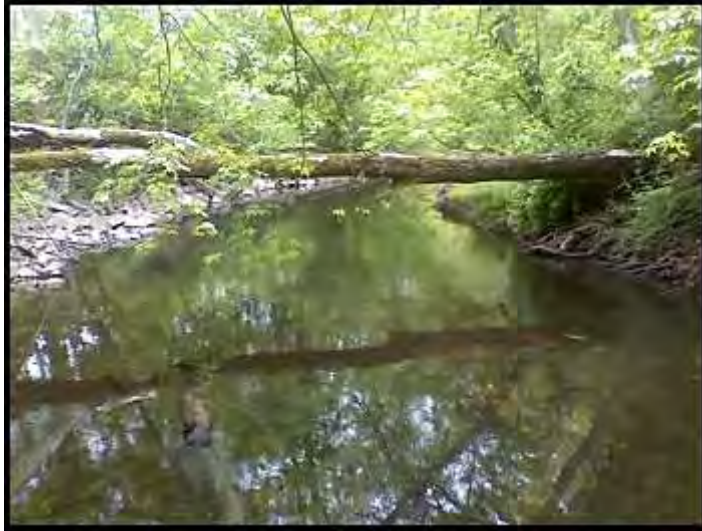
Site 4 (End North Branch Park River) – ENBPR 4

Site 4 is accessible from the back of the Medical Arts Building parking lot off of Woodland Street, .1 mile North of Farmington Avenue. The river is separated from the parking lot of the medical arts building by a brief wooded area. The water is about  $\frac{3}{4}$  of a meter deep and there is a slight current. The bottom of the river is mostly sandy with a few scattered rocks.
