Watershed Field Assessment Report North Branch Park River Watershed

Connecticut Department of
Environmental Protection

March 2010

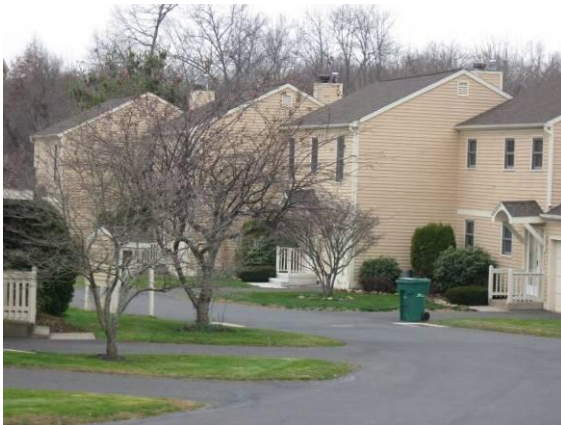
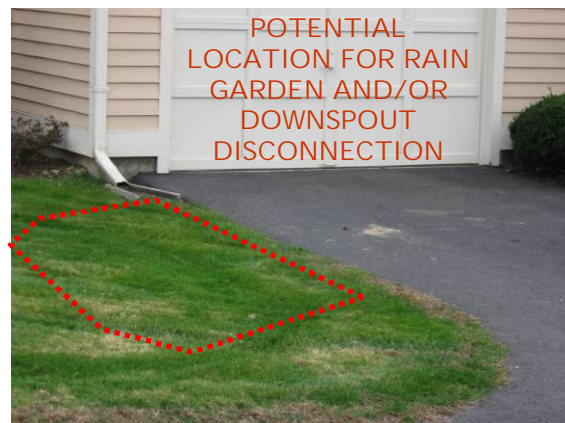
Mills Pond Townhouses

Mills Pond is a townhouse complex located on Chestnut Hill Drive and Pondsides Road in Bloomfield. The complex is approximately 20 years old with no evidence of infill or redevelopment. The neighborhood has some forest canopy and is surrounded by woods causing leaves and organic matter to collect in the curb and gutter street drainage system. An approximately 1-acre stormwater basin located along Pondsides Road receives stormwater runoff from the complex and discharges to a tributary to Wash Brook. Approximately 70% of the roof leaders drain to the turf areas on the side of the townhouses, with the remaining draining directly to driveways. In several locations, catch basins or yard drains are located within landscaped areas. In some instances there is adequate space next to the buildings for rain gardens or to receive runoff if roof downspouts are disconnected.

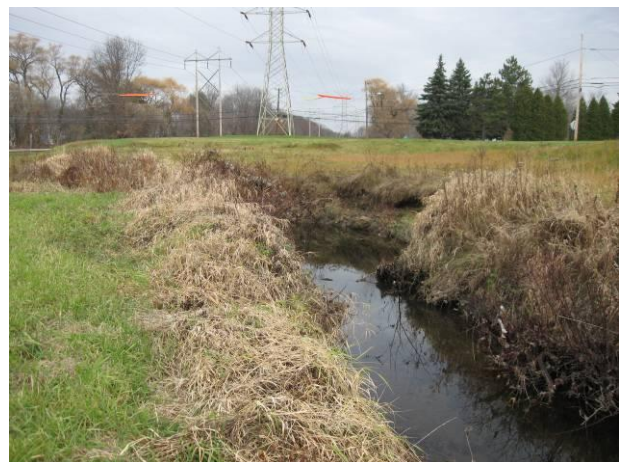
A nearby electrical utility corridor crosses Florence Road. Vegetation management activities in the utility corridor have impacted the vegetative buffer surrounding stream reaches BBW-04 and BBW-06 (the adjacent BBW-02 was assessed as part of the stream assessment portion of this project). The stream downstream of this area appeared to be down-cutting, with the banks severely eroding. The cause of the impacts may be a combination of impacted buffer and stormwater discharges. Opportunities exist to restore the riparian buffer to this segment of the stream by

planting low growing shrubs and native herbaceous vegetation that are compatible with the clearance requirements within the utility corridor right-of-way, combined with modified practices for maintaining the riparian buffer within the utility corridor.

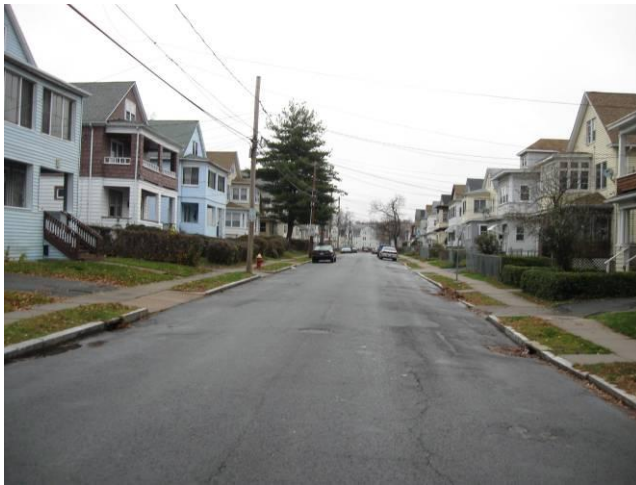
Adams Street is situated between Albany Avenue and the railroad line running along Homestead Avenue in Hartford. The homes on the 1/8-acre lots are two-family, and estimated to be 80 to 100 years old. The neighborhood is located within an area of Hartford serviced by combined sewers. Impervious surfaces comprise approximately 80% to 90% of the lots. Most of the roof leaders drain directly to driveways, which convey runoff to the combined sewer system, although several roof downspouts appeared to be plumbed into the residence, likely

entering the combined sewer system directly. This neighborhood is typical of many of the older, high-density residential neighborhoods in Hartford. Potential opportunities for improvements in this and other similar high-density residential neighborhoods include more frequent catch basin and storm drain cleaning (particularly for leaves), downspout disconnection, and lot-scale Low Impact Development practices and other green infrastructure practices such as green street retrofits.

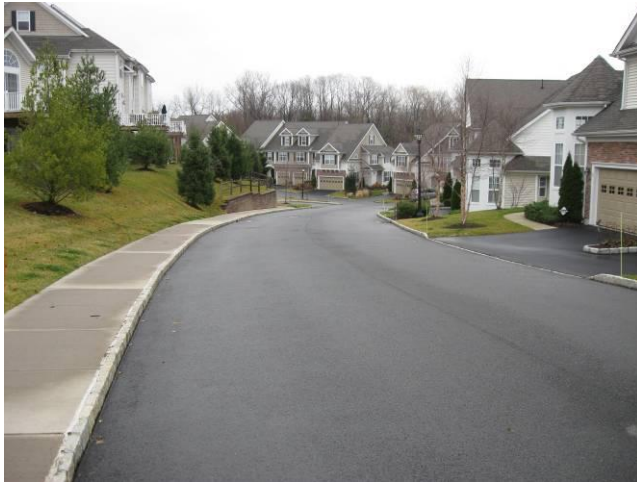
Goodwin Estates is a West End Hartford neighborhood in the North Branch Park River subwatershed. The site is a reclaimed brownfields area that was redeveloped in 2004 with townhouses and condominiums. The development is approximately 5 years old and is believed to have stormwater management infrastructure that includes underground infiltration devices for rooftop runoff. Lawns in the neighborhood are highly managed (i.e., fertilizer usage and permanent irrigation systems). The streets and sidewalks in this neighborhood are

clean of sediment and leaves. Overall, the neighborhood has a moderate pollution rating due to intensive lawn care practices, although the restoration opportunity in this neighborhood is low. The neighborhood is a good candidate for a catch basin stenciling program.

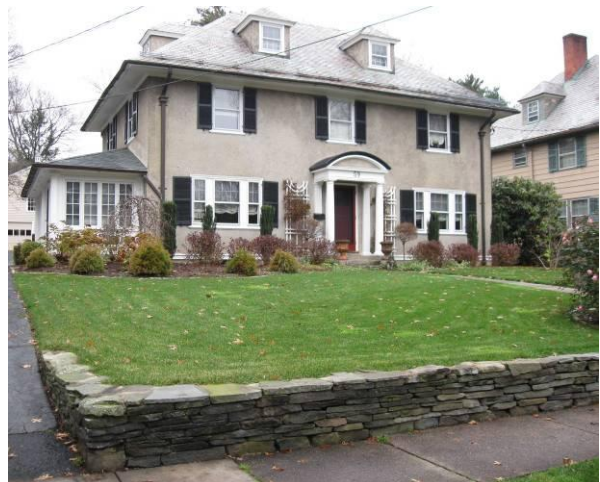
The Concord Street neighborhood is located in the North Branch Park River subwatershed in West Hartford. The ¼-acre lots are well maintained and have approximately 40-50% impervious cover, with approximately 10% of the lots consisting of landscaped planting beds, and the remaining areas consisting of grass lawns. Some lots have as much as 50% tree canopy cover given the age of the neighborhood. There are sidewalks along both sides of the tree-lined street, limiting the retrofit potential for roadside swales or bioretention.

The Concord Street neighborhood may be good candidate for rain barrel retrofits since roof leaders are likely connected directly to the combined sewer system and there are large landscaped areas that could be watered with the collected rainwater. It is recommended that the catch basins be stenciled in this area following the sewer separation along Concord Street (MDC sanitary sewer mapping indicates that sewers along Highland Street to the east and Walbridge Road to the west have been separated, while the Concord Street storm and sanitary sewers remain combined).

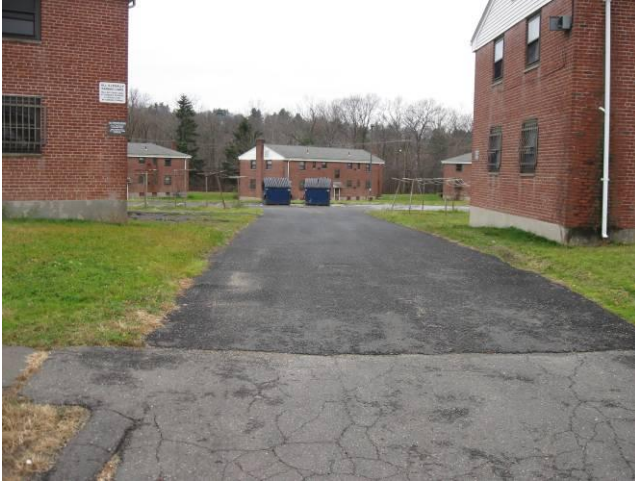
West Brook Village is a public housing development in Hartford located off of Mark Twain Drive and adjacent to the North Branch Park River. The development is mostly vacated, and the Hartford Housing Authority is reportedly working to negotiate the sale of the property. The property is utilitarian, with only the housing structures, lawns and roadways on the property with no landscape plots and a few sparse trees. Runoff from this site drains to the North Branch Park River, which is located nearby across Mark Twain Drive, without

treatment or detention. This and similar public housing developments provide opportunities for urban renewal pilot projects that could incorporate low impact development and green infrastructure elements.

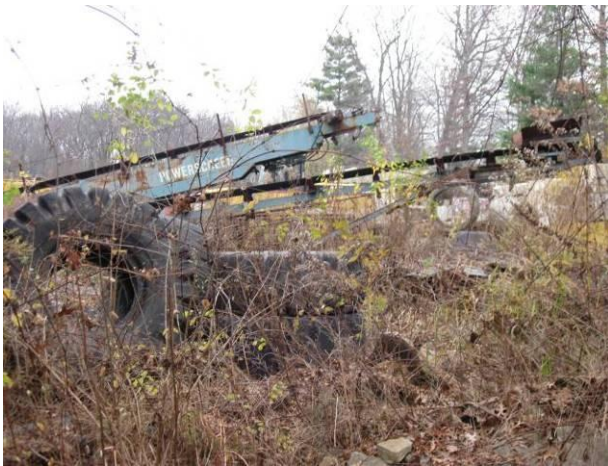
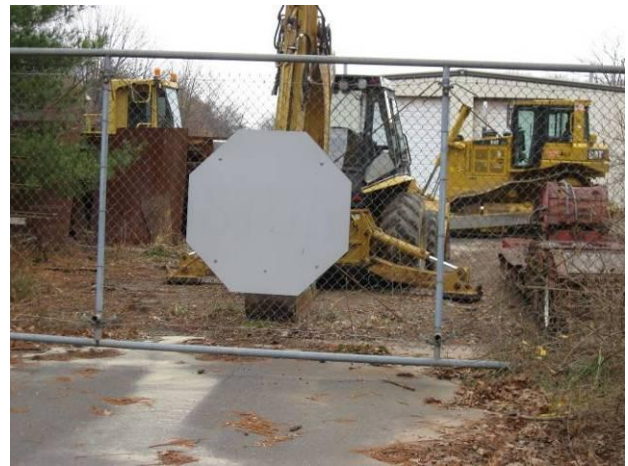
Southwood Road – Used Equipment Storage Lot

A property on Southwood Road of unknown ownership is located between the Mather Corporation parcel and the volunteer fire department building. The property is being used as machine and used equipment storage lot. The ownership of the property is unclear from the Bloomfield Assessors database since the address is unknown. Field crews could not gain access to the site for inspection, although used machinery, tires, roll-off dumpsters, loading trucks, and machine and truck parts were observed to be scattered throughout the site. The equipment and machinery is a potential stormwater pollutant source, and the site is located near a tributary of Beaman Brook. A follow-up evaluation of this site is recommended to confirm property ownership and further evaluate the site for pollution potential.

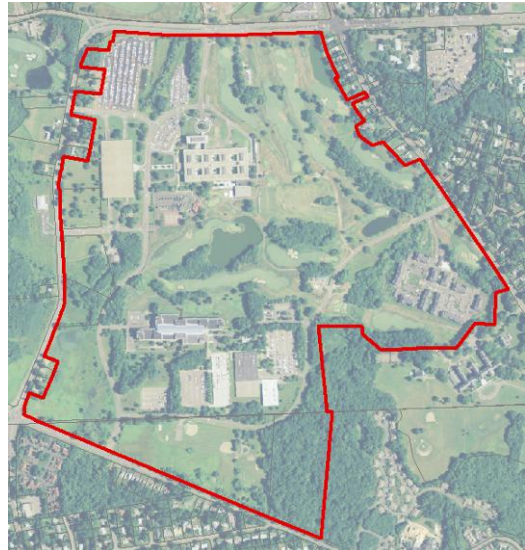
The Cigna Campus is a 304-acre parcel including Cigna, Metlife and Gillette Ridge Golf course offices. The eastern portion of the property also contains part of the Gillette Ridge Golf Course. Based on GIS mapping, there is approximately 60 acres of impervious area on the parcel, for approximately 20% overall imperviousness. Facility trash and other wastes are primarily stored and managed indoors or under covered overhangs, such as a loading dock in the rear of the Cigna building. Stormwater controls are present on the site. A parking garage associated with the Cigna building appears to drain to a constructed wetland along Hall Boulevard.

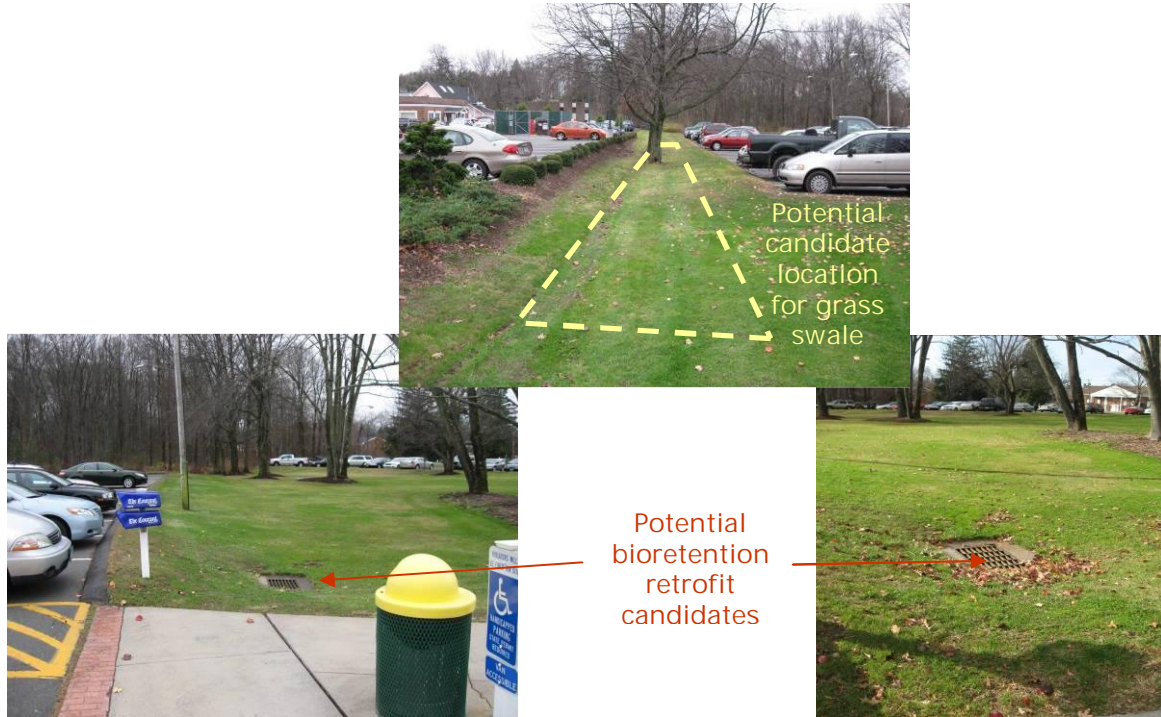
The Bloomfield Town Hall is located on Park Avenue in Bloomfield Center in the Wash Brook South subwatershed. The Town Hall is an administrative building with staff parking and no storage of fleet vehicles or on-site industrial activities. Although the pollution potential of this site is low, it is a good candidate for a demonstration stormwater retrofit project on a high-profile municipal site. The site is highly visible since it is a municipal building located at a main intersection in the Bloomfield town center. There are many stormwater retrofit opportunities at this site at locations where stormwater is currently directed toward catch basins in grassed areas or low areas downgradient of the parking lot. Additionally, there is adequate open space on the property to implement on-site retrofits such as rain gardens, vegetated swales or bioretention to treat runoff from the roof or parking areas.
