Reach Level Assessment

SURVEY REACH ID: <u>NR-4</u>		WTRSHD/SUBSHD:		DATE: <u>11/23/09</u>		ASSESSED BY: <u>SG+CM</u>	
START TIME: <u>10:15</u> AM/PM	LMK: <u>FORMATION</u>	END TIME: <u>11:45</u> AM/PM	LMK: <u>ARMY</u>	GPS ID:			
LAT <u>41° 43' 04"</u> LONG <u>72° 43' 24"</u>		LAT <u>41° 48' 18"</u> LONG <u>72° 43' 34"</u>		DESCRIPTION:

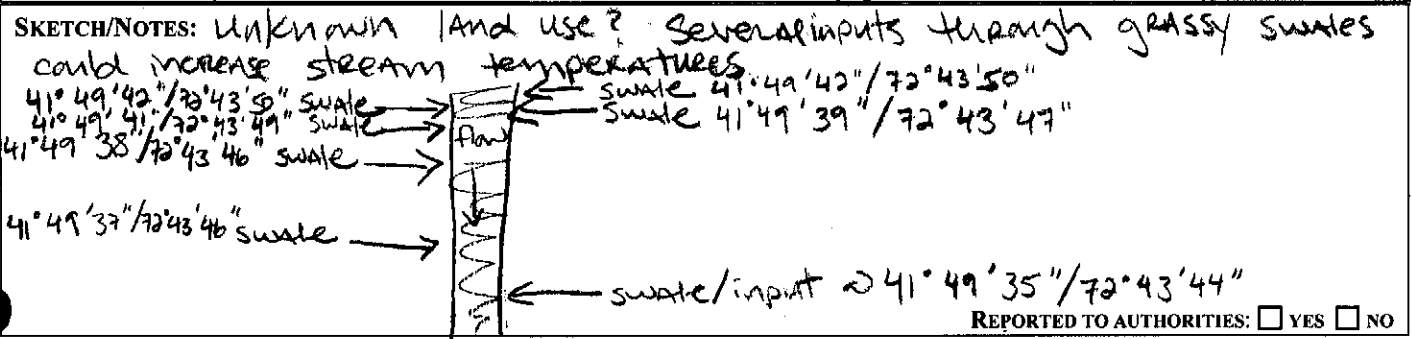
<b>OUTFALL SEVERITY:</b> (circle #)	Heavy discharge with a distinct color and/or a strong smell. The amount of discharge is significant compared to the amount of normal flow in receiving stream; discharge appears to be having a significant impact downstream.	Small discharge; flow mostly clear and odorless. If the discharge has a color and/or odor, the amount of discharge is very small compared to the stream's base flow and any impact appears to be minor / localized.	Outfall does not have dry weather discharge; staining; or appearance of causing any erosion problems.	
	5	4	(3)	2

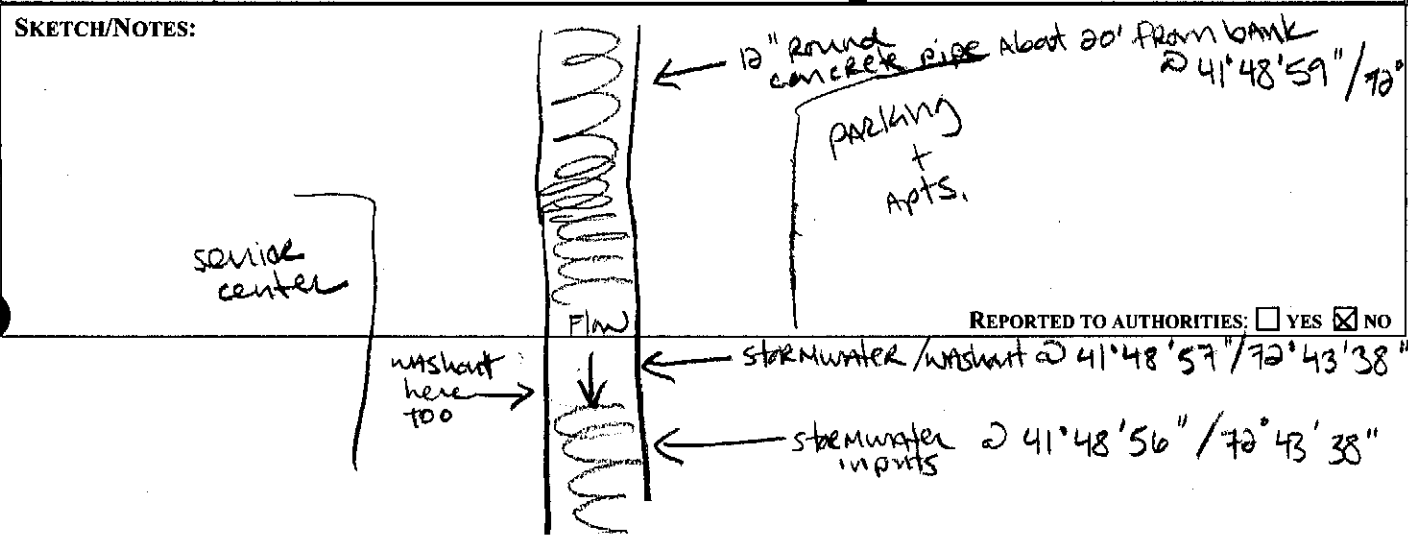
If yes for stormwater:  
 Is stormwater currently controlled?  Yes  No  Not investigated  
 Land Use description: Parking / Building (apartments?)  
 Area available:

<b>OUTFALL SEVERITY:</b> (circle #)	Heavy discharge with a distinct color and/or a strong smell. The amount of discharge is significant compared to the amount of normal flow in receiving stream; discharge appears to be having a significant impact downstream.	Small discharge; flow mostly clear and odorless. If the discharge has a color and/or odor, the amount of discharge is very small compared to the stream's base flow and any impact appears to be minor / localized.	Outfall does not have dry weather discharge; staining; or appearance of causing any erosion problems.
	5	4	3
